# All-India Survey of Photovoltaic Module Degradation: 2013

**National Centre for Photovoltaic Research and Education  
(NCPRE), IIT Bombay**

**Solar Energy Centre, Gurgaon**

May-June 2013  
Report dated March 2014

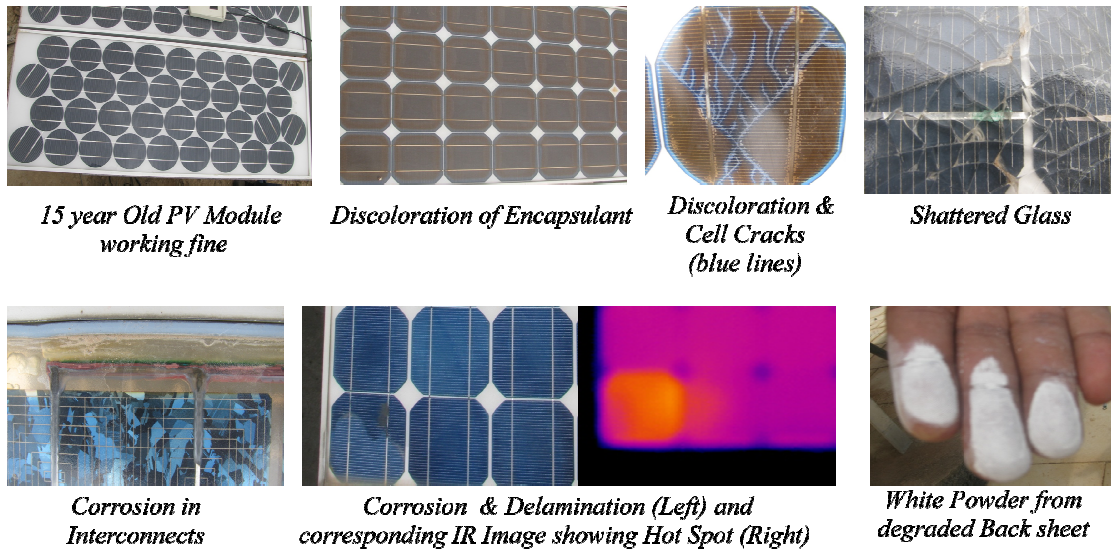
The different types of degradation visibly seen on the modules have been shown in Fig. VIII. Discoloration of EVA, the most commonly used encapsulant now-a-days, results in a brownish colour on the modules, which lowers the amount of light transmitted to the solar cells. Corrosion leads to the reddish and greenish discolorations on the busbars and interconnects. The series resistance of the module increases due to corrosion of the metallization, leading to a reduction in fill factor and power output. Burn marks have been also seen in some of the PV modules. Delamination refers to the separation of the solar cell (or the top glass cover) from the encapsulant, which reduces the thermal conductivity at the site, and results in higher operating temperatures (as shown in the IR image alongside the delaminated module). In a few rare cases, we could find modules with shattered glass cover and these modules were actually performing quite well, but signs of corrosion due to moisture ingress could also be seen in such modules. The backsheets of the modules had bubbles in some cases, and sometimes we could also find chalking (generation of white powder) in the backsheets. Out of the various modes of module degradation, discoloration of the EVA has been found to be the most widespread (seen in 71% of the inspected modules), while the corrosion of metallization and interconnects comes a close second. The first mode reduces the short circuit current while corrosion decreases the fill factor, both ultimately reducing the power output of the module.

Fig. VIII: Different types of module condition/degradation seen during the survey.

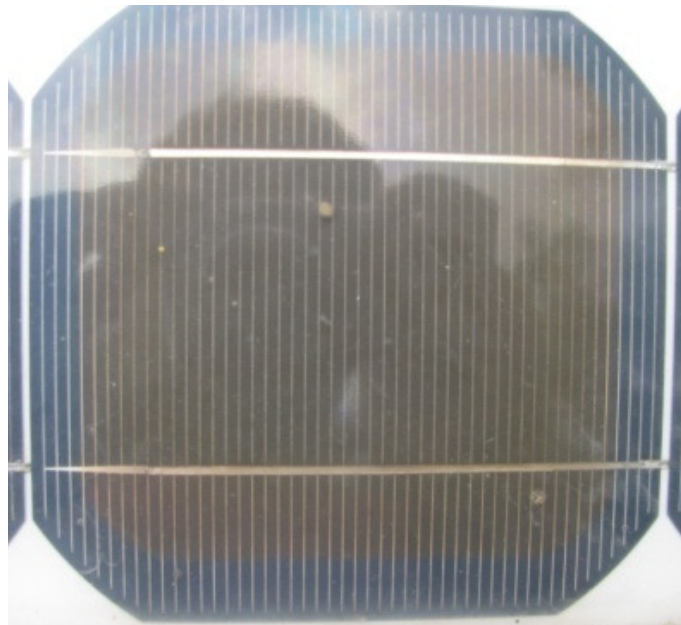
Fig. 8.7: Browning of EVA from the centre with transparent EVA intact at the edge of the solar cell

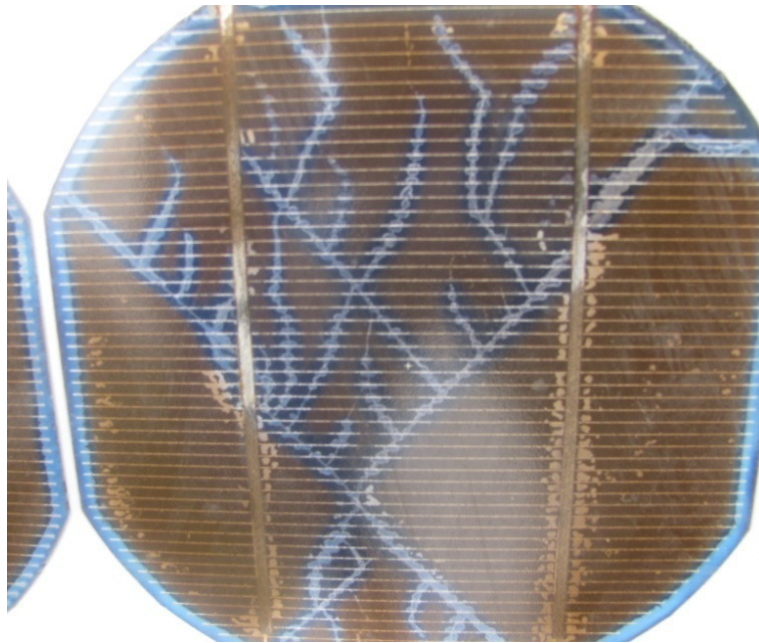
Fig. 8.9: Cracks in a solar cell are made visible by the photo-oxidative bleaching effect on the otherwise discolored EVA.

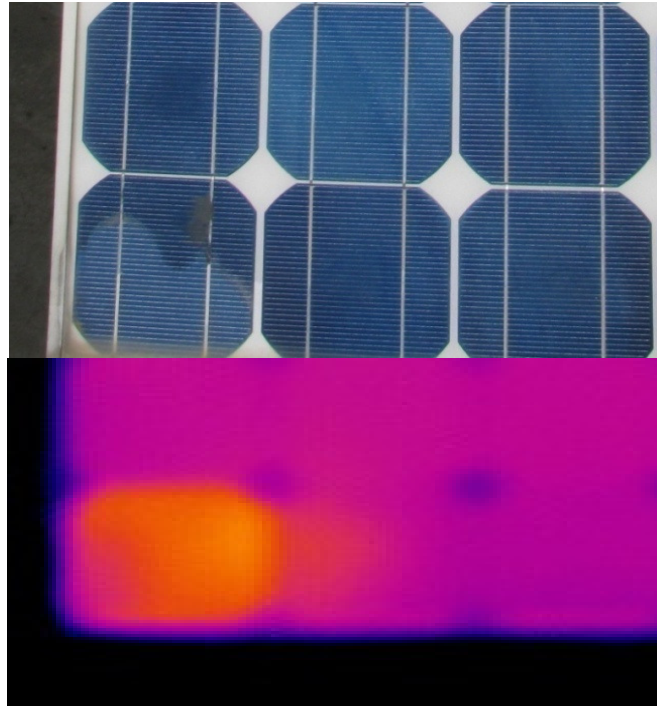
Fig. 8.10: Delamination (seen as light blue region in the bottom left-most solar cell) of a module (top image) installed in Composite zone in 1999 and its infra-red image (bottom image)

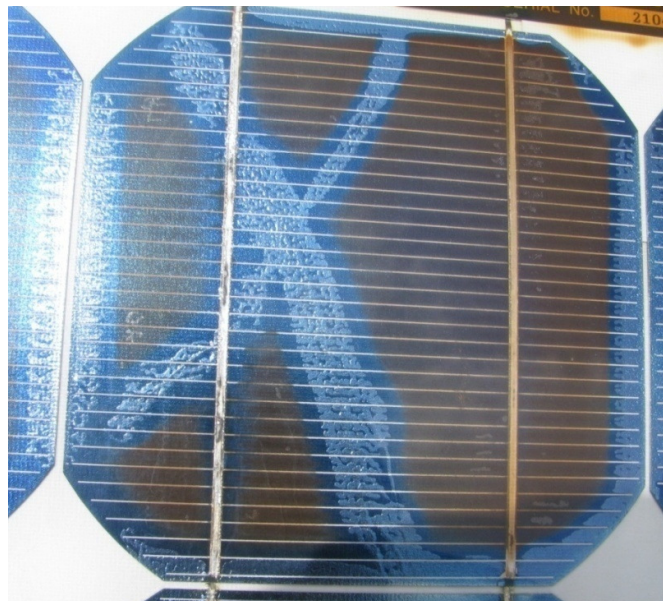
Fig. 8.11: Delamination (light blue region seen along the edges of the solar cell and crisscrossing the centre of the solar cell) in a PV module installed in Hot & Dry climate in 2000.

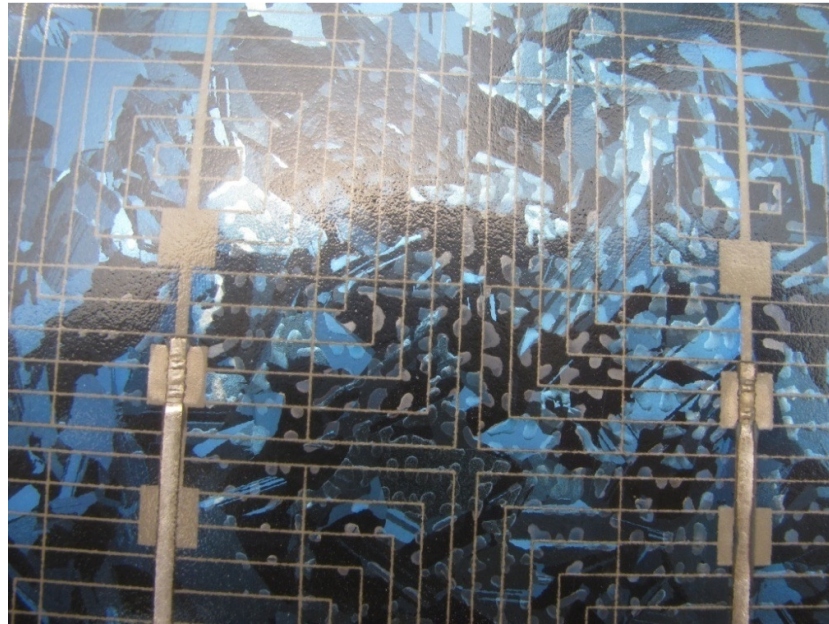
Fig. 8.12: Delamination (bubbles) in a PV module installed in Hot & Dry climate in 1988.

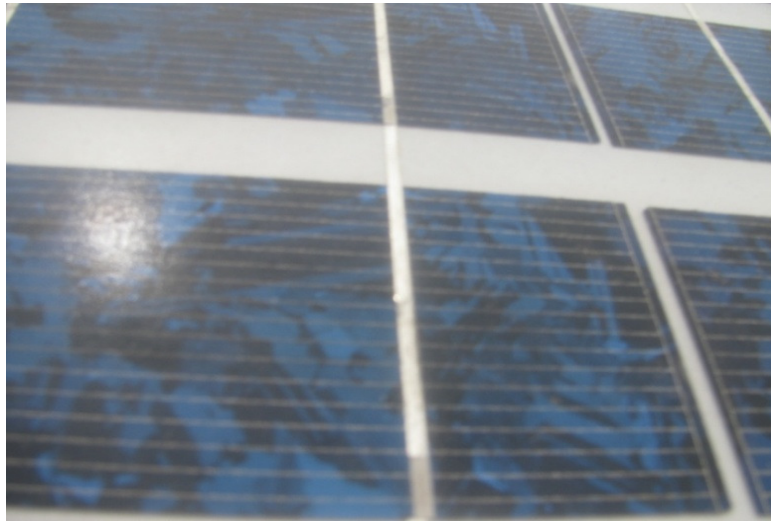
Fig. 8.15: Corrosion (discoloration) in fingers

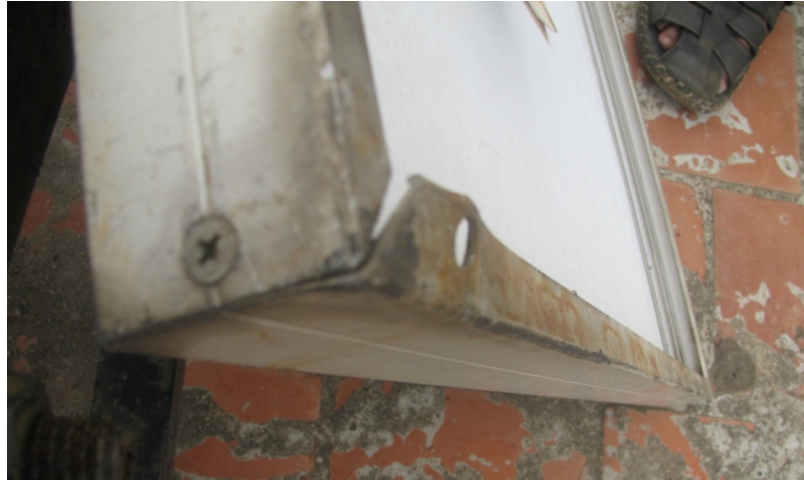
Fig. 8.31: Corroded and dented frame of a PV module

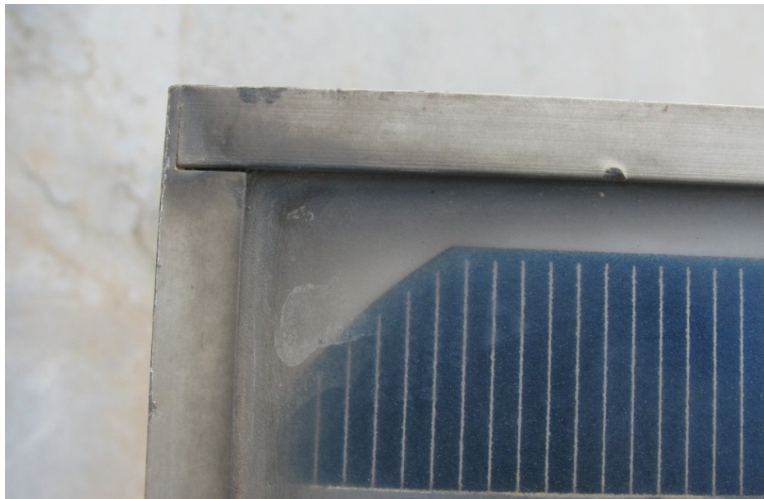
Fig. 8.32: Corrosion (blackening) of the frame of a PV module

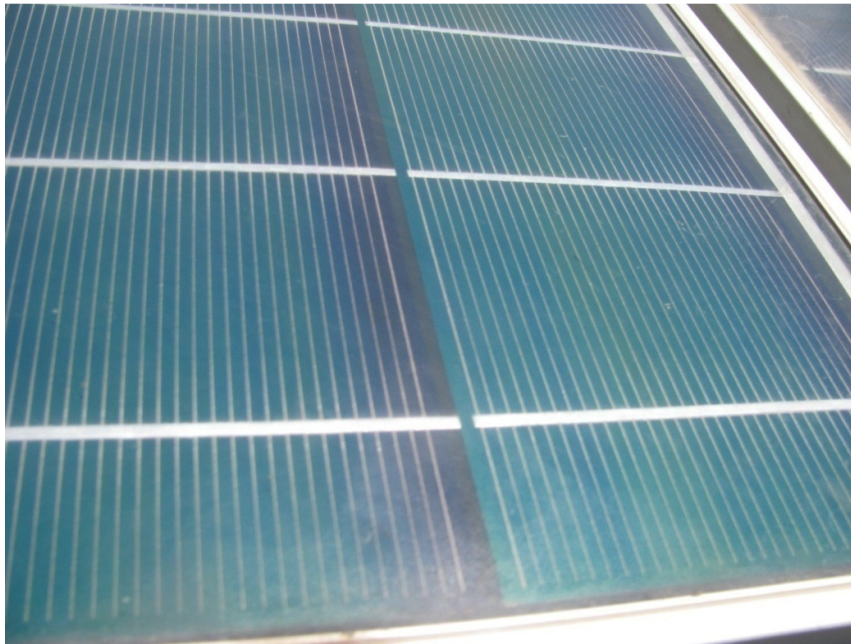
Fig. 8.34: Light yellow discoloration seen in CIGS module

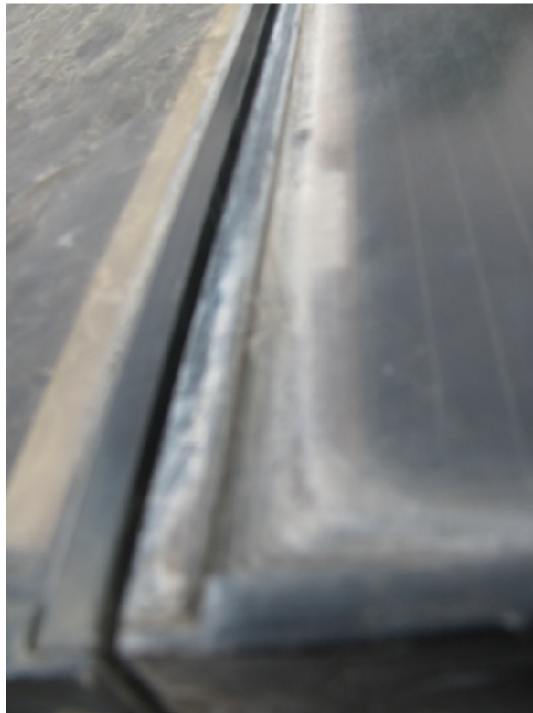
Fig. 8.38: White deposits (salts) at the edges of the CIGS Module

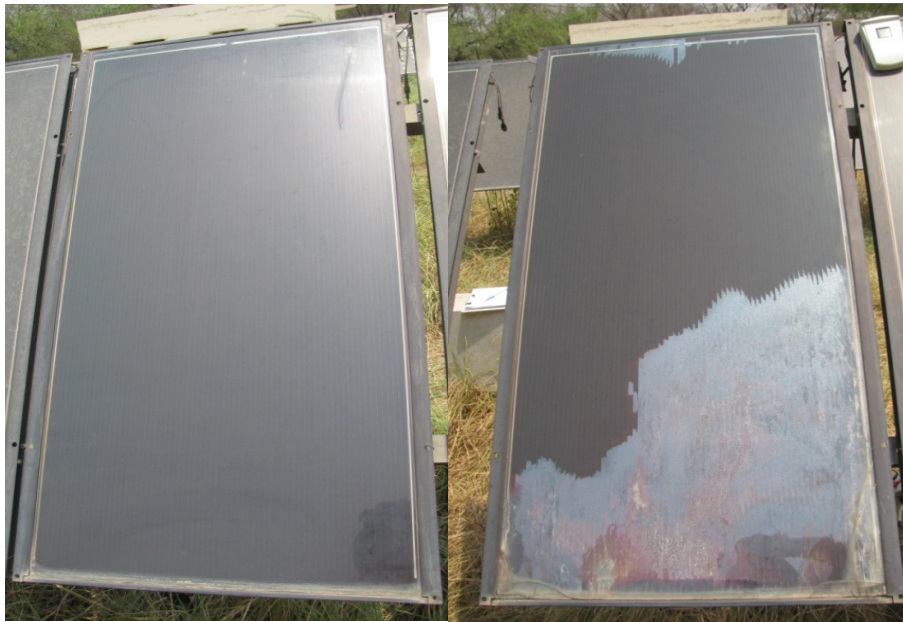
Fig. 8.39: Bar-graph corrosion in amorphous silicon double tandem PV module

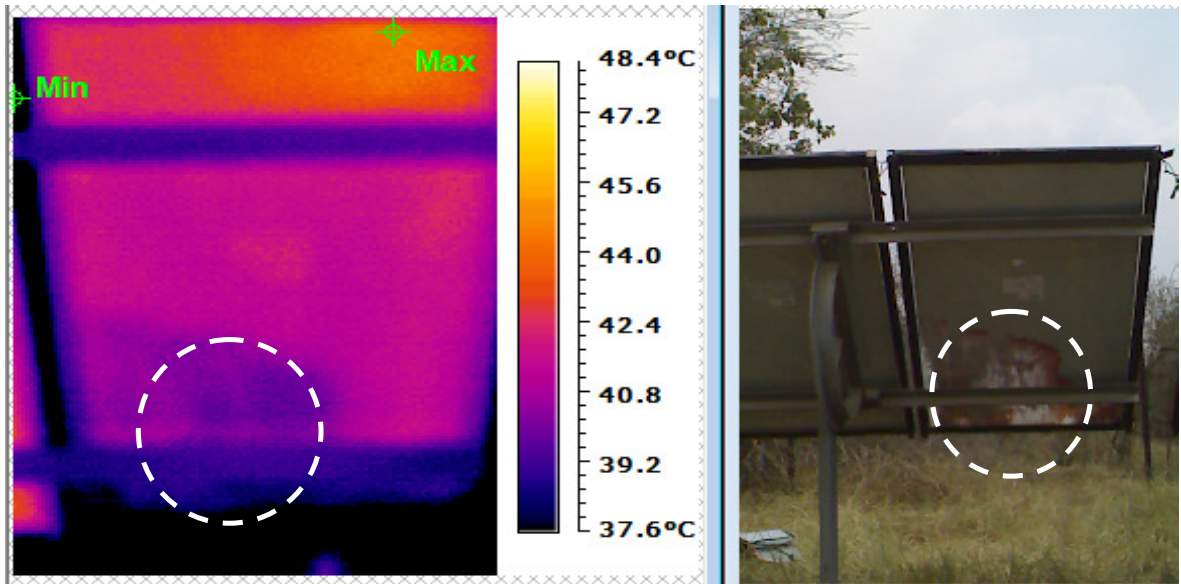
Fig. 8.42: Infra-red image (left side) of the corroded module shows that the corroded portion (blue patch near the bottom) is the coldest in the module.

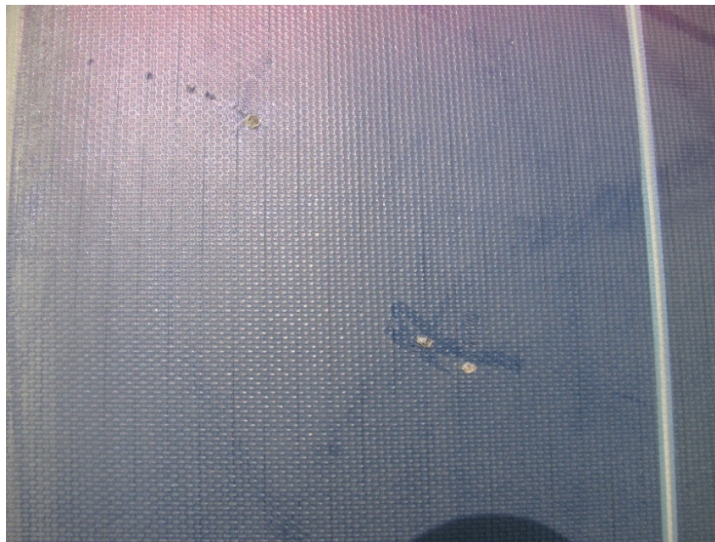
Fig. 8.45: Puncture marks on the module top fabric

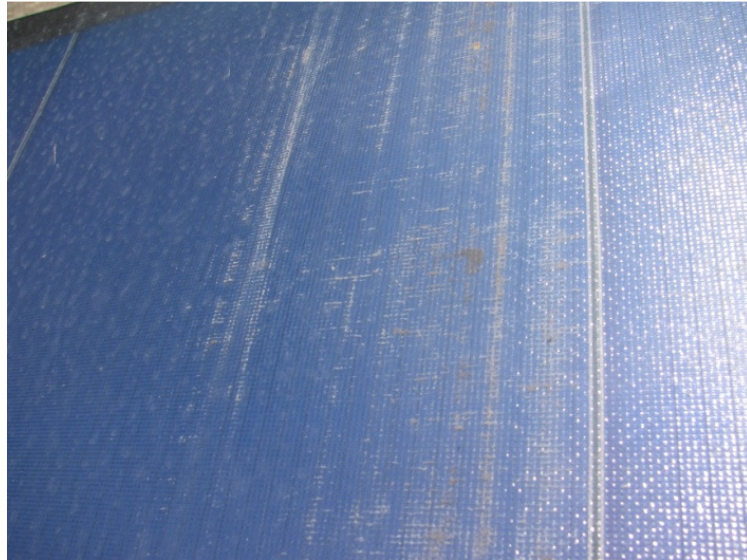
Fig. 8.47: Damaged surface of the triple tandem a-Si module

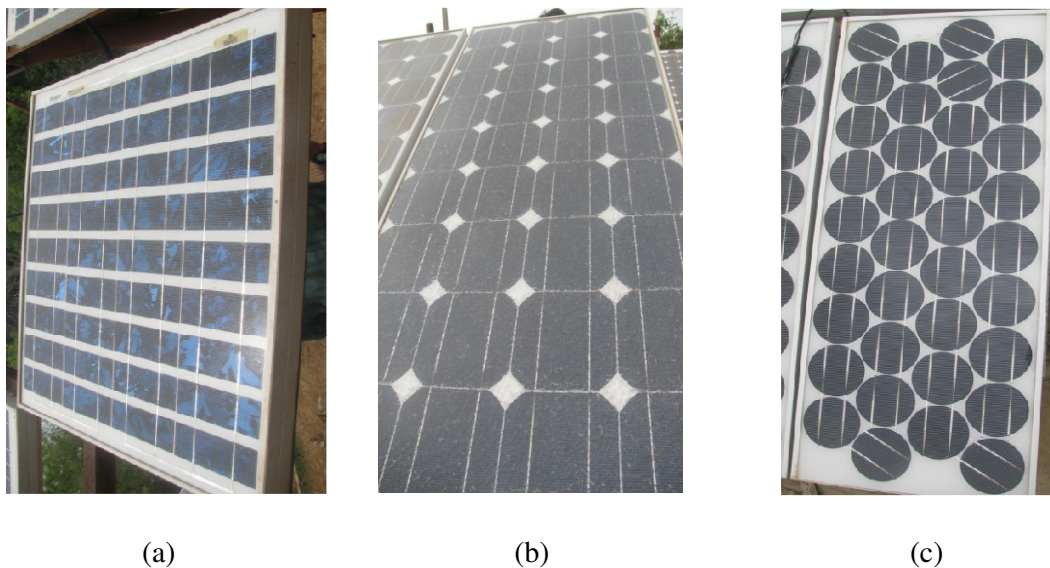
Fig. 8.53: (a) 7 year old PV Module (placed in Hot & Humid climate) showing no degradation in  $P_{max}$   
 (b) 15 year old PV Module (placed in Hot & Humid climate) with shattered front glass having  $P_{max}$  degradation rate of 0.05% per year,  
 (c) 15 year old PV Module (placed in Cold climate) having degradation rate of  $P_{max}$  degradation of 0.12% per year
