# All-India Survey of Photovoltaic Module Degradation: 2013

**National Centre for Photovoltaic Research and Education  
(NCPRE), IIT Bombay**

**Solar Energy Centre, Gurgaon**

May-June 2013  
Report dated March 2014

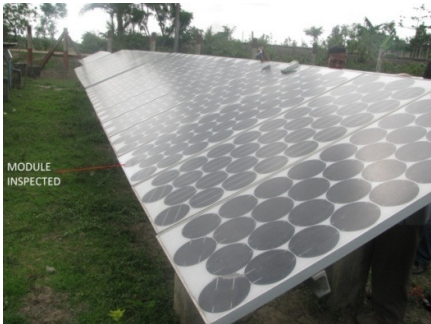
<p>DATE OF VISIT : 26 May 2013</p> <p>LOCATION: Sagar Island (21.94 N, 88.8 E)</p> <p>TYPE OF MODULES SURVEYED (Nos.) : Mono c-Si (3)</p>

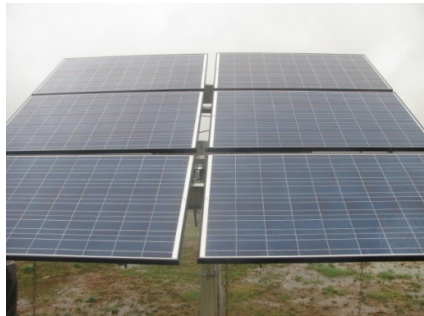
<p>DATE OF VISIT : 31 May 2013</p> <p>LOCATION: Patna (25.08 N, 85.27E)</p> <p>TYPE OF MODULES SURVEYED (Nos.) : Mono c-Si (2)</p>

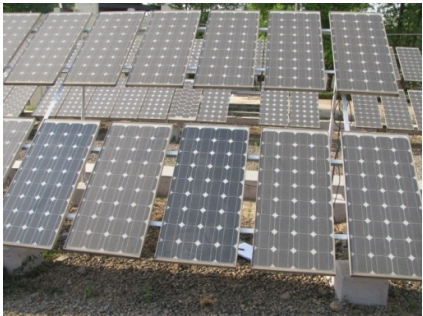
<p>YEAR OF INSTALLATION: 2010 (2 nos.)</p>	<p>SITE NO. : 21</p> <p>CLIMATE : Composite</p> <p>DATE OF VISIT : 1 June 2013</p> <p>LOCATION: Gurgaon (28.47 N,77.03 E)</p> <p>TYPE OF MODULES SURVEYED (Nos.) : Mono c-Si (5), a-Si(3), CIGS(1)</p>

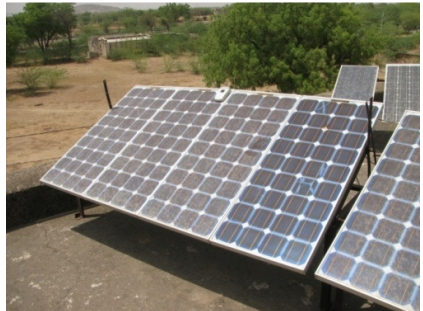
<p>YEAR OF INSTALLATION: 1988</p>	<p>SITE NO. : 23</p> <p>CLIMATE : Composite</p> <p>DATE OF VISIT : 5 June 2013</p> <p>LOCATION: Tilonia (26.65 N,74.95E)</p> <p>TYPE OF MODULES SURVEYED (Nos.) : Multi c-Si (1), Mono c-Si(5)</p>

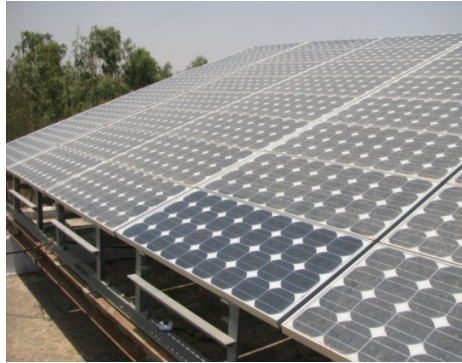
SITE NO. : 25

LOCATION: Tilonia (26.65 N,74.95E)

TYPE OF MODULES SURVEYED (Nos.) : Mono c-Si (4)

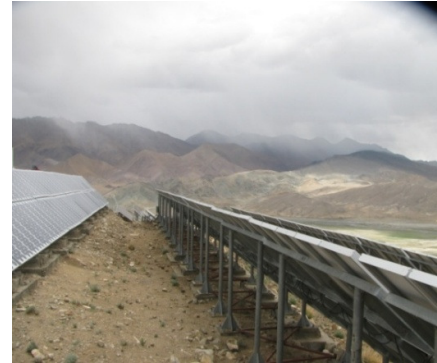
SITE NO. : 26

LOCATION: Hanle (32.77 N,78.96 E)

TYPE OF MODULES SURVEYED (Nos.) : Mono c-Si (3)

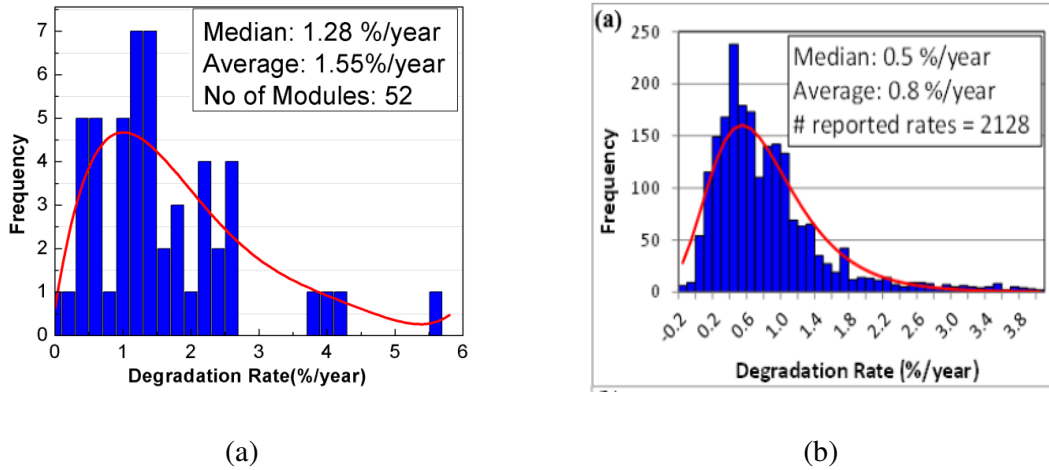
The degradation rates observed during the survey are shown in the histogram in Fig. 7.1 a, where the red curve is the extreme value distribution fit. A similar analysis has been done by Jordon *et al.* [8], who had compiled data from various sources, and this is shown in Fig. 7.1 b. The value of mean degradation is 1.51%/year and median value of degradation to be 1.24%/year. *It should be noted that in our survey we have inspected mainly visibly degraded modules, since the aim was to assess degradation mechanisms. Hence, the degradation rates reported in this survey are not typical degradation rates of a particular technology, but rather the degradation rates seen for modules showing visible degradation, and hence are higher than typical degradation rates.* This caveat should always be borne in mind while looking at the data in this and the next two chapters.

Fig 7.1 a: Histogram of degradation rate with extreme value fit.

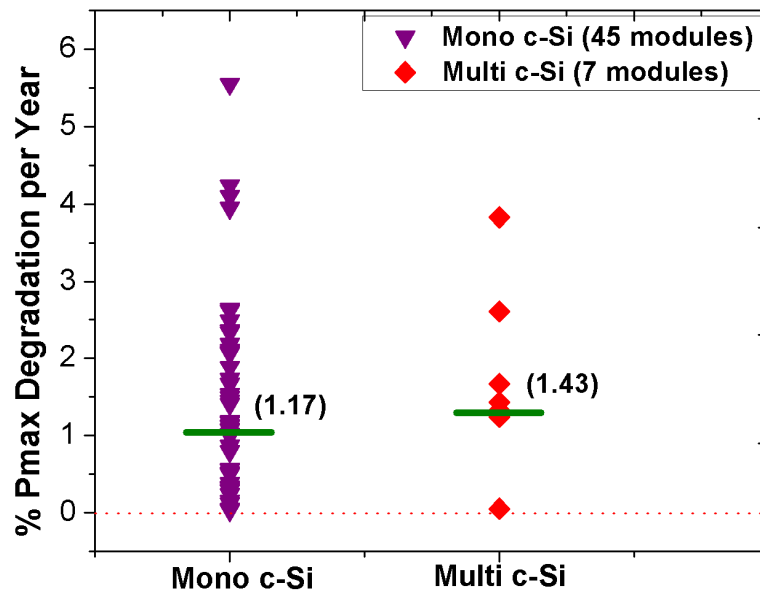
The Fig. 7.2 shows the  $P_{max}$  degradation per year for mono and multi crystalline silicon with the median as the crossbar. It is evident that the degradation rate for multi c-Si is slightly more than mono c-Si which is supported by the analysis done by Jordon *et al.* [8].

Fig 7.2:  $P_{max}$  degradation per year for mono and multi crystalline modules

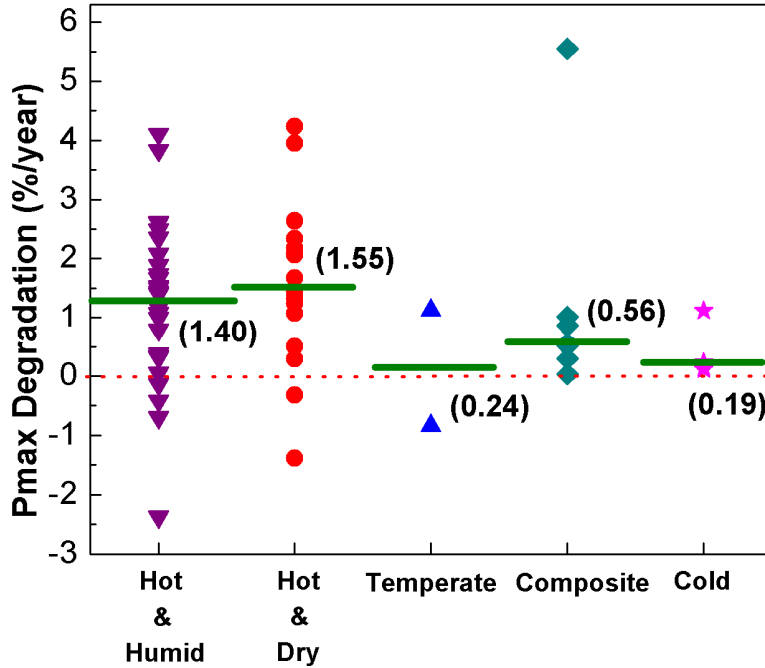
From the Fig. 7.3 it can be evident that the degradation in power is highest in Hot & Dry type of climate and least in Cold type of climate. The reason may be that discoloration which causes the heavy degradation in power is accelerated at higher temperature.

Fig 7.3: Comparison of  $P_{max}$  degradation rates in different climatic zone.

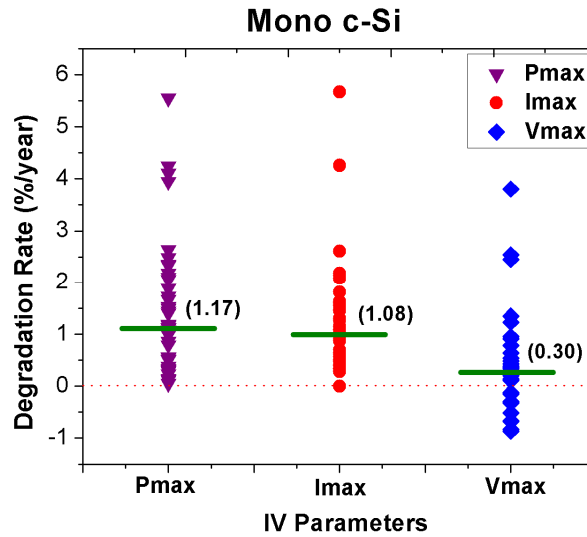
Figure 7.4 and 7.5 shows the annualized degradation rate for  $P_{max}$ ,  $I_{max}$  and  $V_{max}$  for mono and multi c-Silicon. The predominant decline appears to be in current and not in voltage. This is similar to the trend observed by Jordon *et al.* [8].

Fig 7.4: Annual degradation rate for  $P_{max}$ ,  $I_{max}$  and  $V_{max}$  for mono c-Si

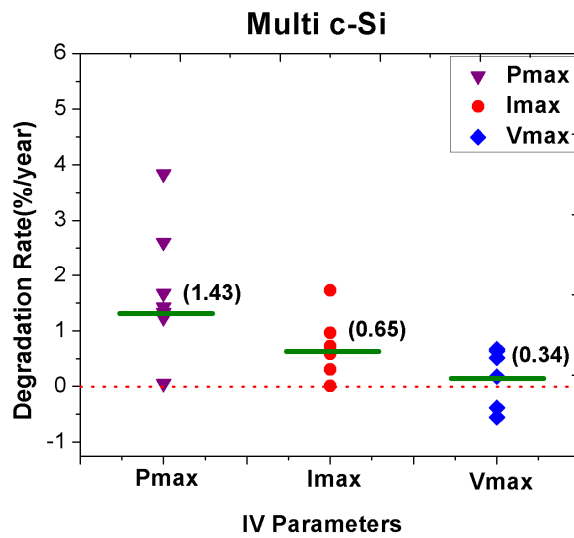
Fig 7.5: Annual degradation rate for  $P_{max}$ ,  $I_{max}$  and  $V_{max}$  for multi c-Si

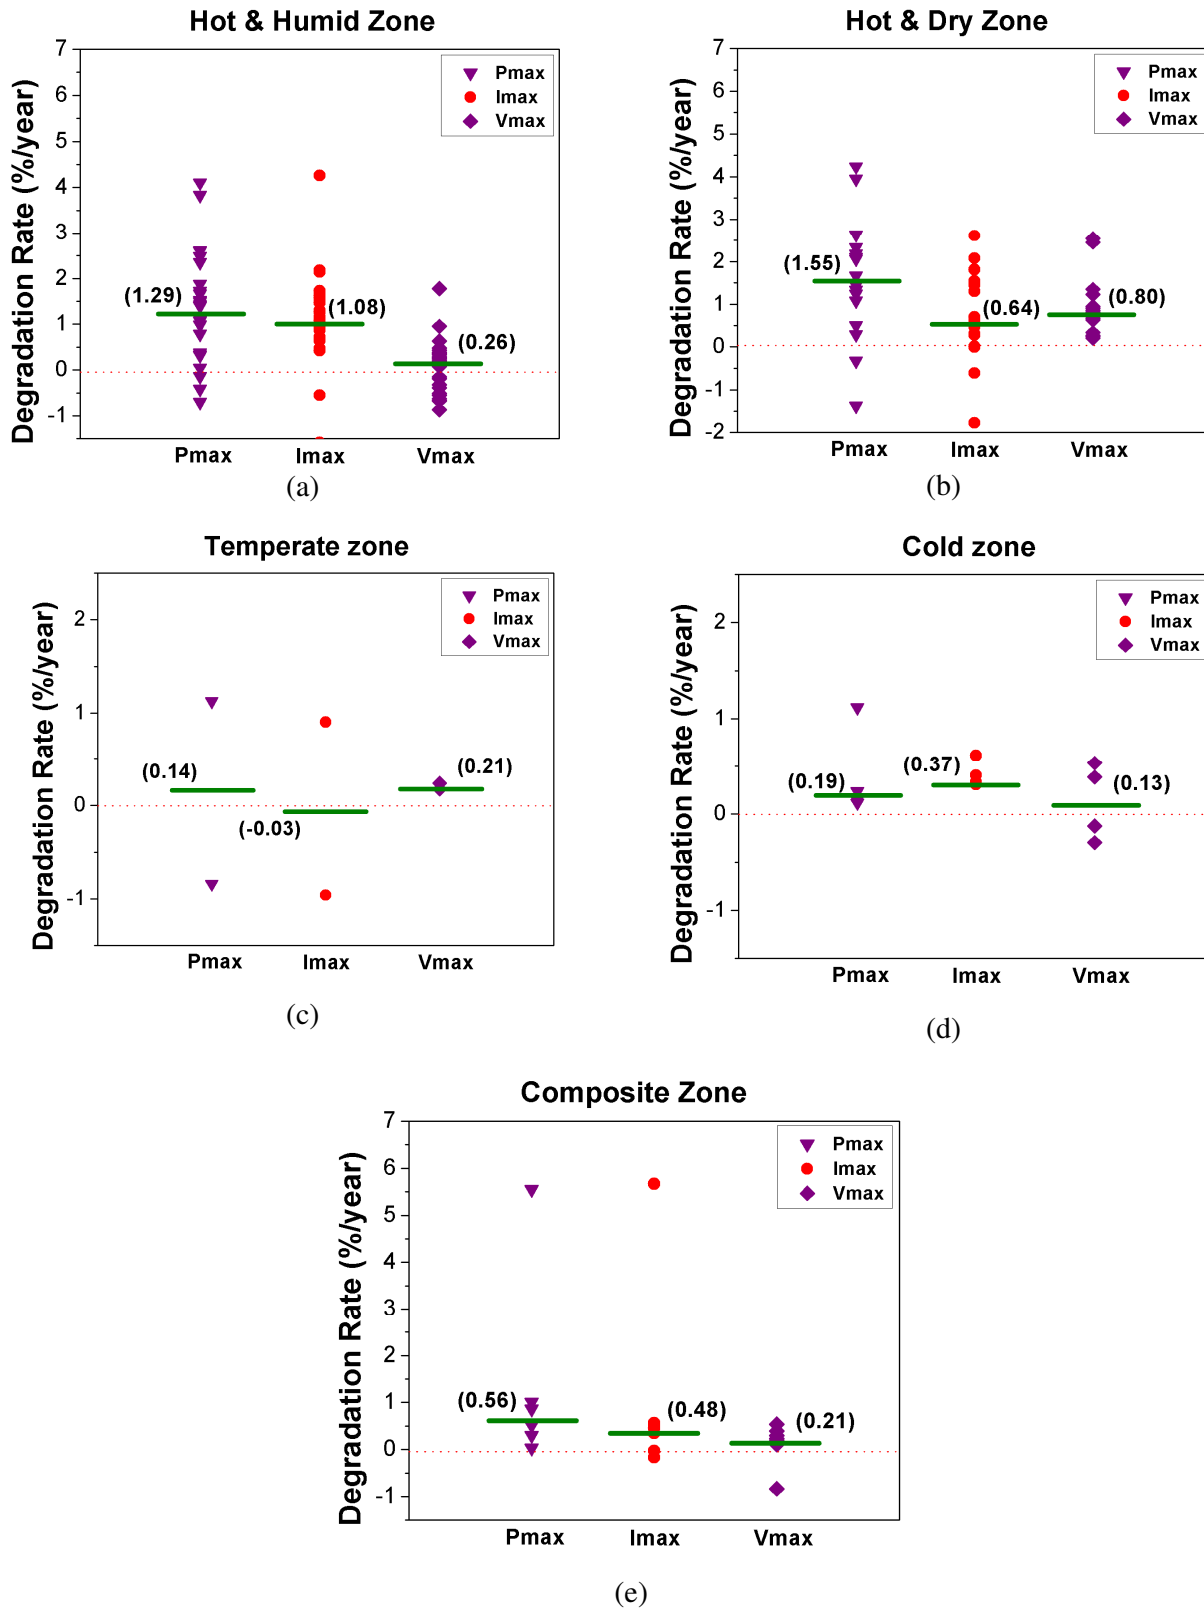
The maximum power point parameters distribution by the climatic zone for crystalline silicon modules is shown in fig. 7.6 (a)-(e). For most of the climatic zones,  $I_{max}$  degradation is the largest contributor to the  $P_{max}$  degradation. It can also be seen that for Cold and Dry type of climate,  $I_{max}$  degradation is more than the  $P_{max}$  degradation.

Fig 7.6: Maximum power point parameter degradation distribution for (a) Hot & Humid Climatic Zone (b) Hot & Dry Zone (c) Temperate Zone (d) Cold Zone (e) Composite Zone.

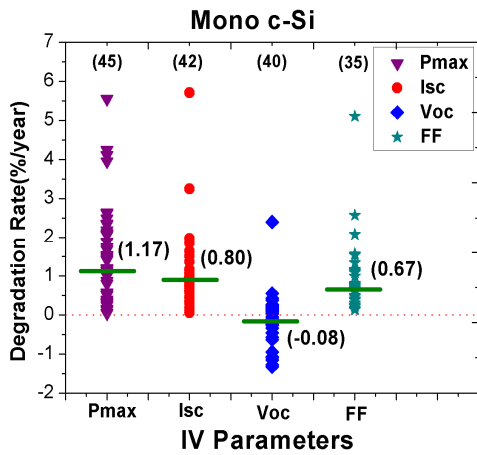
(a)

Of further interest is to understand how I-V parameter degradation differs by technology. Figures 7.7 and 7.8 show  $P_{max}$ ,  $I_{sc}$ ,  $V_{oc}$  and  $FF$  degradation for c-Si technologies: mono c-Si (Fig 7.7 a) and multi c-Si (Fig 7.8 a). Mono-Si and multi-Si display a similar pattern in which the highest  $P_{max}$  degradation is most closely correlated with degradation in  $I_{sc}$ , followed by  $FF$  and finally  $V_{oc}$ , which degrades little. Typical observed  $I_{sc}$  degradation can be attributed to delamination, discoloration and cracked individual cells while a smaller percentage can be attributed to light-induced degradation and soiling. Significantly less degradation comes from  $FF$ , typically associated with corrosion and solder-bond breakage. Similar results, shown in Fig 7.7 b and 7.8 b, are obtained by Jordon *et al.* [8].

Fig 7.7 a:  $P_{max}$ ,  $I_{sc}$ ,  $V_{oc}$  and  $FF$  degradation for mono c-Si

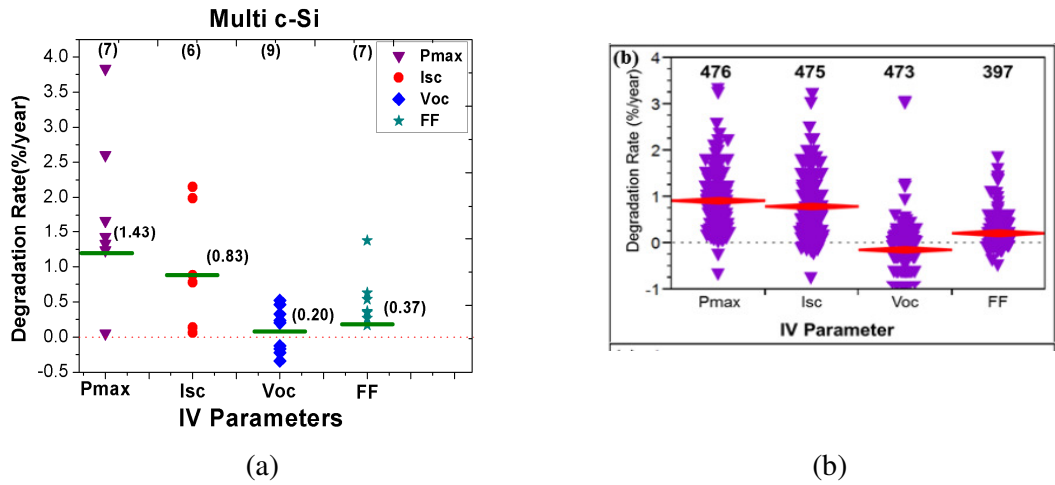
Fig 7.8 a:  $P_{max}$ ,  $I_{sc}$ ,  $V_{oc}$  and  $FF$  degradation for multi c-Si  
 Fig 7.8 b: Corresponding degradation rates quoted from the paper by Jordon *et al.* [8]

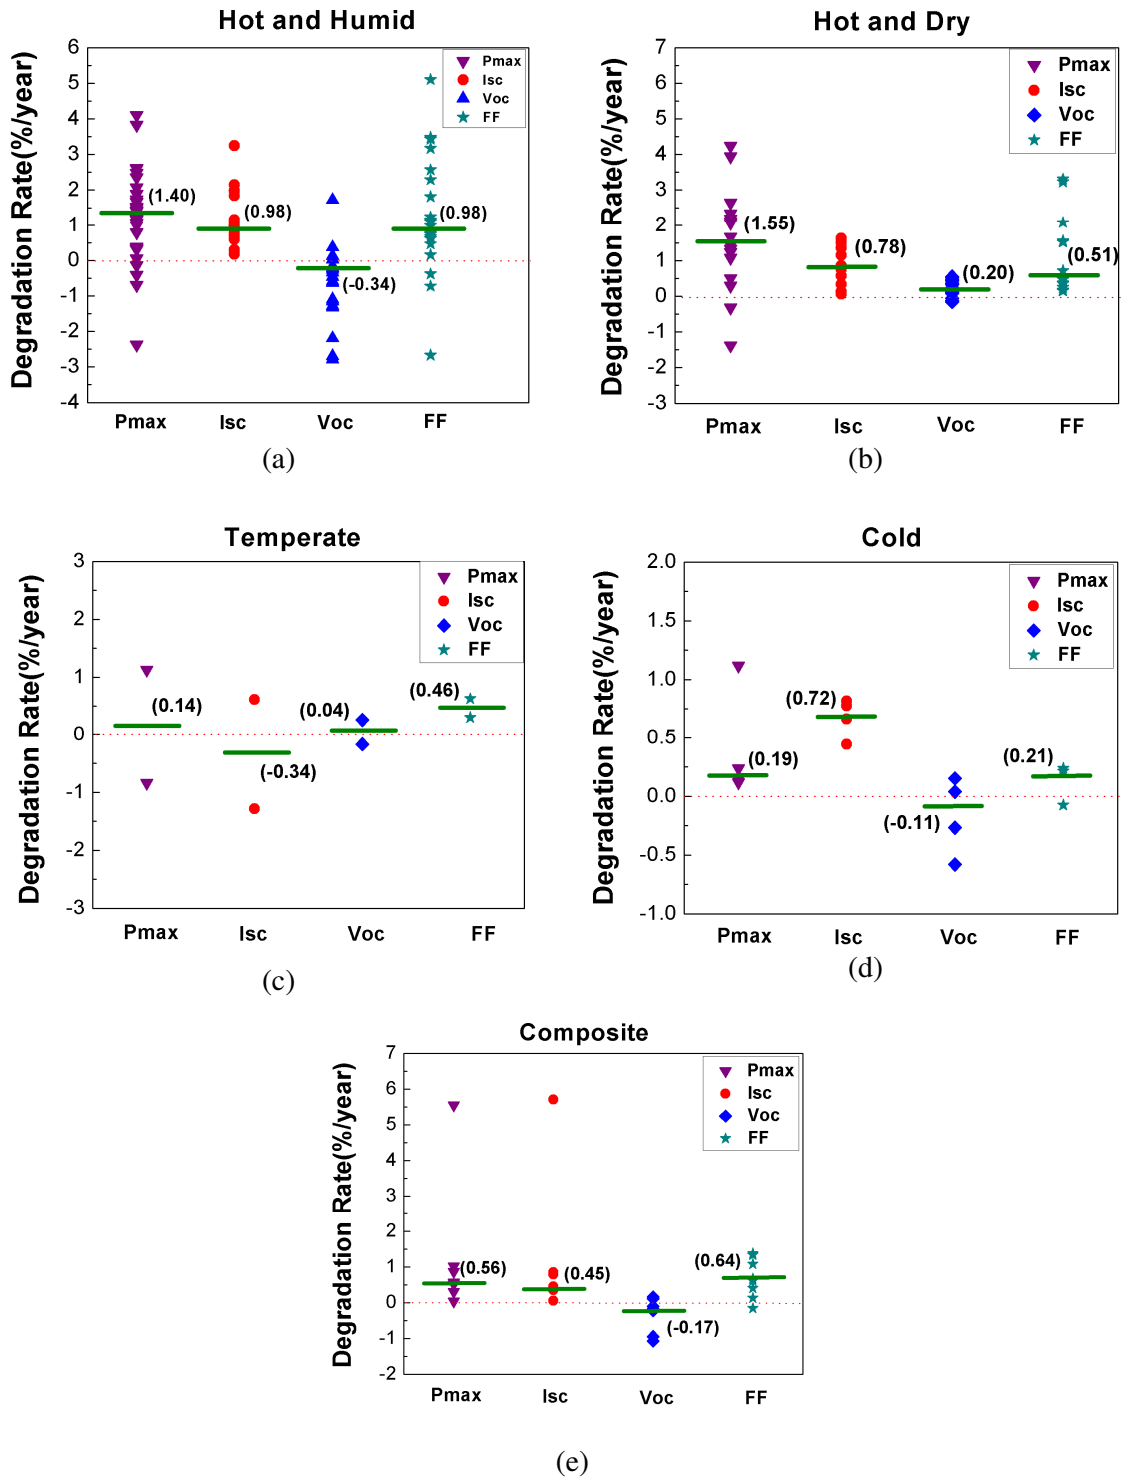
The I-V parameter degradation distribution by climate zone for mono-c Si and multi-c Si is shown in Fig. 7.9 (a-e). For most climate zones  $I_{sc}$  degradation is the largest contributor to  $P_{max}$  degradation. It can be seen that for Cold type of climatic zone, the  $I_{sc}$  degradation is more than  $P_{max}$  degradation whereas  $V_{oc}$  actually improves.

Table 7.1 shown below gives the median values of  $P_{max}$  and I-V parameter percentage degradation per year in the five different climatic zones. In Temperate zone, we have data for only two modules and we are planning to undertake survey of some more sites in the temperate zone. It is clearly seen that the degradation rate for Hot & Dry type of climatic zone is the highest of all zones. This is likely due to the high temperatures of the desert-type climate leading to increased EVA browning which manifests itself in high  $I_{sc}$  degradation (see next chapter also).

Fig 7.9: I-V parameter degradation distribution for (a) Hot & Humid climatic zone (b) Hot & Dry climatic zone (c) Temperate zone (d) Cold climatic zone and (e) Composite zone.

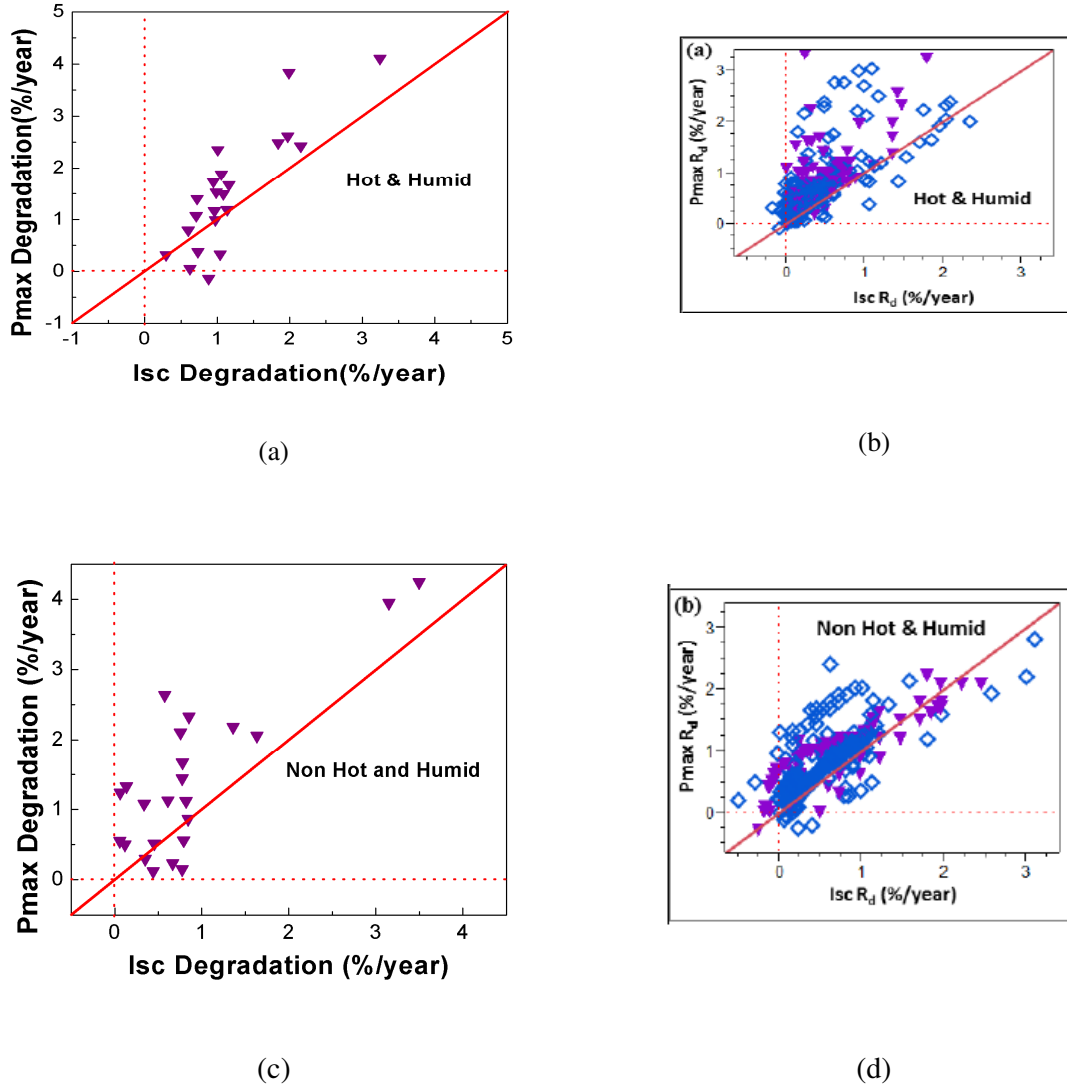
From Fig. 7.10(a) and Fig 7.10(c) it can be seen that most of the data points fall on the correlation line in both Hot & Humid and non Hot& Humid types of climate. Therefore it can be inferred that in any type of climate degradation in  $P_{max}$  is mainly because of degradation in  $I_{sc}$ . A similar result can be noted in Fig 7.10 (b) and 7.10 (d) taken from Jordon *et al.* [8].

Fig 7.10: (a) Correlation of  $P_{max}$  with  $I_{sc}$  degradation for hot and humid climatic  
 (b) Corresponding correlation ( $P_{max}$  vs  $I_{sc}$  degradation) in paper by Jordan *et al.* [8]  
 (c) Correlation of  $P_{max}$  with  $I_{sc}$  degradation for non hot and humid climatic  
 (d) Corresponding correlation ( $P_{max}$  vs  $I_{sc}$  degradation) in paper by Jordan *et al.* [8]

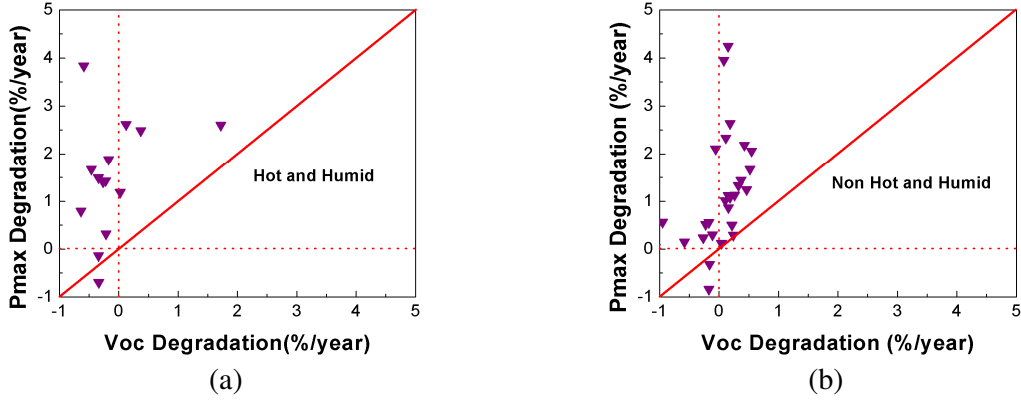
Figure 7.11(a) show some data indicating substantial  $V_{oc}$  degradation in Hot and Humid climates. From Fig. 7.11(b) we can clearly see that in non Hot and Humid type of climate most of the  $V_{oc}$  data fall on the non-correlation line. It implies that degradation in  $P_{max}$  is not influenced by  $V_{oc}$  degradation. Similar result have also been reported in Jordon *et al.* [8]

Fig 7.11: (a) Correlation of  $P_{max}$  with  $V_{oc}$  degradation for Hot and Humid climatic  
 (b) Correlation of  $P_{max}$  with  $V_{oc}$  degradation for non Hot and Humid climatic

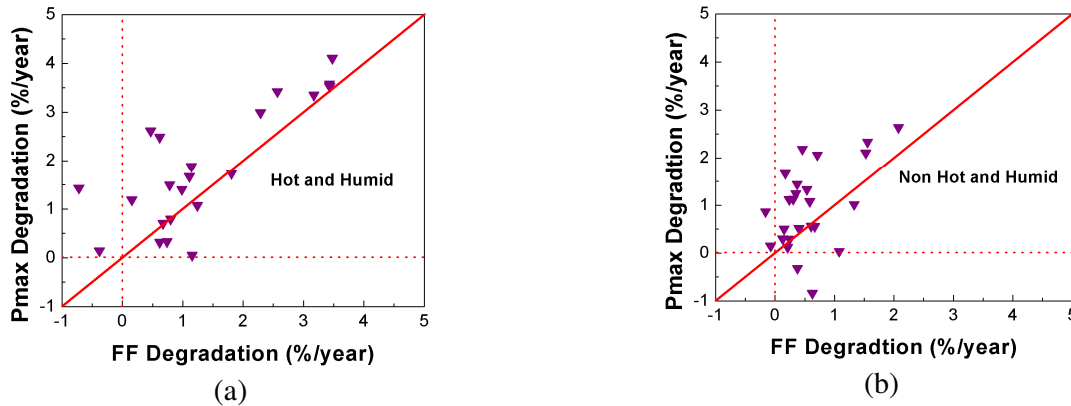
Figure 7.12(a) illustrates some modules with significant  $FF$  degradation in the Hot & Humid climate caused by increased series resistance. Most of the data points Fig. 7.12(b) are shifted away from the solid correlation line. It implies that degradation in  $FF$  is responsible for degradation in  $P_{max}$  in Hot & Humid zone but does not significant effect in non-Hot & Humid zone. Similar result have also been reported in Jordon *et al.* [8]

Fig 7.12: (a) Correlation of  $P_{max}$  with  $FF$  degradation for Hot & Humid climatic  
 (b) Correlation of  $P_{max}$  with  $FF$  degradation for non Hot & Humid climatic

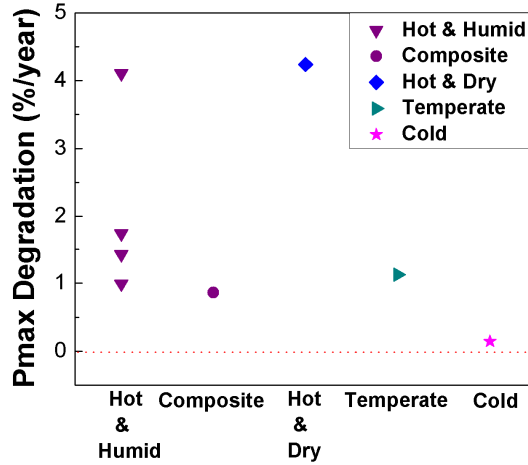
From Fig.7.13 we can infer that in hot climatic zones (Hot & Humid and Hot & Dry zones) we have the highest degradation in power as compared to other zones. It is well known that higher temperatures accelerate most of the degradation reactions and provide the activation energy necessary for such reactions. The modules in the cold climatic zone have the least degradation in the performance.

Fig 7.13: Comparison of  $P_{max}$  in different climatic conditions

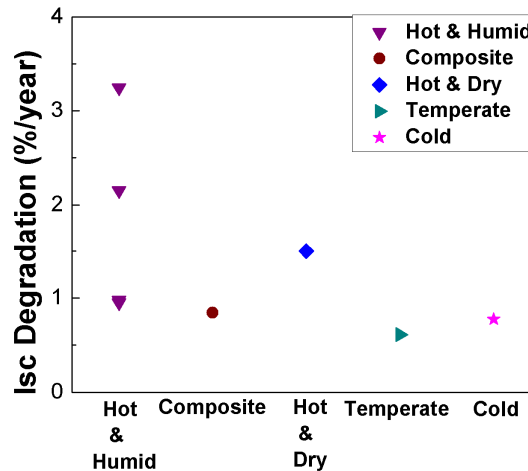
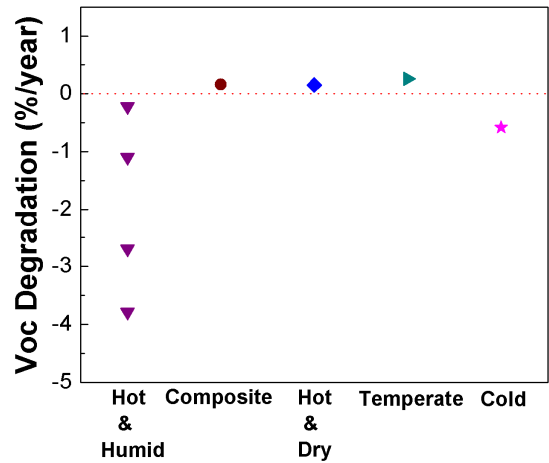
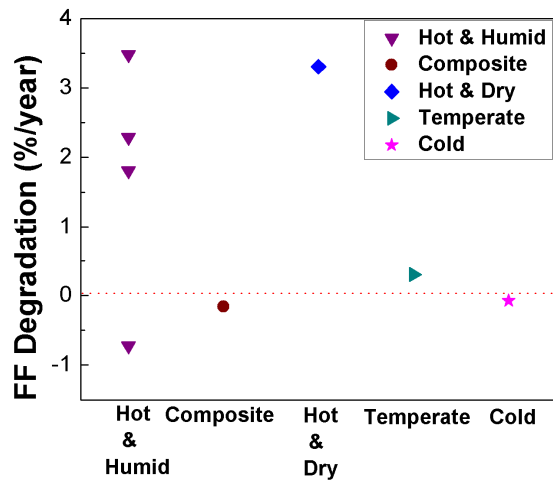
Figure 7.14 (a-c) shows the comparison of I-V parameters ( $I_{sc}$ ,  $V_{oc}$  &  $FF$ ) degradation in different climatic zones.

Fig: 7.14 (a): Comparison of  $I_{sc}$  in different climatic conditions

Fig: 7.14 (b): Comparison of  $V_{oc}$  in different climatic conditions

Fig: 7.14 (c): Comparison of  $FF$  in different climatic conditions

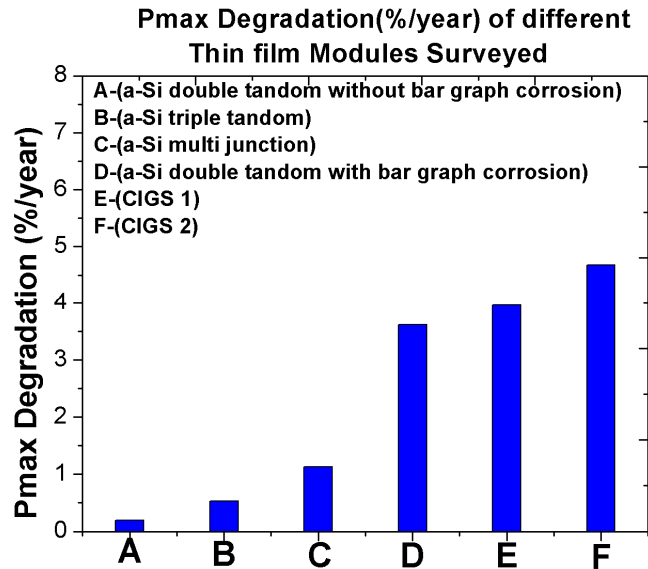
Histogram of Fig 7.15 gives the degradation rate for different thin film technologies modules that were surveyed during the survey. Figure 7.15 indicates that the degradation in power is more in CIGS than amorphous silicon.

Fig 7.15:  $P_{max}$  degradation rate for different thin film technologies

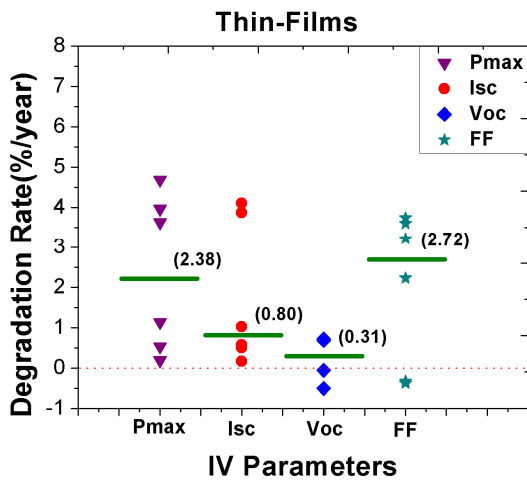
Figure 7.16 (a) shows  $P_{max}$ ,  $I_{sc}$ ,  $V_{oc}$  and  $FF$  degradation for different thin film technologies. Due to the small number of data points, amorphous silicon (a-Si) and copper indium gallium selenide (CIGS) modules have been overlaid on one plot. The IV parameter degradation pattern differs for thin-film technologies in comparison to crystalline silicon. All thin-film technologies show a significantly higher FF degradation (compared to crystalline silicon technologies), often associated with light-induced degradation of a-Si and an increase in series resistance in CIGS [9]. Similar results can be seen in Fig 7.16 b taken from Jordon *et al.* [8].

Fig 7.16 (a):  $P_{max}$ ,  $I_{sc}$ ,  $V_{oc}$  and  $FF$  degradation for thin film technology

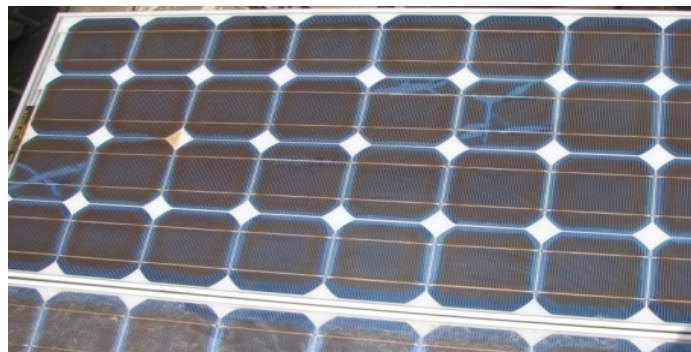
The encapsulant in a PV module provides structural support & protection to the fragile solar cells, while also providing electrical isolation and good optical coupling with the glass. Since the incident photons must reach the solar cells unhindered, the encapsulant should be transparent. The most widely used encapsulant today is Ethyl-Vinyl Acetate (EVA), but different manufacturers use different formulations by adding various additives to stabilize the EVA and protect it from degradation. In spite of their efforts, EVA has been found to discolor in the long run, initially turning yellow (light discoloration) and progressively moving to darker shades of brown [27] (dark discoloration), as is evident in Fig. 8.1 below. This browning is due to generation of long-chain polyenes in the EVA upon exposure to UV rays and high temperatures [27].

Fig. 8.2: Module having dark discoloration on solar cells

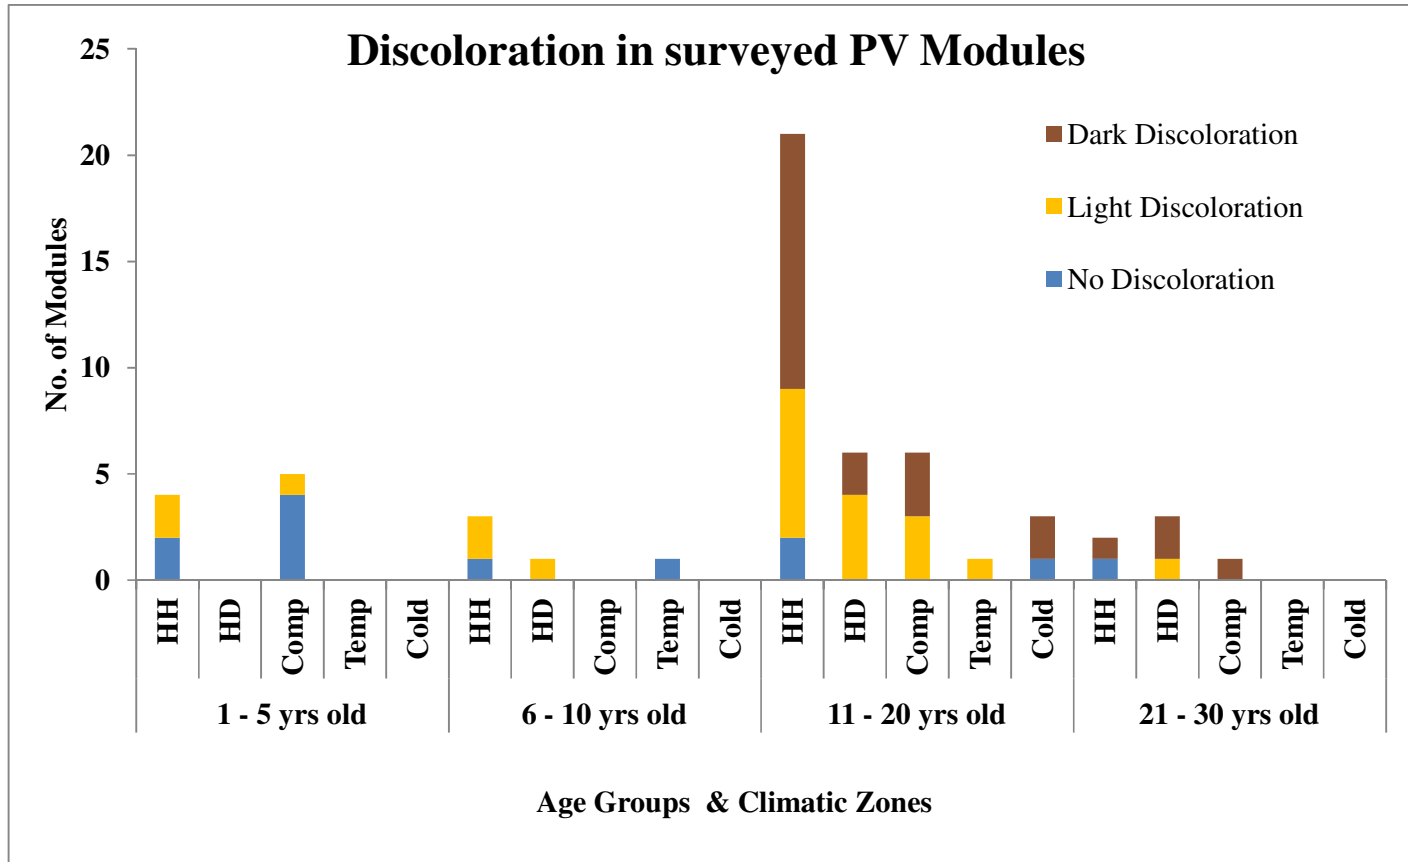
Fig. 8.3: Discoloration in modules in the respective climatic zones and age groups.  
 HH: Hot & Humid zone, HD: Hot & Dry zone, Comp: Composite zone, Temp: Temperate zone, Cold: Cold zone

From above graphs, it can be seen that discoloration has been observed in all climatic zones of India and in all age bins (wherever samples are available). The highest percentage of discolored modules has been found in the Hot & Dry zone, followed by the Hot & Humid zone. In the Cold zone site (Hanle Astronomical Observatory in Ladakh) we have seen that crystalline silicon modules of one particular manufacturer had all shown dark discoloration while those of another manufacturer installed side-by-side had no discoloration, though both systems were installed 15 years ago (see Fig. 8.4). This hints that the composition of the encapsulant and/or the processing has a significant bearing on the discoloration. Also we have found a 28 year old crystalline silicon module with glass-glass packaging (installed in Hot & Humid climatic zone) which has shown no discoloration (refer Fig. 8.5). We suspect that the encapsulant used might not be EVA (the concerned manufacturer has been contacted for details about the encapsulant, and their response is awaited). EVA has a particular shelf-life in storage within which period it must be used in the module. Some manufacturers stock huge amounts of EVA and hence may sometimes use expired EVA in their modules if their module production rate is slowed down due to market conditions. This inevitably gives rise to discoloration of the EVA in the long run. A mechanism should be put in place so that such practices can be checked as far as possible. Detailed study by A.W.Czanderna and F.J.Pern [27] has indicated that using the proper ratio of additives (ratio of UV absorber to UV stabilizer) can retard the UV induced degradation of the EVA and slow down the discoloration process. However, not all PV manufacturers may be aware of these guidelines. Another way to reduce the rate of discoloration is to use cerium oxide containing glass (which will act as a UV screen), but this is not always used by all manufacturers.

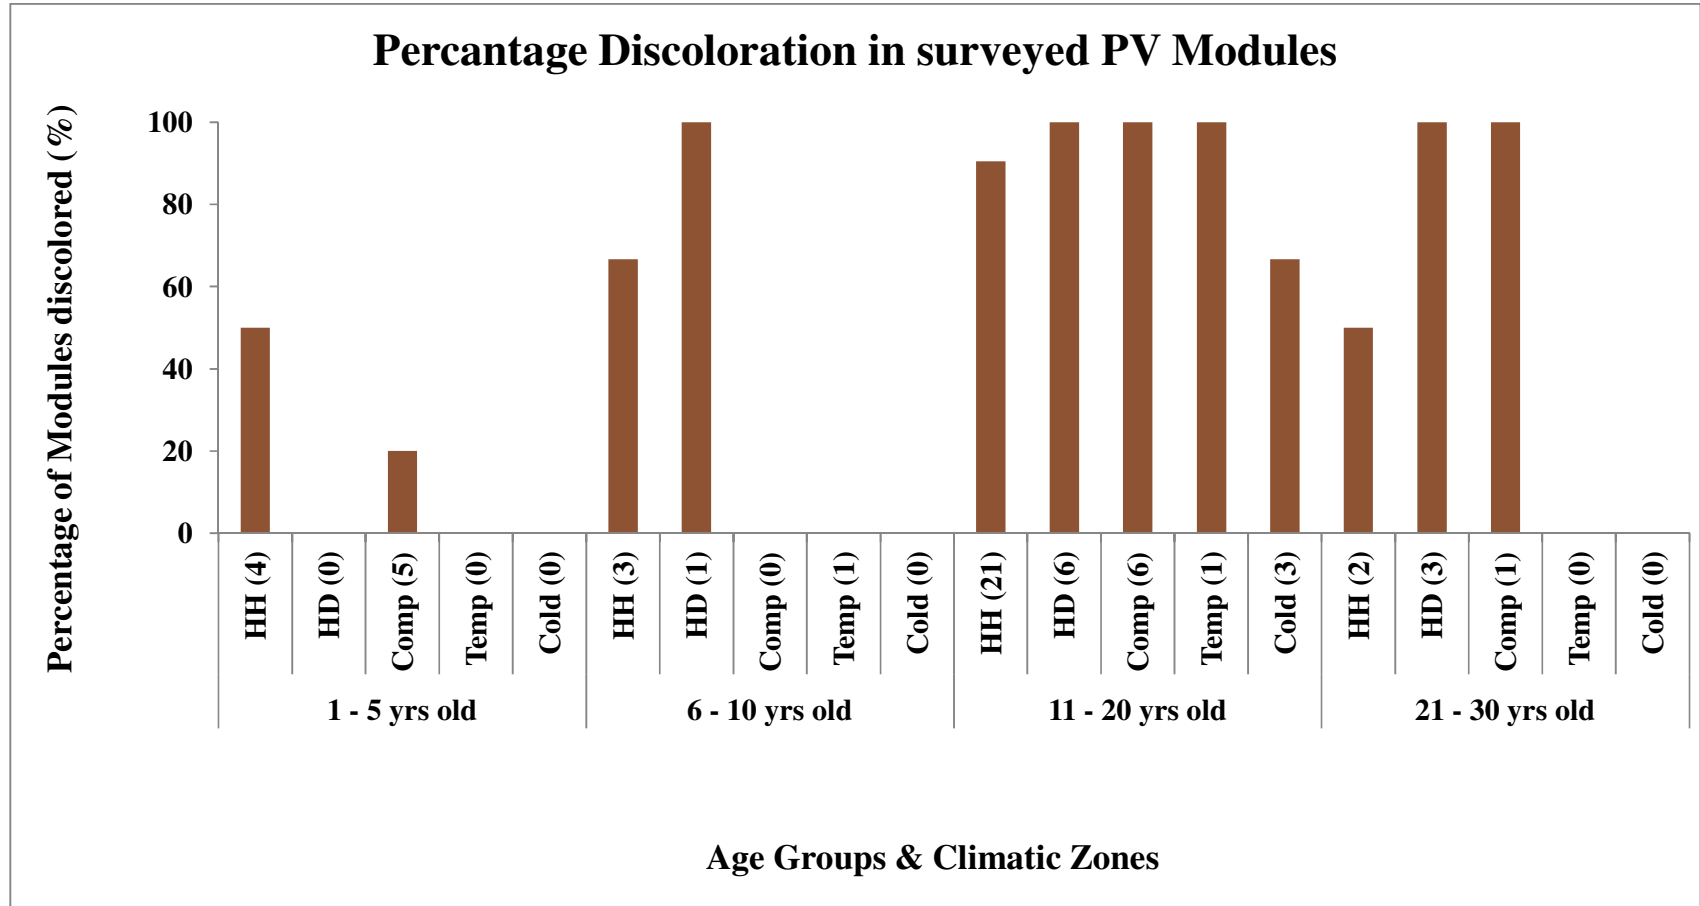
Fig. 8.4. Percentage of surveyed modules that had encapsulant discoloration (light or dark) in the respective climatic zone & age group. The figures in bracket indicate the total sample size in that climatic zone for that age-group (“0” indicates no module sample).  
 HH: Hot & Humid zone, HD: Hot & Dry zone, Comp: Composite zone, Temp: Temperate zone, Cold: Cold zone

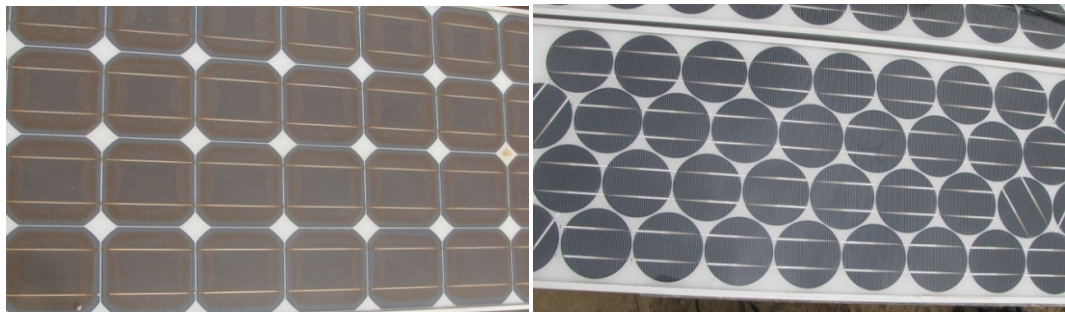
Fig. 8.5: Modules of different manufacturers installed at Hanle 15 years ago

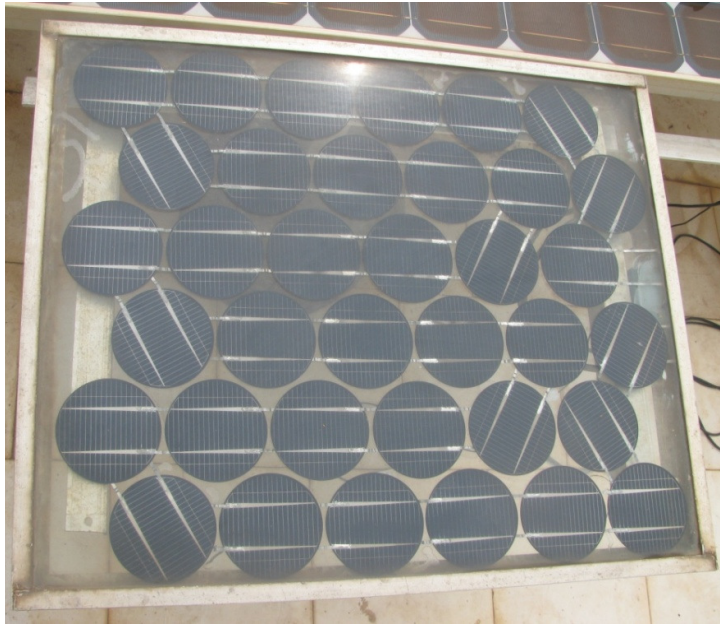
Fig. 8.6: 28 year old PV module (glass on both top & bottom) showing no discoloration of the encapsulant

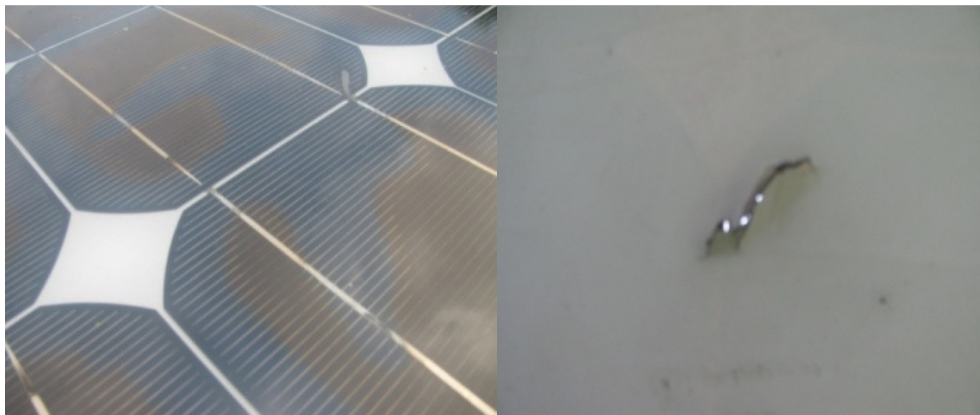
Fig. 8.8: Uneven discoloration (left) in a module and puncture in the back-sheet (right) of same module.

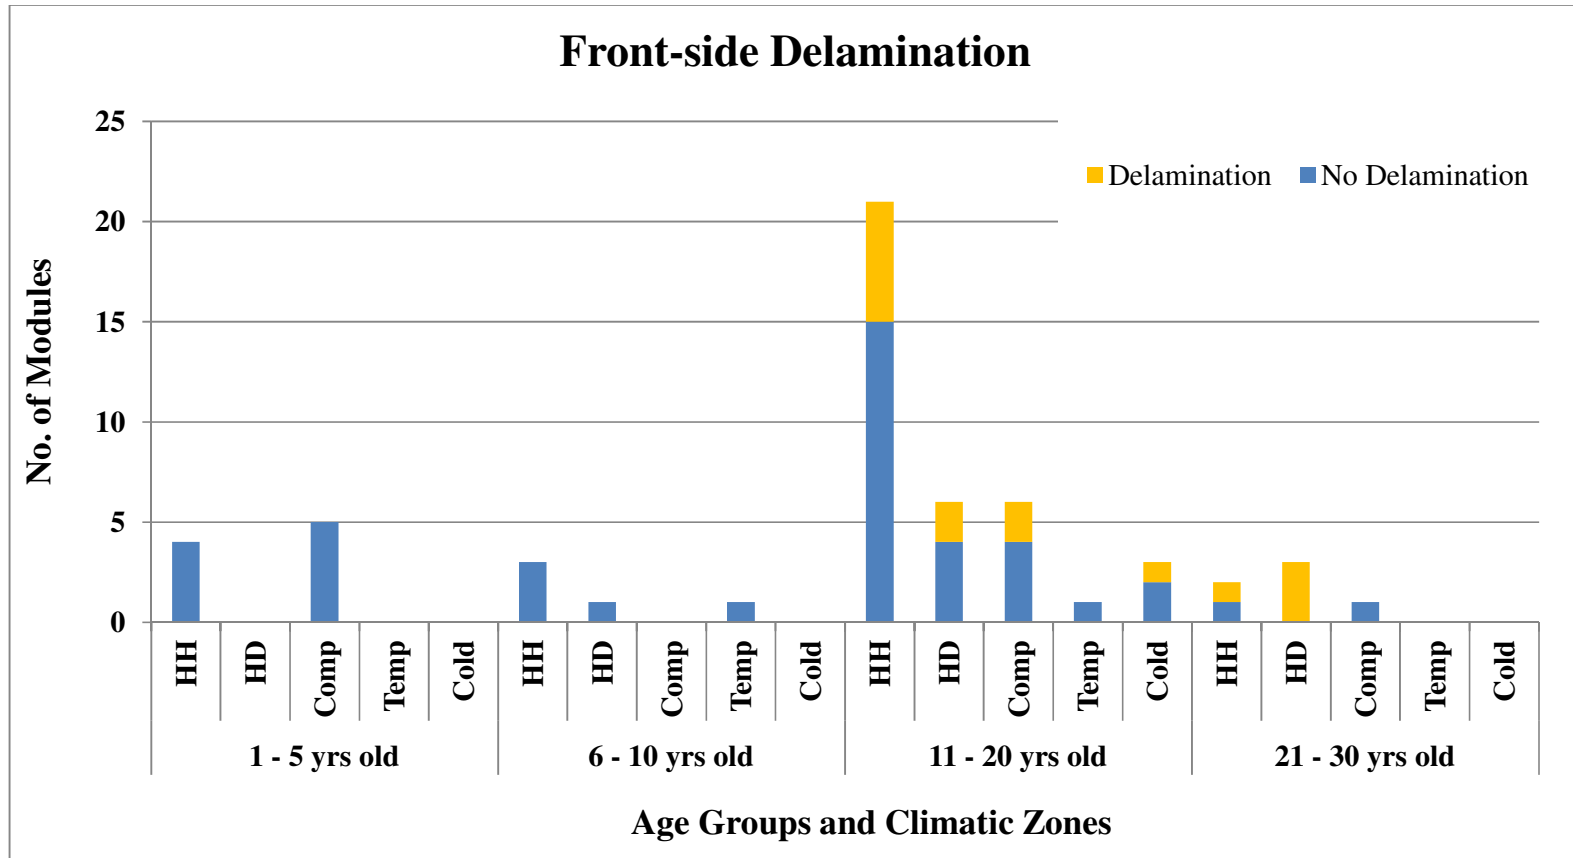
In the survey, delamination has not been observed in the younger modules (age below 10 years) in any of the climatic zones, as indicated in the Table 8.3. About one-third of the inspected modules in 11-20 years age bin showed delamination irrespective of climatic zone while all modules older than 20 years in Hot & Dry zone were affected. The data for temperate zone is too small to draw any conclusion. This data has been graphically shown in Figs. 8.13 and 8.14.

Fig. 8.13: Front-side delamination in modules in the respective climatic zones and Age groups.  
 HH: Hot & Humid zone, HD: Hot & Dry zone, Comp: Composite zone, Temp: Temperate zone, Cold: Cold zone

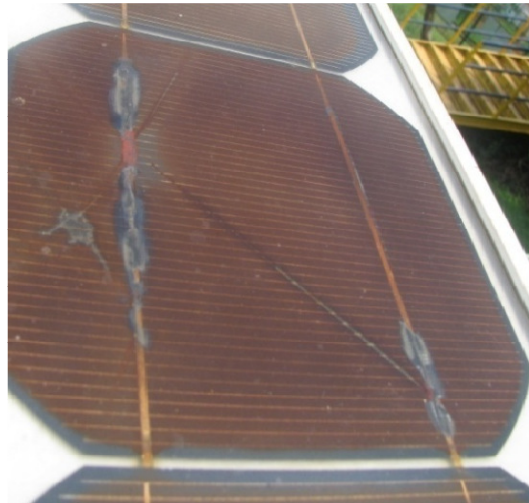
The term “metallization” refers to the fingers and busbars that crisscross the surface of the solar cell and gather the charge carriers for exporting outside of the module. The busbars in the various solar cells are interconnected using the interconnect ribbons. These metallization and interconnects should be low resistance paths so as to prevent voltage loss while conducting the current. However, it has been found that PV modules in the field suffer from corrosion in the long run, which increases the series resistance and lowers the output power of the module. Corrosion of the metallization can be inferred from the discoloration of the fingers and/or the busbars, but such visual identification becomes difficult if the encapsulant has also discolored (turned brown). The initial stages of corrosion in fingers can be seen in Fig. 8.14 whereas Figures 8.15 and 8.16 show some of the extreme cases of corrosion in the busbars.

Fig. 8.16: Corrosion & burn marks on busbars & interconnects

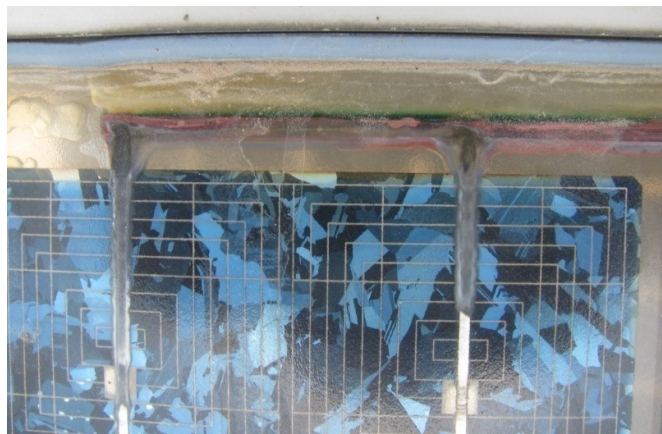
Fig. 8.17: Corrosion (seen as red, green & black discoloration) in the string interconnect of a PV module installed in Hot & Dry zone in 1988.

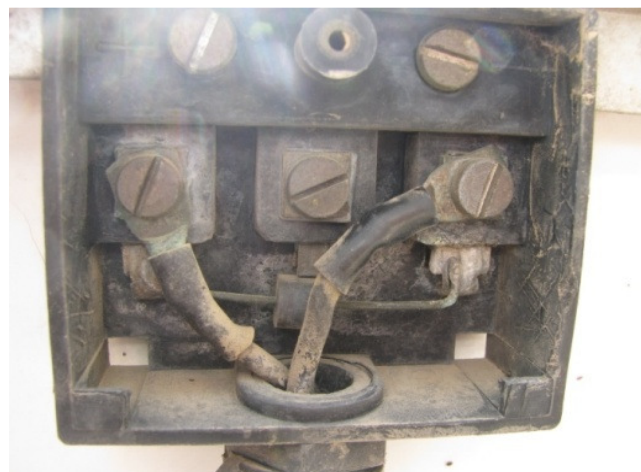
Fig. 8.18: Corrosion in output terminals

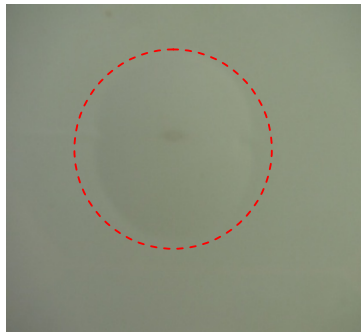
Fig. 8.21: Bubble in backsheet of a module (encircled in red dots)

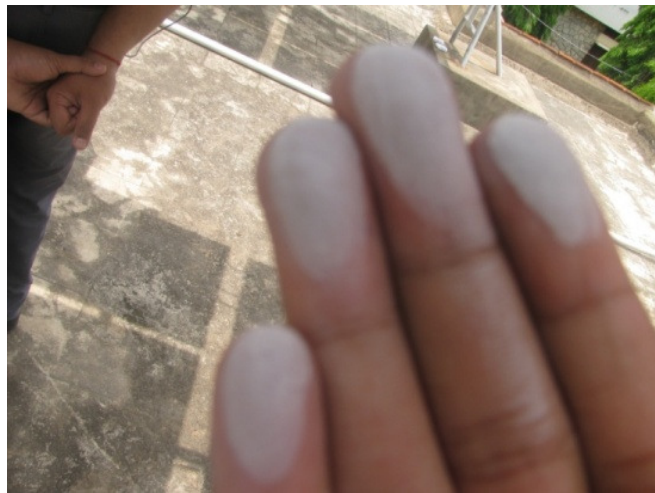
Chalking refers to the formation of a white powder from the backsheet (refer Fig. 8.24) due to the photo-thermal degradation of the back-sheet polymer. Table 8.6 shows that chalking has been found only in some modules in the 11 – 20 years age bin (and not in other age groups). Modules older than 20 years did not show chalking, which hints that the backsheet material might have been changed by the PV module manufacturers about a decade back. Chalking has been seen in all climatic zones except the cold zone, where the low temperatures prevent thermal degradation of the backsheet. Figure 8.25 presents graphically the actual data collected during the survey, while Figure 8.26 presents the percentage of affected modules in the various climatic zones.

Fig. 8.24: White powder from backsheet of a module

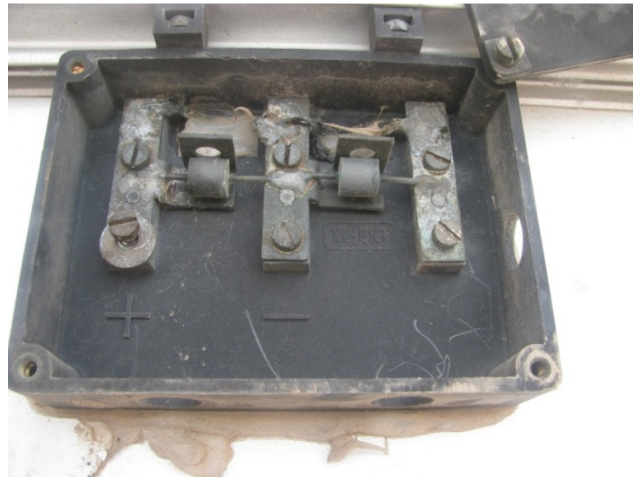
The junction box houses the output terminals of the PV module and the by-pass diodes and protects these from ingress of water and dust. If the structure of the junction box is compromised or the sealing is not appropriate, rain water can reach the terminals and corrode them (refer Figs. 8.27 and 8.28), leading to higher series resistance and lower power output. The survey data presented graphically in Figs. 8.29 and 8.30 indicate that the junction box structure was unsound in 22% of the cases, and the sealing of the junction box was poor in 24% of the cases.

Fig. 8.27: Junction box with no sealing, which has lead to corrosion of output terminals and Bypass Diodes
