# All-India Survey of Photovoltaic Module Degradation: 2013

**National Centre for Photovoltaic Research and Education  
(NCPRE), IIT Bombay**

**Solar Energy Centre, Gurgaon**

May-June 2013  
Report dated March 2014

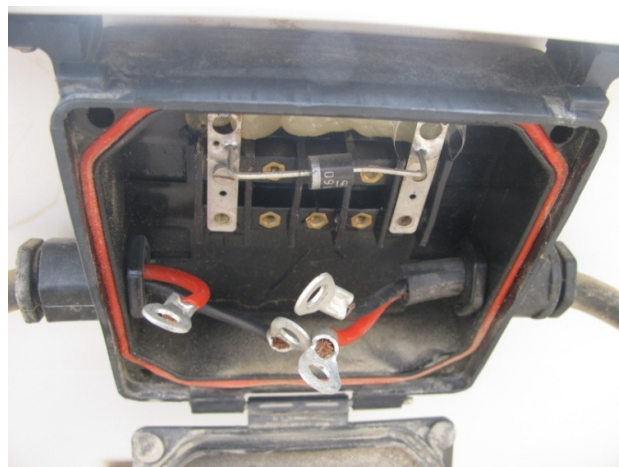
Fig. 8.28: Junction box with good sealing, which has prevented corrosion of output terminals and Bypass Diodes

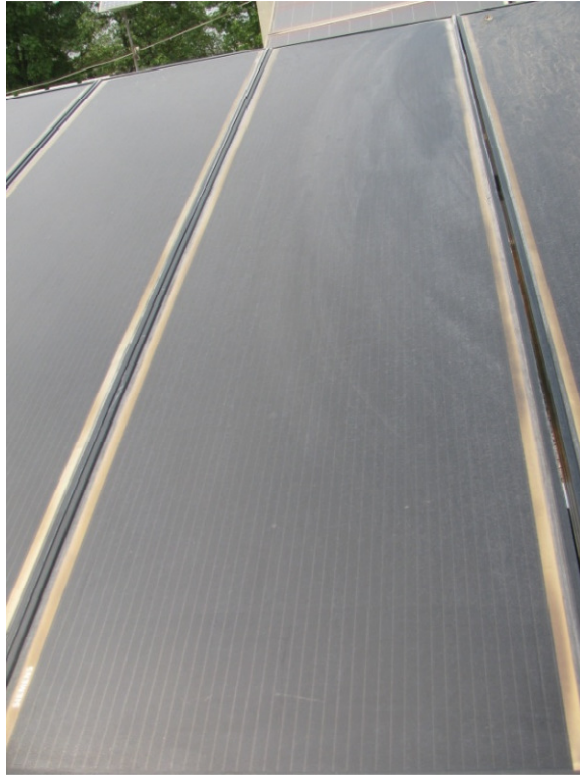
A CIS module installed around 13 years ago was investigated in Haryana (refer Fig. 8.35). Fig. 8.36 shows dark patches near the electrodes of the module and there was also a puncture in its backsheet (shown in Fig. 8.37). White deposits could be found on its bottom edges near the frame, as visible in Fig. 8.38. On cleaning the module with water, we could see white powder (salts) settling on top of the module. It appears that the hardness of the ground water used for cleaning of the modules is causing the white deposits.

Fig. 8.35: 13 years old CIGS Module installed in Composite climate

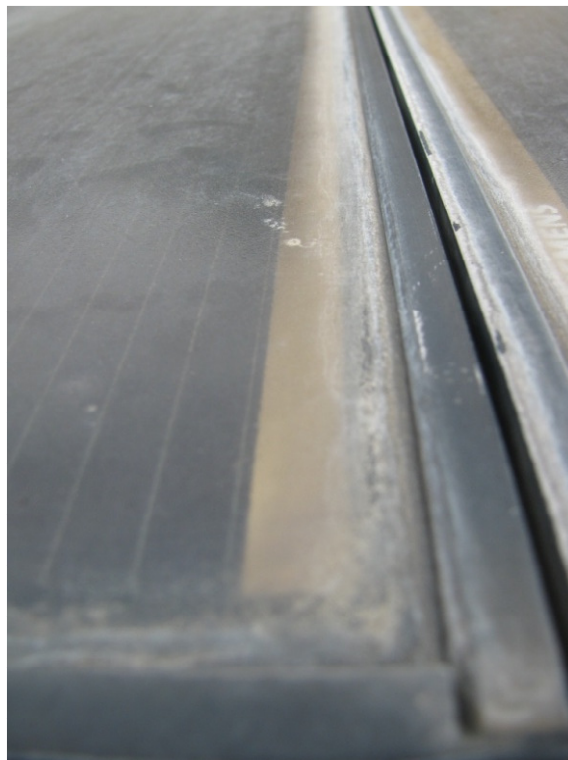
Fig. 8.36: Dark patches close to electrode of CIGS module

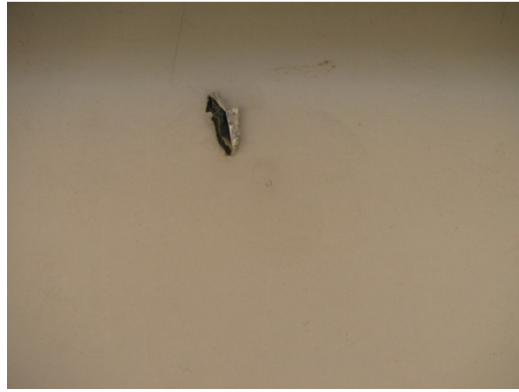
Fig. 8.37: Puncture in the backsheet of the CIGS module

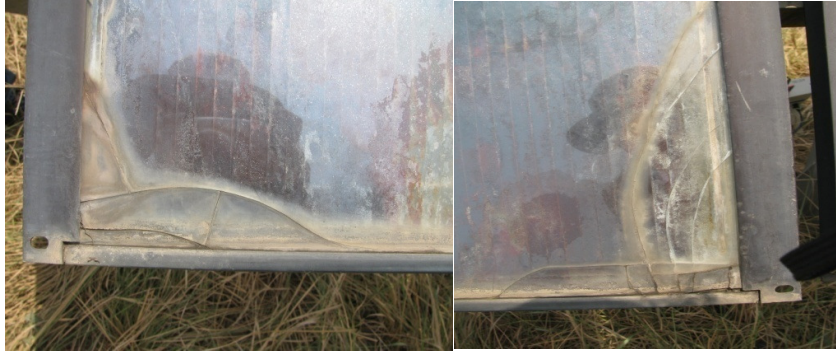
Fig. 8.40: Cracks in the glass of the corroded module

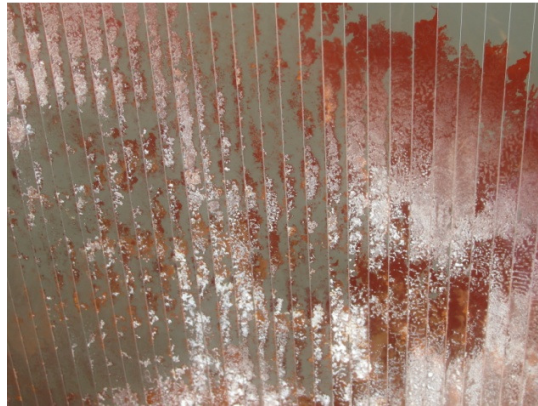
Figure 8.41 shows a close-up view of the corroded portion of the module from the backside. Infrared thermograph of this module is shown in Fig. 8.42 (left side). The IR camera has identified the hottest and the coldest parts in its field of view, marking their positions as “Max” and “Min”, and colour-coded the temperatures of all the parts from black (indicating lowest temperature) to white (indicating highest temperature). In this colour coding, blue is cooler than red. The lower portion of the Infrared image (left hand side picture) corresponds to the corroded part of the module, and as we can see, it is cooler than the rest of the module. The top portion of the module is the hottest.

Fig. 8.41: Corroded portion of the module (image from backside)

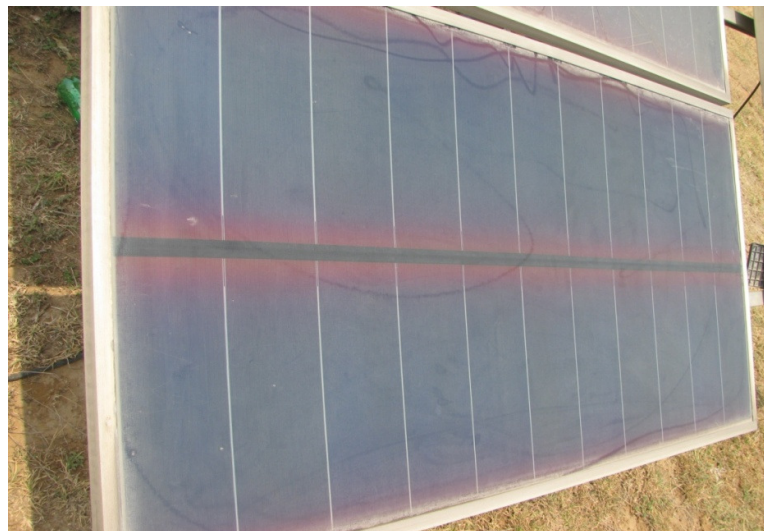
An 11-year old amorphous silicon triple tandem module was inspected at the same site in Composite zone. This module had a certain type of polymer at the top. There were strange tracks on the module, as if some snail or other insect has walked on it (refer Fig. 8.43). These tracks could not be removed by cleaning using a wet cloth. The infra-red image of the module showed that the snail track is operating at a higher temperature than the adjoining areas (Fig. 8.44). Some punctures were also noticed on the top fabric (Fig. 8.45).

Fig. 8.43: Triple tandem amorphous silicon module with “snail trails”

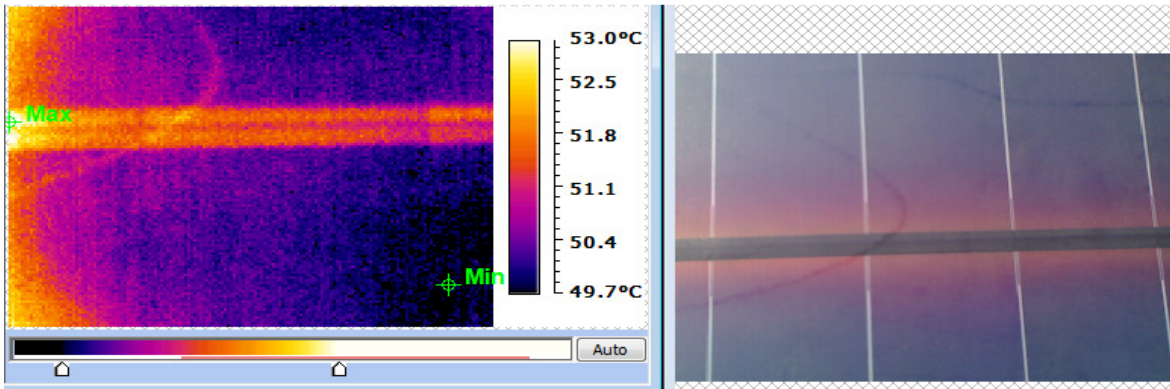
Fig. 8.44: IR image of the module showing that the snail trail is operating at higher temperature than the adjoining areas

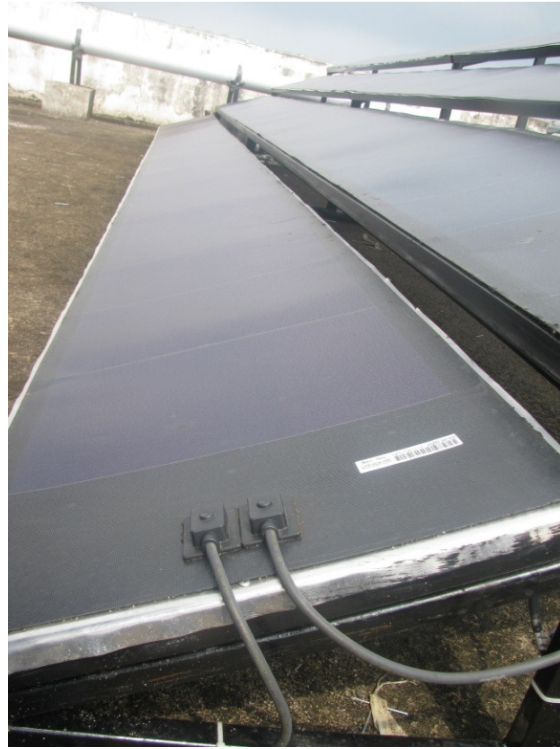
A triple tandem amorphous silicon module was also inspected in Kerala which falls in Hot & Humid climatic zone. This module is similar to the module shown above, in terms of construction (refer Fig. 8.46), and is just 6 months old. The top layer of this module suffered damage at some localized places as shown in figure 8.47.

Fig. 8.46: 6-month old amorphous silicon triple tandem module

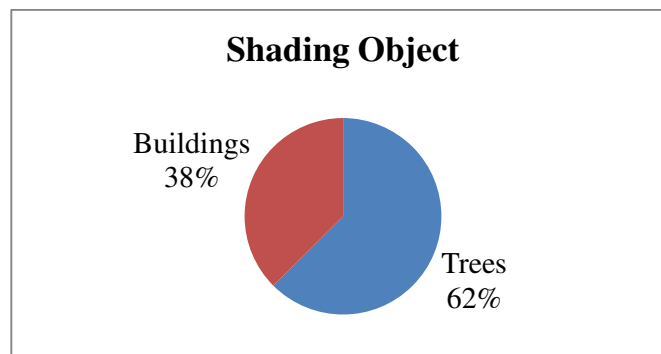
Fig. 9.3: Causes for shading of modules

Almost 62 percentage of the modules surveyed were shaded. The major shading objects were trees or buildings, as shown in Fig. 9.3.

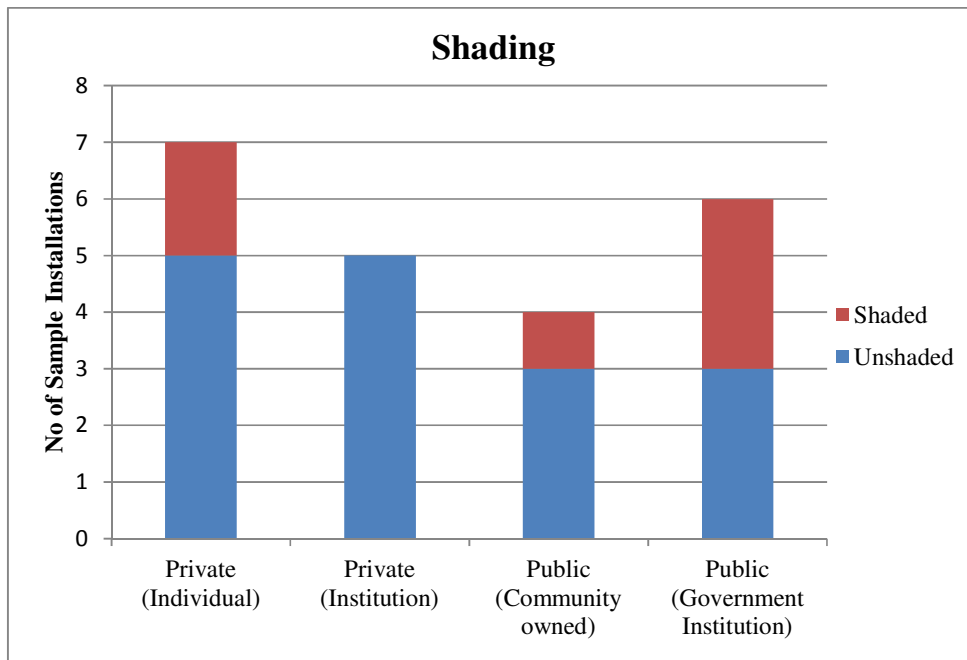
Fig. 9.4: Shading of PV modules based on ownership category

Shading is an issue with some of the individually owned smaller size systems (households), where in most of the cases, trees were the shading objects. Almost all the private institutions and community owned public installations had taken care in installing the modules in a shade free area. It was observed that 3 out of 6 installations over government institutions were shaded by either trees or nearby buildings.

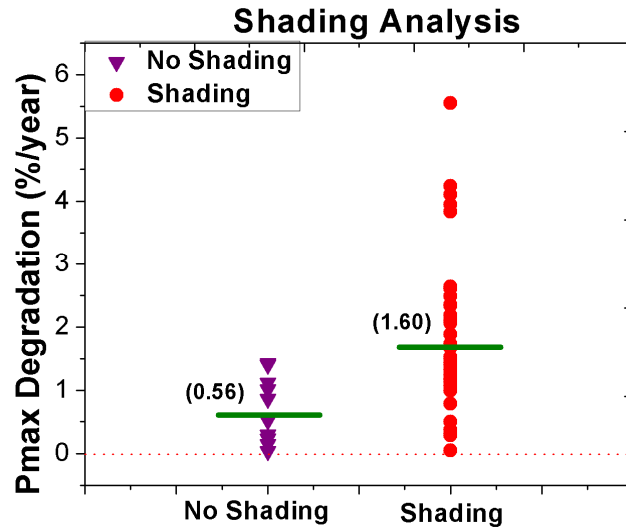
Fig. 9.5: Comparison of degradation rates of shaded and un-shaded modules

It is known that partial shading of a module can cause local hot spots which can lead to long-term degradation. An analysis of the degradation rates of shaded and un-shaded modules covered in the survey was performed. In order to eliminate the spurious effect of very low degradation rates observed in Cold climate (Ladakh, where there is also very no shading), we have eliminated from our analysis all the modules from the Cold climate. As shown in Fig. 9.5, the shaded modules degrade almost three times faster than the unshaded modules (median value of annual degradation of shaded modules is 1.6% whereas the median value of degradation of un-shaded modules is just 0.56%). This interesting data is, as far as we know, the first field observation of the deleterious effect of partial shading on the long-term performance of modules. Figure 9.6 shows the  $P_{max}$  degradation rate with respect to the amount of module area under shade. It seems to imply that  $P_{max}$  degradation rate increases with increase in the amount of module area shaded. Literature shows that apart from the shaded area, the geometry of the shaded region also plays a role in deciding the effect of shading on the module performance. However, in our case, the geometry of shading was not recorded, so we are unable to assess its effect.

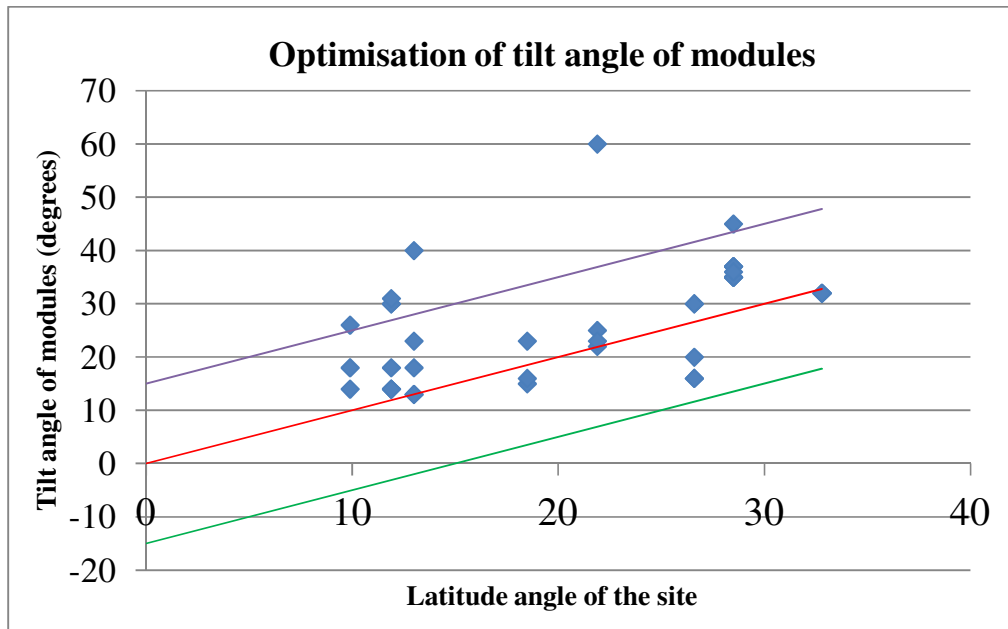
Fig. 9.6: Optimisation of tilt angle of the modules

*Orientation and Tilt angle*– Based on the location and use of the installation, modules should be optimised in terms of direction and tilt angle (latitude degree). Almost all of the installations covered in the survey were properly oriented (south facing), whereas the tilt angle was very often not the correct one. Figure 9.6 shows the tilt angle used versus the latitude of the site.

If the modules were optimised for maximum annual yield, then the sample points should have followed the red line in the above picture (where tilt angle = latitude angle  $\pm 2^\circ$ ). If they were optimised for maximum yield in winter, then they should lie along the violet line (latitude +  $15^\circ$ ).

For maximum yield in summer months, the modules should have been aligned along the green line (latitude – 15°). 50% of the installations had their modules at an un-optimized tilt angle, which will reduce the annual PV generation. Figure 9.7 shows the histograms for tilt angle. Two out of the 7 installations covered in the individually owned systems were having manual tracking facility and were optimised for maximum yield. The rest of them were just installed at the angle of the rooftop itself. Two out of 5 private institutions have installed the modules at an angle of 10 to 18 degrees more than the required angle. In case of the community owned public installations, the error in angle for the incorrectly oriented modules varied from -6 to -10 degrees. In government institutions, where the module tilts were not optimised, the deviation in angle varied from +10 to +15 degrees from the optimum angle required.

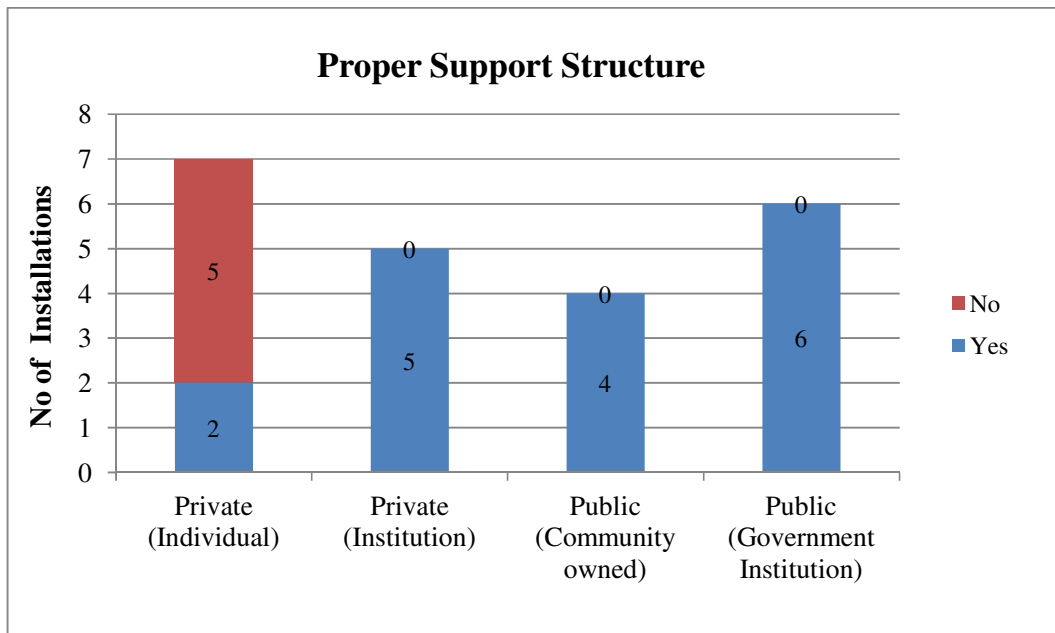
Fig. 9.8: Provision for proper support structure for modules

The additional cost on support structures has kept the household-level individual installations from adopting proper support structures for the panels. It was observed that in some cases the PV modules were just laying on top of the thatched roof tops without adequate air flow on the back of it. All the other ownership types had proper support structures.

*Support structure* – The modules should be placed on a proper support structure (strong and durable). It is also important to have air flow at the back of the modules in case of rooftop installations. Figure 9.8 shows the histograms for support structure.

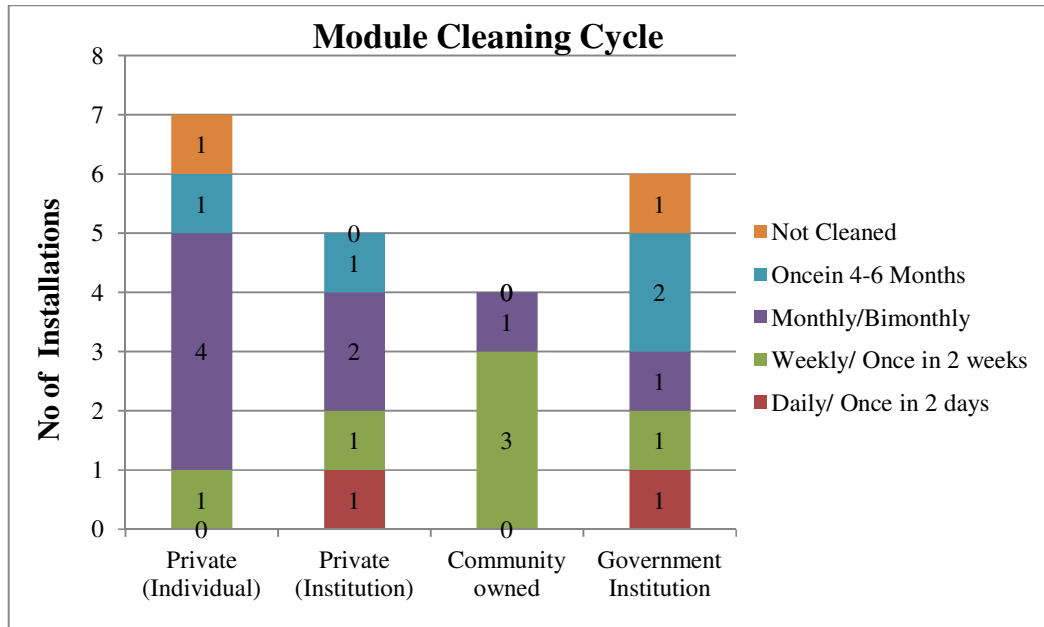
Fig. 9.10: Comparison of cleaning cycles of PV installations categorized based on ownership

*Module cleaning cycle* – The frequency of cleaning of the modules was analysed. This is shown in Fig 9.10. It is pretty clear that the individually owned household installations on the rooftop are cleaned less frequently. There were some modules which were never cleaned, or the users were not aware of the necessity of cleaning. Private institutions and community based institutions clean their modules more regularly than individual owners. The lower frequency of module cleaning in individual installations can be correlated with the difficulty of access as observed in the previous section, or ignorance about the necessity of cleaning the modules. The three installations in the government institutions which are not frequently cleaned (all of which are easily accessible as observed in the previous section) show clear negligence. The effect of soiling on  $P_{max}$  degradation rate can be seen in Fig. 9.11. We find that Power degradation (%/year) for heavily soiled modules is higher than for lightly soiled modules. In the figure, the numbers in bracket above the green crossbars indicate median values of  $P_{max}$  degradation rate. A possible reason can be that the soil deposit on top of the module is cutting off the amount of sunlight reaching the solar cells beneath, but the dust layer is itself getting heated up by absorbing sunlight. Since the module is getting lesser light and its output power (converted electrical power exported out of the module) is reducing significantly. The effective input energy to the soiled module (= incident solar radiation – reflected radiation due to dust cover) also reduces but not to that extent as the reduction in the output power of soiled module. The difference between the effective input power and output power is dissipated by the PV module as heat. This difference is higher for the soiled modules as compared to the cleaned modules. So, the soiled modules operate at higher temperature than the clean modules. This can also be observed by taking the IR images of soiled and cleaned modules. Figure 9.12 and 9.13 shows the visual and its corresponding IR image of the modules. The IR images shown on the left hand side of the figures are colour coded where the temperature scale is shown by the colour bar. The colour near the blue region indicates a lower operating temperature whereas higher operating temperature is shown by the red colour. It can be clearly noticed from the figures that the cleaned modules are operating at lower temperature (shown by blue colour in the IR image) as compared to the soiled modules (shown by orange colour in IR image). Operation at

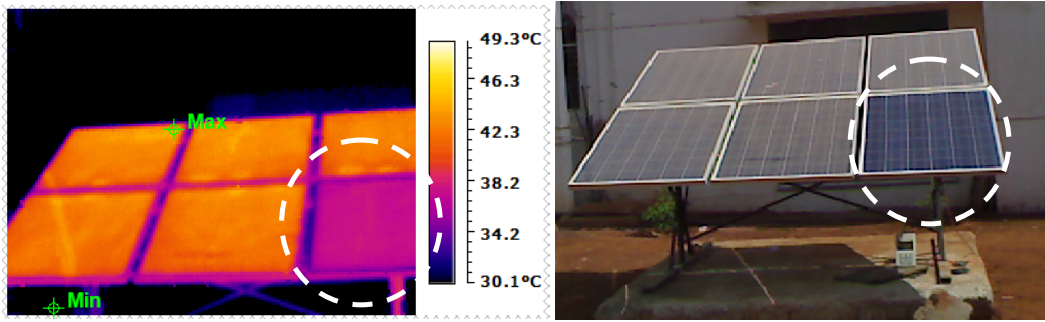
higher temperatures will induce faster degradation in the module components, and hence we are seeing higher power degradation for higher degree of soiling. The correlation between the cleaning interval and  $P_{max}$  degradation rate can be seen in Fig. 9.14. It can be seen that the  $P_{max}$  degradation (%/year) increases on increasing the interval between successive cleaning of modules. This trend also supports our finding that soiling is causing faster degradation of  $P_{max}$ .

Fig. 9.12: Infra-red Image of a set of soiled and cleaned modules.

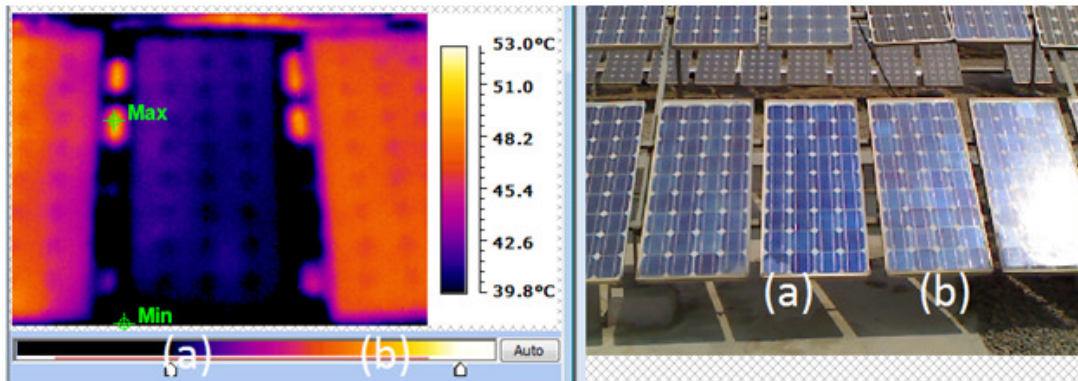
Fig. 9.13: Infra-red Image (a) cleaned module and (b) soiled module

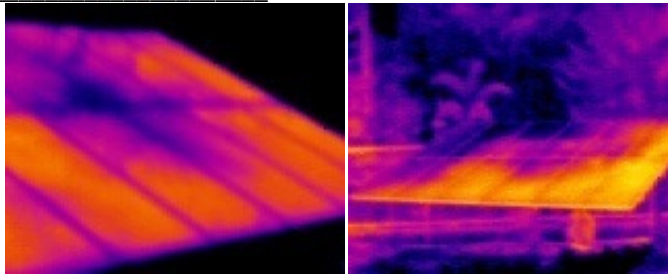
(NOTE : Blue colour represents cooler regions, while orange colour represents hotter regions in above IR image).

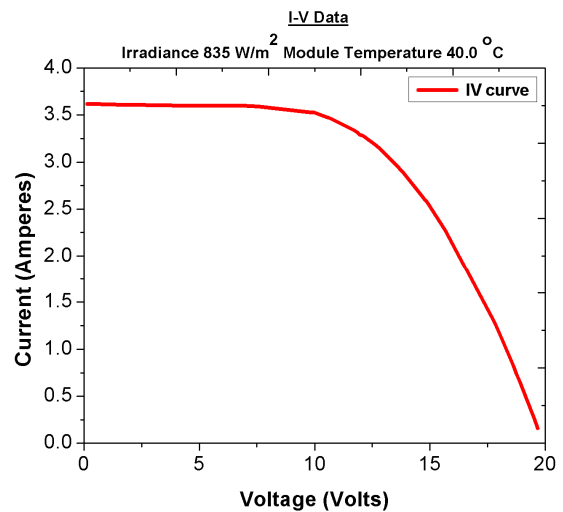
- Yellow discoloration and delamination in 1 cell
- Discoloration in the Metallization (fingers)
- Green discoloration in Frames and in junction box terminals (probably due to Algae growth)
- Tilt angle of Module is 18 deg. whereas Latitude is 9 deg. (Non-optimum tilt)
- Heavy shading from nearby trees, which will degrade the module performance

Tilt Angle should be rectified and nearby trees to be pruned to get higher energy generation and longer module life. Modules should be cleaned at least once a week since dust on the modules can reduce the power generation.

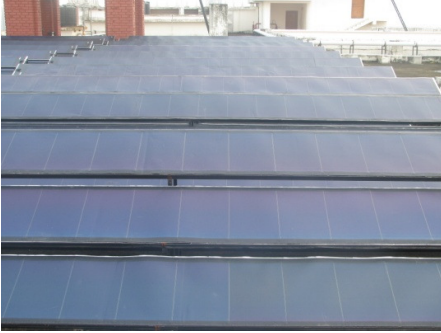
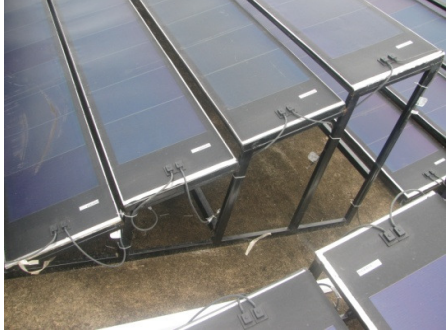
* Based on I-V Curve correction using assumed values for various coefficients (alpha = 0.12% per C, beta = -0.2% per C, Rs=0 & k=0) and assuming linear rate of degradation with time.							
<b>Key Observations:</b>							
<ul style="list-style-type: none"> <li>The module surface is undulating (wavy) indicating improper installation</li> <li>Some of the modules have suffered scratches on the top surface.</li> <li>The spacing between the module stands is too small which will cast shadow on the row behind.</li> <li>Tilt angle of Module is 26 deg. whereas Latitude is 9.9 deg. (Non-optimum tilt)</li> </ul>							
<b>Recommendations:</b>							
The distance between the module supporting stands should be increased so as to prevent shading of the modules. The Modules should be placed at Latitude Tilt so as to maximize the annual energy generation. Modules should be cleaned at least once a week since dust on the modules can reduce the power generation.

<b>Undulating surface of the modules</b>		<b>Scratches and soiling on modules</b>		<b>Insufficient spacing between modules</b>

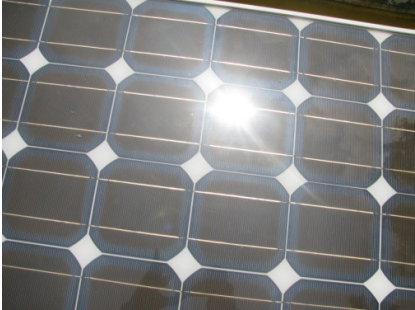
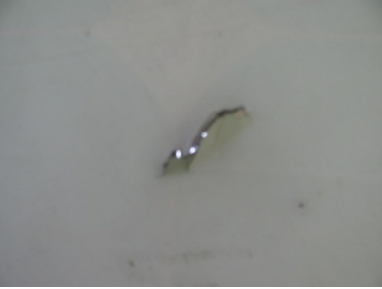
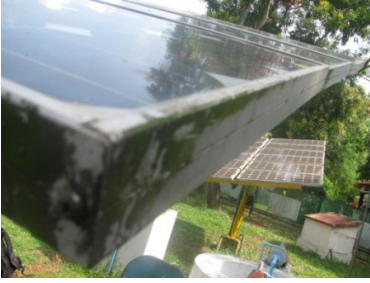
* Based on I-V Curve correction using assumed values for various coefficients (alpha = 0.12% per C, beta = -0.2% per C, Rs=0 & k=0) and assuming linear rate of degradation with time.							
<b>Key Observations:</b>							
<ul style="list-style-type: none"> <li>• Dark discoloration covering 90% of the solar cells</li> <li>• Puncture in the backsheet</li> <li>• Green discoloration in Frames (probably due to Algae growth)</li> </ul>							
<b>Recommendations:</b>							
Modules need to be handled carefully in future installations so as to avoid punctures and scratches in the backsheet. Algae growth in the backsheet and frame needs to be prevented as it can reduce the heat conduction rate (which will increase the module operating temperature) and also cause corrosion. Modules should be cleaned at least once a week since dust on the modules can reduce the power generation.							
<b>Dark Discoloration on Module</b>		<b>Puncture in backsheet</b>		<b>Corrosion &amp; Algae growth on frame</b>

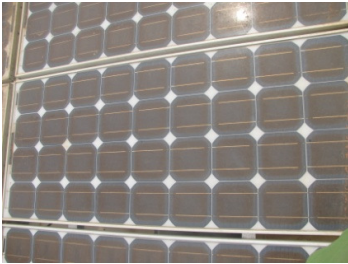
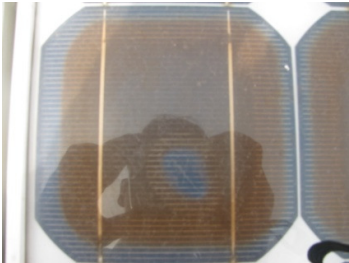
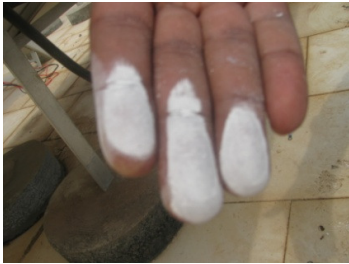
* Based on I-V Curve correction using assumed values for various coefficients (alpha = 0.12% per C, beta =-0.2% per C, Rs=0 & k=0) and assuming linear rate of degradation with time.					
<b>Key Observations:</b>					
<ul style="list-style-type: none"> <li>• Yellow discoloration on modules</li> <li>• Crack in solar cell lead to photo-oxidative bleaching of EVA</li> <li>• Chalking (white powder) of backsheet</li> </ul>

<b>Recommendations:</b>					
When multiple modules are in series, the performance of the system is limited by the most degraded module. So to improve performance, the worst performing modules should be removed from the circuit. Modules should be cleaned at least once a week since dust on the modules can reduce the power generation.					
<b>Yellow Discoloration</b>		<b>Crack in the solar cell leading to photo-bleaching of discolored EVA</b>		<b>Chalking (white powder) of backsheet</b>

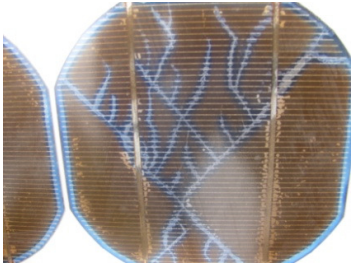
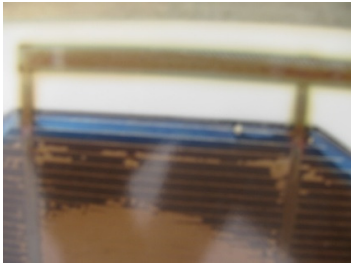
* Based on I-V Curve correction using assumed values for various coefficients (alpha = 0.12% per C, beta =-0.2% per C, Rs=0 & k=0) and assuming linear rate of degradation with time.							
<b>Key Observations:</b>							
<ul style="list-style-type: none"> <li>Major delamination and discoloration in most of the solar cells</li> <li>Cracks in the solar cell revealed by the photo oxidative bleaching of the discoloured encapsulant</li> <li>Corrosion in the cell and string interconnects</li> </ul>							
<b>Recommendations:</b>							
The presence of degraded module in series with better modules is going to limit the performance of the system so it is better to get rid of modules that have degraded significantly more than others. Modules should be cleaned at least once a week since dust on the modules can reduce the power generation.							
<b>Major delamination &amp; Yellow Discoloration</b>		<b>Cracks in the solar cell</b>		<b>Corrosion in the cell and string interconnects</b>

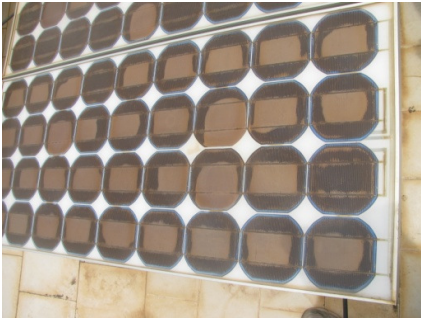
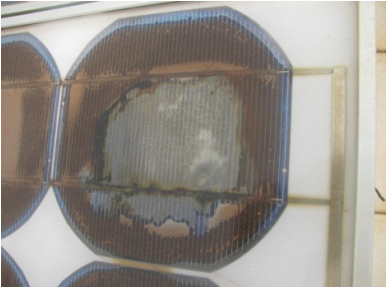
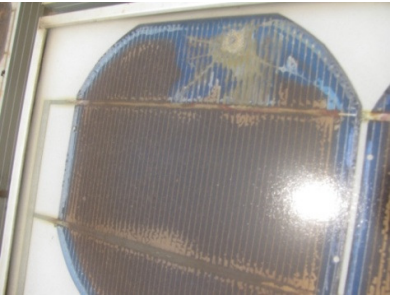
* Based on I-V Curve correction using assumed values for various coefficients (alpha = 0.12% per C, beta =-0.2% per C, Rs=0 & k=0) and assuming linear rate of degradation with time.						
<b>Key Observations:</b>						
<ul style="list-style-type: none"> <li>• Module has heavy discoloration or delamination</li> <li>• Puncture and discoloration in backsheet</li> <li>• Corrosion in the terminals</li> </ul>

<b>Recommendations:</b>						
The most degraded module in a series string of multiple modules limits the performance of the entire string, so it is better to remove the worst modules from the series string. Modules should be cleaned at least once a week since dust on the modules can reduce the power generation.						
<b>Major delamination and discoloration</b>		<b>Corrosion of Cell Interconnects, major delamination</b>		<b>Breakage in glass</b>

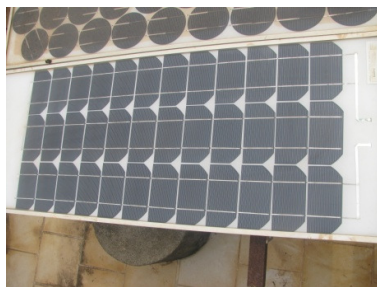
- Module has no discoloration or delamination
- Puncture and discoloration in backsheet
- Corrosion in the output terminals

**No Discoloration**

Module should be handled carefully so as to avoid any scratches and punctures in the backsheet, which could enhance the degradation rate of the module. Junction Boxes should be tightly sealed against entry of water since corrosion of terminals can lead to loss in power output (which seems to be the reason behind the high Pmax degradation in this case). Modules should be cleaned at least once a week since dust on the modules can reduce the power generation.

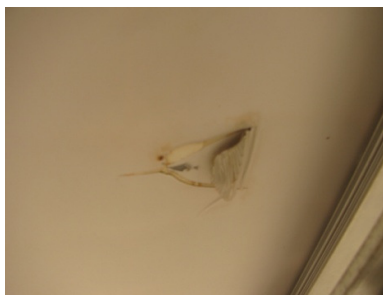
**Scratches in backsheet**

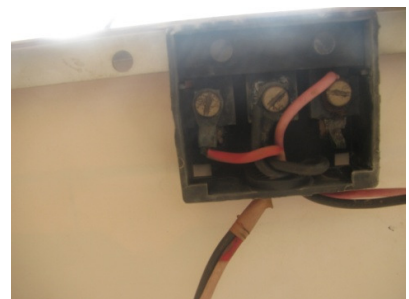
**Corrosion in output terminals**

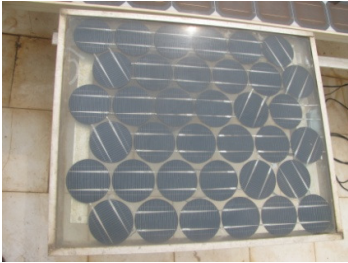
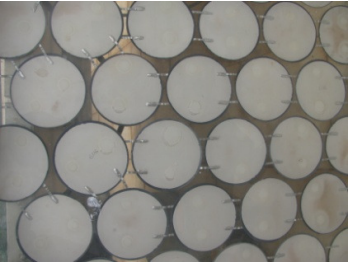
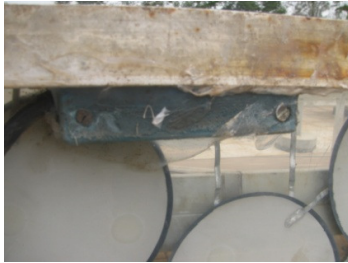
* Based on I-V Curve correction using assumed values for various coefficients (alpha = 0.12% per C, beta =-0.2% per C, Rs=0 & k=0) and assuming linear rate of degradation with time.						
<b>Key Observations:</b>						
<ul style="list-style-type: none"> <li>The module is having glass as top cover and bottom cover both.</li> <li>There is no discoloration in the encapsulant even after 18 years of service.</li> <li>There is no corrosion of the interconnects</li> <li>The frame has suffered corrosion</li> </ul>						
<b>Recommendations:</b>						
All modules in operation should be cleaned at regular intervals (at least once a week) to prevent power loss due to dust.						
<b>No discoloration in encapsulant</b>		<b>Module backside</b>		<b>Non-standard Output Terminals</b>

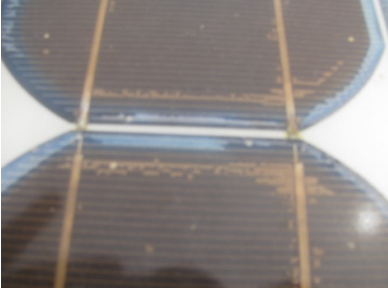
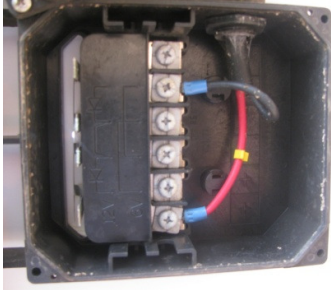
* Based on I-V Curve correction using assumed values for various coefficients (alpha = 0.12% per C, beta =-0.2% per C, Rs=0 & k=0) and assuming linear rate of degradation with time.					
<b>Key Observations:</b>					
<ul style="list-style-type: none"> <li>Dark discoloration on the solar cells</li> <li>Corrosion in the Metallization and interconnects</li> <li>Delamination along the solar cell periphery</li> </ul>					
<b>Recommendations:</b>					
The degraded module is placed on the same tracker in series with some of the better modules, which is not advisable. The degraded module should be replaced by a new module having same short circuit current rating as the other modules in series. Modules should be cleaned at least once a week since dust on the modules can reduce the power generation.					
<b>Modules placed on 2 Axis Tracker</b>	<b>Delamination &amp; Discoloration on cells</b>			<b>Output terminals in good condition</b>

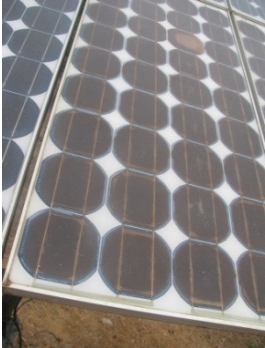
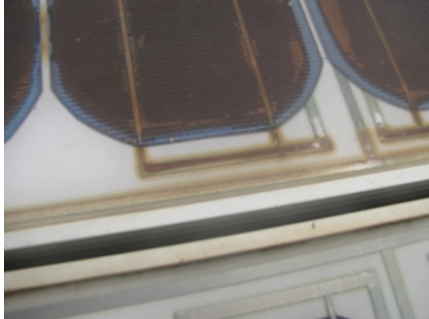
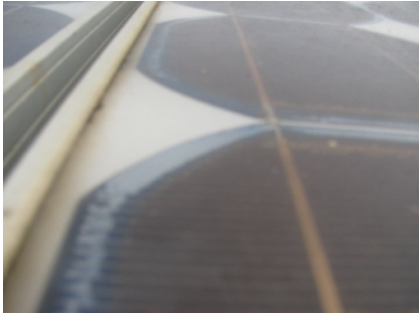
* Based on I-V Curve correction using assumed values for various coefficients (alpha = 0.12% per C, beta =-0.2% per C, Rs=0 & k=0) and assuming linear rate of degradation with time.							
<b>Key Observations:</b>							
<ul style="list-style-type: none"> <li>• Dark discoloration on all solar cells</li> <li>• Corrosion of metallization and interconnects, delamination along cell edge</li> <li>• Glass cover has become hazy</li> </ul>							
<b>Recommendations:</b>							
The degraded module should not be placed in series with other better modules, since it will bring down the system performance. Modules should be cleaned at least once a week since dust on the modules can reduce the power generation.							
<b>Dark discoloration on all cells</b>		<b>Corrosion of metallization and interconnects, delamination along cell edge</b>			<b>Haziness in the Glass cover</b>

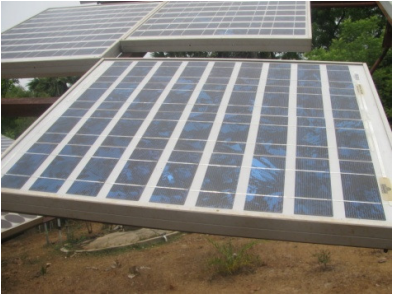
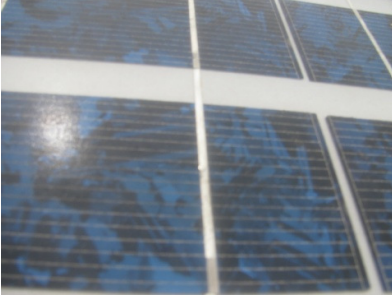
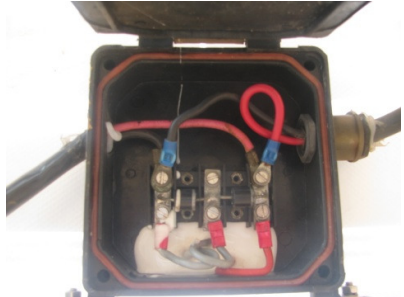
* Based on I-V Curve correction using assumed values for various coefficients (alpha = 0.12% per C, beta =-0.2% per C, Rs=0 & k=0) and assuming linear rate of degradation with time.					
<b>Key Observations:</b>					
<ul style="list-style-type: none"> <li>• No signs of discoloration or delamination</li> <li>• Slight corrosion in the fingers and also in terminals</li> </ul>					
<b>Recommendations:</b>					
Modules should be cleaned at least once a week since dust on the modules can reduce the power generation.					
<b>No Discoloration or delamination</b>		<b>Light Discoloration in Fingers (Metallization)</b>		<b>Corrosion in output terminals</b>

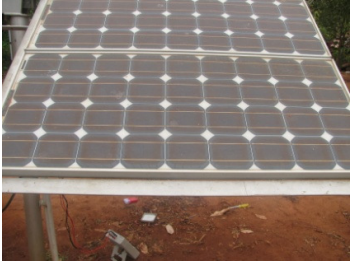
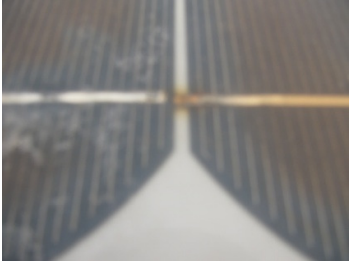
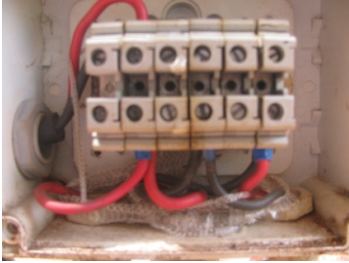
* Based on I-V Curve correction using assumed values for various coefficients (alpha = 0.12% per C, beta =-0.2% per C, Rs=0 & k=0) and assuming linear rate of degradation with time.					
<b>Key Observations:</b>					
<ul style="list-style-type: none"> <li>• Discoloration in all solar cells</li> <li>• Corrosion in the cell interconnects</li> <li>• Corrosion in the junction box terminals</li> </ul>					
<b>Recommendations:</b>					
Modules should be cleaned at least once a week since dust on the modules can reduce the power generation.					
<b>Yellow Discoloration</b>		<b>Corrosion in cell interconnects</b>		<b>Corrosion in the Junction Box terminals</b>

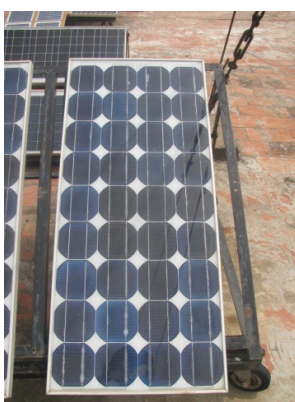
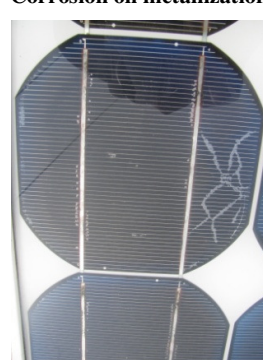
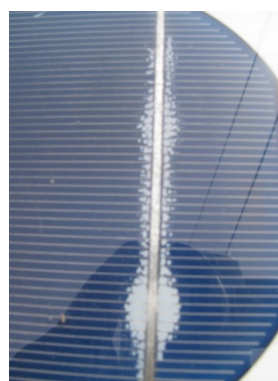
* Based on I-V Curve correction using assumed values for various coefficients (alpha = 0.12% per C, beta = -0.2% per C, Rs=0 & k=0) and assuming linear rate of degradation with time.							
<b>Key Observations:</b>							
<ul style="list-style-type: none"> <li>• Dark discoloration in most of the solar cells</li> <li>• Delamination near the busbars and also elsewhere on top of the solar cells</li> </ul>							
<b>Recommendations:</b>							
Tilt Angle should be rectified to get higher energy generation. Modules should be cleaned at least once a week since dust on the modules can reduce the power generation.							
<b>Discoloration in majority of cells</b>		<b>Delamination and discoloration on cell, Corrosion on metallization</b>			<b>Delamination near busbars</b>

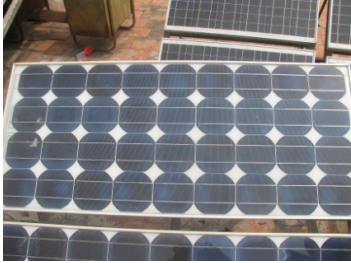
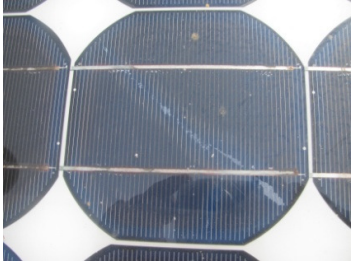
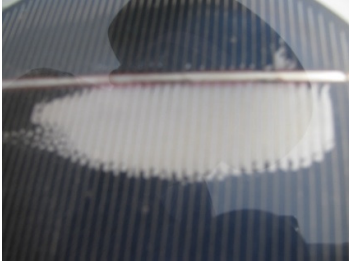
* Based on I-V Curve correction using assumed values for various coefficients (alpha = 0.12% per C, beta = -0.2% per C, Rs=0 & k=0) and assuming linear rate of degradation with time.						
<b>Key Observations:</b>						
<ul style="list-style-type: none"> <li>Discoloration on some of the solar cells</li> <li>Major Delamination on a few of the solar cells</li> <li>Delamination along the diagonal of a solar cell along with change in colour may be due to a crack in the cell</li> <li>Tilt angle of modules is 23 degrees while the latitude of the place is 13 degrees, so the modules are placed at a non-optimum tilt</li> </ul>						
<b>Recommendations:</b>						
Modules should be cleaned at least once a week since dust on the modules can reduce the power generation. The tilt angle should be equal to the Latitude angle for maximizing the annual energy generation.						
<div style="text-align: center;">

<b>Discoloration on some solar cells</b>			<b>Delamination along a diagonal</b>		<b>Major delamination on a solar cell</b>

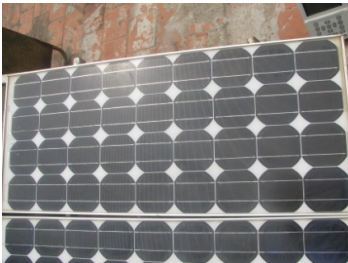
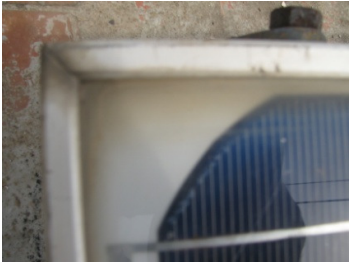
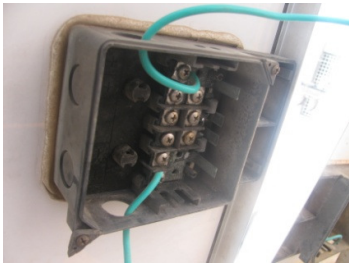
* Based on I-V Curve correction using assumed values for various coefficients (alpha = 0.12% per C, beta = -0.2% per C, Rs=0 & k=0) and assuming linear rate of degradation with time.					
<b>Key Observations:</b>					
<ul style="list-style-type: none"> <li>Light discoloration in some of the solar cells</li> <li>Minor delamination in 1 cell</li> <li>Minor corrosion in the frame</li> <li>Glass has become yellowish at the edges due to dust deposition</li> <li>Corrosion in the output terminals</li> <li>The tilt angle of the modules is close to the latitude angle at the site.</li> </ul>

<b>Recommendations:</b>					
Modules should be cleaned at least once a week since dust on the modules can reduce the power generation.					
<b>Light Discoloration in some cells</b>		<b>Corrosion in the frame and dust deposits on the Glass at the corner</b>		<b>Corrosion in the output terminals</b>

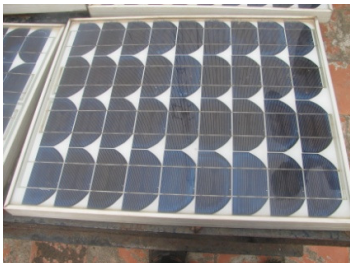
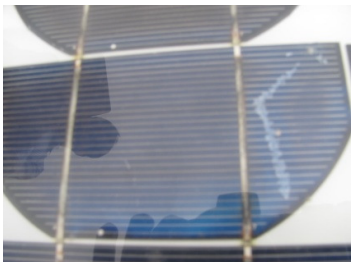
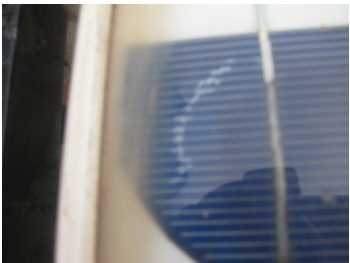
* Based on I-V Curve correction using assumed values for various coefficients (alpha = 0.12% per C, beta = -0.2% per C, Rs=0 & k=0) and assuming linear rate of degradation with time.					
<b>Key Observations:</b>					
<ul style="list-style-type: none"> <li>Discoloration in most of the solar cells</li> <li>Corrosion in the bus bars and cell interconnects</li> <li>Delamination in some of the cells</li> <li>Hard-to-remove dust deposits on the glass</li> <li>The tilt angle of the modules is close to the latitude angle at the site</li> </ul>					
<div style="display: flex; align-items: center;"> <div style="flex: 1;"> <p style="text-align: center; margin: 0;"><b>I-V Data</b></p> <p style="text-align: center; margin: 0;">Irradiance 588 W/m<sup>2</sup>    Module Temperature 48.9 °C</p> </div> <div style="flex: 0 0 100px; text-align: center;"> <p style="font-size: small;">IV curve</p> </div> </div>

<b>Recommendations:</b>					
Modules should be cleaned at least once a week since dust on the modules can reduce the power generation.					
<b>Discoloration in most of the cells</b>		<b>Corrosion in Metallization, and delamination</b>		<b>Dust</b>

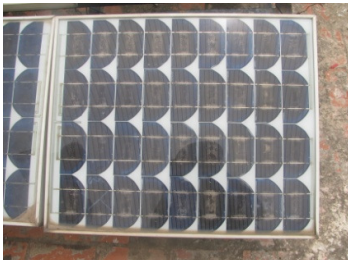
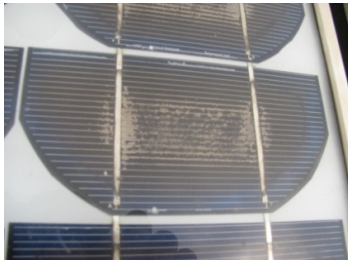
* Based on I-V Curve correction using assumed values for various coefficients (alpha = 0.12% per C, beta = -0.2% per C, Rs=0 & k=0) and assuming linear rate of degradation with time.					
<b>Key Observations:</b>					
<ul style="list-style-type: none"> <li>Discoloration and delamination in all the solar cells</li> <li>Minor corrosion in some sections of the metallization</li> <li>Chalking (white powder) from the backsheet</li> <li>Tilt angle of Module is 40 deg. whereas Latitude is 13 deg.</li> <li>(Non-optimum tilt)</li> </ul>

<b>Recommendations:</b>					
Modules should be cleaned at least once a week since dust on the modules can reduce the power generation. The Tilt angle should be adjusted close to the Latitude angle to increase the annual energy generation.					
<b>Degradation visible in all the cells</b>		<b>Discoloration and delamination</b>		<b>White powder from backsheet</b>

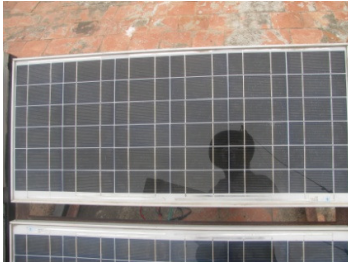
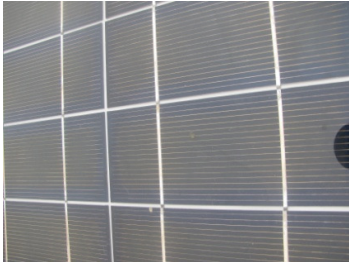
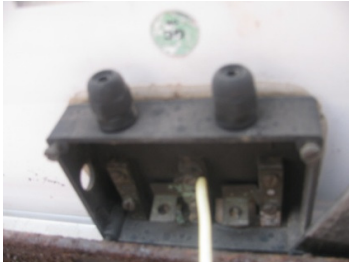
* Based on I-V Curve correction using assumed values for various coefficients (alpha = 0.12% per C, beta =-0.2% per C, Rs=0 & k=0) and assuming linear rate of degradation with time.					
<b>Key Observations:</b>					
<ul style="list-style-type: none"> <li>Light discoloration but no delamination</li> <li>Minor corrosion in the Metallization (fingers)</li> <li>Corrosion in the output terminals</li> <li>Tilt angle of Module is 40 deg. whereas Latitude is 13 deg.</li> <li>(Non-optimum tilt)</li> </ul>					
<b>Recommendations:</b>					
Modules should be cleaned at least once a week since dust on the modules can reduce the power generation. The Tilt angle should be adjusted close to the Latitude angle to increase the annual energy generation.					
<b>Light Discoloration</b>		<b>Minor Corrosion of fingers</b>		<b>Corrosion of the output terminals</b>

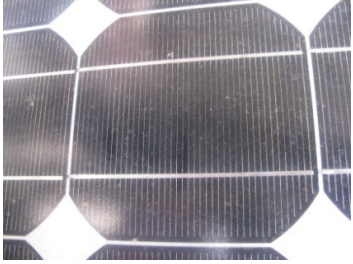
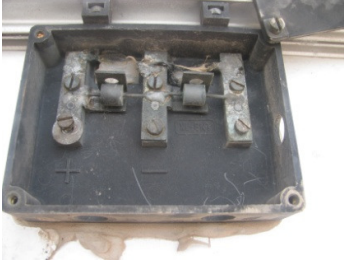
Degradation in Isc (% per year *)	0.72						
Degradation in Voc (% per year *)	-0.26						
<p>* Based on I-V Curve correction using assumed values for various coefficients (alpha = 0.12% per C, beta = -0.2% per C, Rs=0 &amp; k=0) and assuming linear rate of degradation with time.</p>							
<b>Key Observations:</b>							
<ul style="list-style-type: none"> <li>Light discoloration</li> <li>Discoloration on the Metallization (fingers)</li> <li>Output terminals have corroded</li> </ul>							
<b>Recommendations:</b>							
Modules should be cleaned at least once a week since dust on the modules can reduce the power generation.							
<b>Light Discoloration in most of the cells</b>			<b>Discoloration on Fingers</b>		<b>Corrosion of output terminals</b>

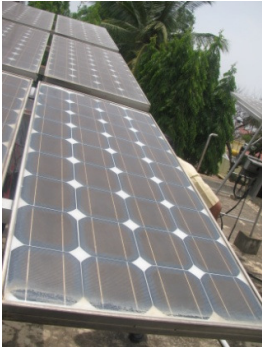
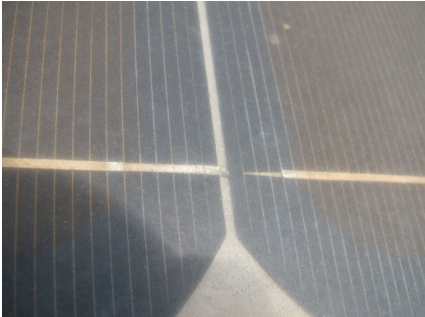
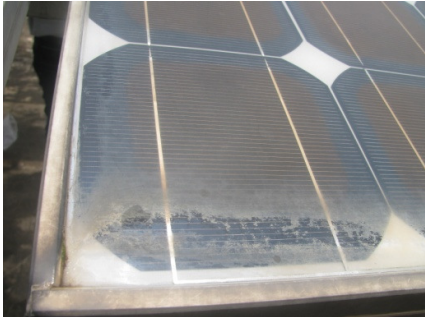
* Based on I-V Curve correction using assumed values for various coefficients (alpha = 0.12% per C, beta = -0.2% per C, Rs=0 & k=0) and assuming linear rate of degradation with time.					
<b>Key Observations:</b>					
<ul style="list-style-type: none"> <li>Discoloration is visible in the middle portion of all the solar cells</li> <li>Discoloration on the Metallization (fingers)</li> <li>A hard patch of dust can be seen near the bottom edge of the module</li> <li>Tilt angle of Module closely matches the latitude angle of the site, so the annual power generation will be maximum.</li> </ul>					
<b>Recommendations:</b>					
Modules should be cleaned at least once a week since dust on the modules can reduce the power generation.					
<b>Discoloration on all cells</b>		<b>Glass has become hazy</b>		<b>Hard-to-remove dust deposits on the Glass</b>

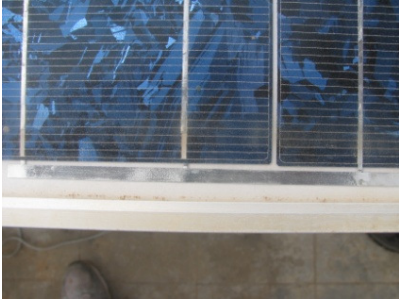
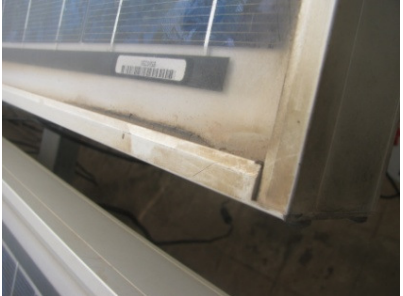
* Based on I-V Curve correction using assumed values for various coefficients (alpha = 0.12% per C, beta = -0.2% per C, Rs=0 & k=0) and assuming linear rate of degradation with time.					
<b>Key Observations:</b>					
<ul style="list-style-type: none"> <li>• All except the frame are in good condition</li> <li>• Frame has suffered minor corrosion</li> <li>• A thin film of dust has stuck to the front glass and is proving difficult to remove.</li> <li>• Tilt angle of Module closely matches the latitude at the site, which will produce the maximum annual energy.</li> </ul>					
<b>Recommendations:</b>					
Modules should be cleaned at least once a week since dust on the modules can reduce the power generation.					
<b>Light dust deposition on the module</b>		<b>Thin layer of hard-to-remove dust deposits near the bottom edge</b>		<b>Minor corrosion in the frame</b>

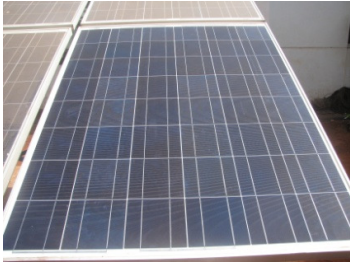
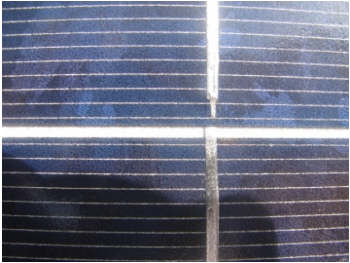
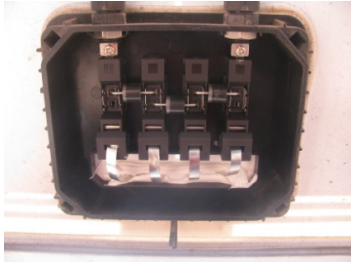
* Based on I-V Curve correction using assumed values for various coefficients (alpha = 0.12% per C, beta =-0.2% per C, Rs=0 & k=0) and assuming linear rate of degradation with time.					
<b>Key Observations:</b>					
<ul style="list-style-type: none"> <li>• There is no discoloration (browning) or delamination.</li> <li>• The solar cells have small dark spots spread all over the surface.</li> <li>• The modules are heavily soiled</li> </ul>

<b>Recommendations:</b>					
Modules should be cleaned at least once a week since dust on the modules can reduce the power generation.					
<b>Heavy soiling evident from the contrast</b>		<b>Small dark spots spread all the solar cells</b>		<b>Output terminals in good condition</b>

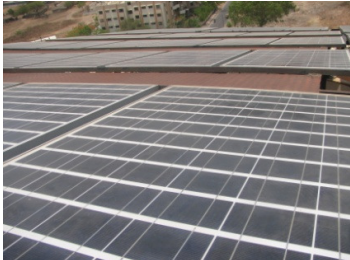
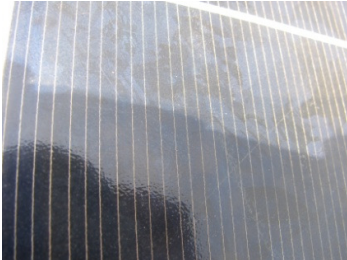
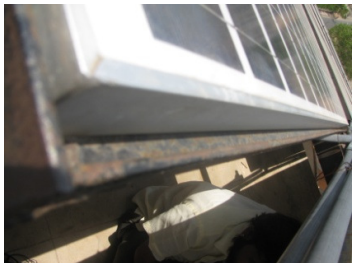
* Based on I-V Curve correction using assumed values for various coefficients (alpha = 0.12% per C, beta = -0.2% per C, Rs=0 & k=0) and assuming linear rate of degradation with time.						
<b>Key Observations:</b>						
<ul style="list-style-type: none"> <li>• There is no discoloration or delamination in the module.</li> <li>• The glass appears to be slightly hazy.</li> <li>• The module supporting structure is corroded.</li> <li>• Tilt angle of Module is very close to the Latitude angle.</li> </ul>						
<b>Recommendations:</b>						
Modules should be cleaned at least once a week since dust on the modules can reduce the power generation						
<b>Yellow Discoloration</b>		<b>Haziness in the glass</b>		<b>Corrosion in Module supporting structure</b>
