# All-India Survey of Photovoltaic Module Degradation: 2013

**National Centre for Photovoltaic Research and Education  
(NCPRE), IIT Bombay**

**Solar Energy Centre, Gurgaon**

May-June 2013  
Report dated March 2014

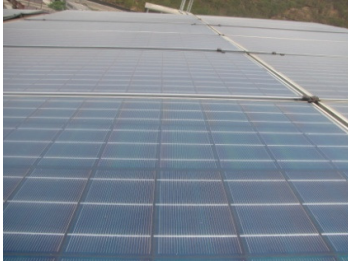
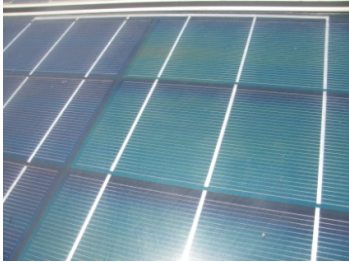
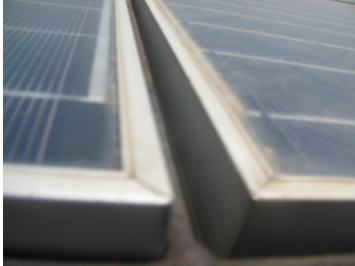
* Based on I-V Curve correction using assumed values for various coefficients (alpha = 0.12% per C, beta =-0.2% per C, Rs=0 & k=0) and assuming linear rate of degradation with time.					
<b>Key Observations:</b>					
<ul style="list-style-type: none"> <li>Light discoloration in 1 cell of the module but no delamination</li> <li>Small amount of dust has deposited at the corners of the module and could not be removed by wiping with dry cloth.</li> <li>Tilt angle of Module is very close to the Latitude angle, so annual generation will be maximized.</li> </ul>					
<b>Recommendations:</b>					
Tilt Angle should be rectified and nearby trees to be pruned to get higher energy generation and longer module life.					
<b>Multiple modules connected in string</b>	<b>Light yellow discoloration in some cells</b>	<b>Dust deposition at the corners of the modules</b>

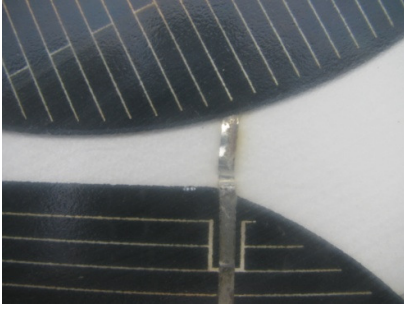
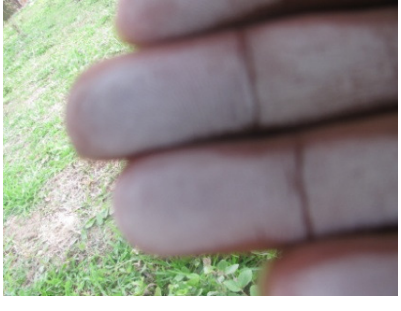
* Based on I-V Curve correction using assumed values for various coefficients (alpha = 0.12% per C, beta = -0.2% per C, Rs=0 & k=0) and assuming linear rate of degradation with time.						
<b>Key Observations:</b>						
<ul style="list-style-type: none"> <li>Dark discoloration in the centre of each cell.</li> <li>Minor corrosion in the cell interconnects</li> <li>Chalking of the backsheet of the module</li> </ul>						
				<div style="text-align: right; font-size: small;">I-V Data</div> <div style="text-align: right; font-size: x-small;">Irradiance 590 W/m<sup>2</sup> Module Temperature 44.0 °C</div>

<b>Dark Discoloration</b>		<b>Minor corrosion in the cell interconnects</b>			<b>Chalking of the backsheet</b>

<b>Recommendations:</b>						
Modules should be cleaned at least once a week since dust on the modules can reduce the power generation. Module should be handled with care during installation so as to prevent any scratches or puncture in the modules. Module junction boxes should be properly covered to prevent moisture ingress (which can corrode the output terminals) and the cables should be regularly checked for any breakage, animal bites etc.

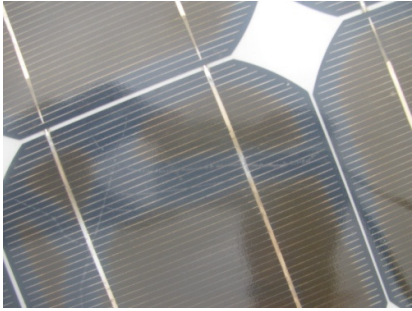
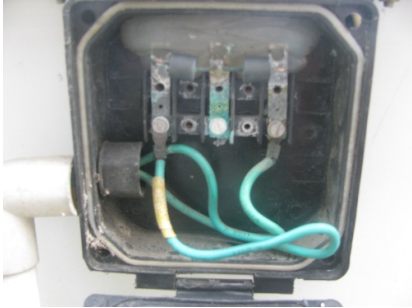
* Based on I-V Curve correction using assumed values for various coefficients (alpha = 0.12% per C, beta = -0.2% per C, Rs=0 & k=0) and assuming linear rate of degradation with time.					
<b>Key Observations:</b>					
<ul style="list-style-type: none"> <li>• Dark discoloration.</li> <li>• Cracks in cell revealed by discoloration</li> <li>• Heavy corrosion in output terminals</li> </ul>

<b>Recommendations:</b>					
Junction box should be properly covered so that moisture ingress is prevented (which is corroding the terminals and causing reduction in FF and eventually result in power loss). Modules should be cleaned at least once a week since dust on the modules can reduce the power generation.					
<b>Dark discoloration in all Solar cells</b>		<b>Cracks in the Solar cell revealed by discoloration</b>		<b>Corrosion in output terminals</b>

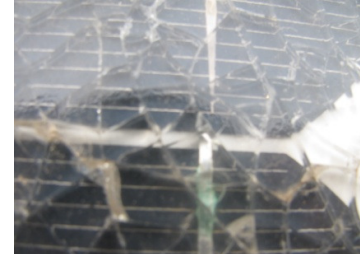
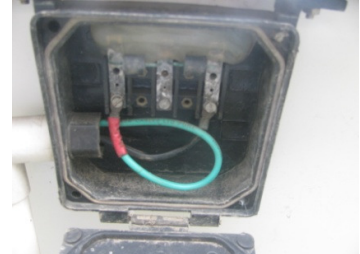
* Based on I-V Curve correction using assumed values for various coefficients (alpha = 0.12% per C, beta = -0.2% per C, Rs=0 & k=0) and assuming linear rate of degradation with time.							
<b>Key Observations:</b>							
<ul style="list-style-type: none"> <li>• No discoloration and delamination in cell</li> <li>• Corrosion in the bus bar (green)</li> <li>• Heavy corrosion in output terminals.</li> <li>• Front glass broken.</li> </ul>							
<b>Recommendations:</b>							
It is safety hazard to use a module with broken glass. Modules should be cleaned at least once a week since dust on the modules can reduce the power generation.							
<b>Module with front glass shattered</b>		<b>Corrosion in the busbar (green)</b>		<b>Corrosion in output terminals</b>

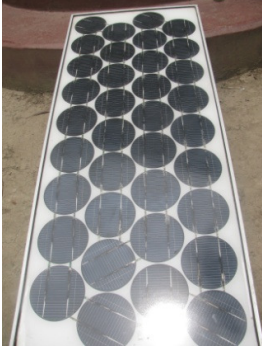
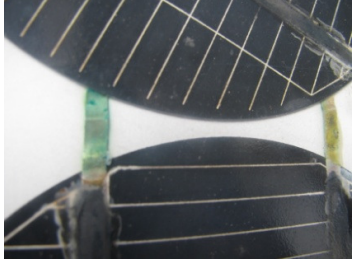
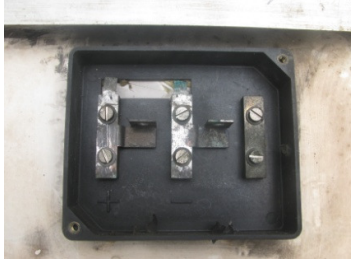
* Based on I-V Curve correction using assumed values for various coefficients (alpha = 0.12% per C, beta = -0.2% per C, Rs=0 & k=0) and assuming linear rate of degradation with time.						
<b>Key Observations:</b>						
<ul style="list-style-type: none"> <li>• No and delamination in cell</li> <li>• Corrosion in the Metallization (bus bars)</li> <li>• Green discoloration on bus bars.</li> <li>• Corrosion on output terminals.</li> </ul>						
<div style="display: flex; align-items: center;"> <div style="flex: 1;"> <p><b>I-V Data</b></p> <p>Irradiance 570 W/m<sup>2</sup> Module Temperature 48.0 °C</p> </div> <div style="flex: 0.5; text-align: center;"> <p>— IV curve</p> </div> </div>						
<b>Recommendations:</b>						
Modules should be cleaned at least once a week since dust on the modules can reduce the power generation.						
<b>No Discoloration or delamination</b>		<b>Corrosion in cell interconnects</b>		<b>Corrosion in output terminals</b>

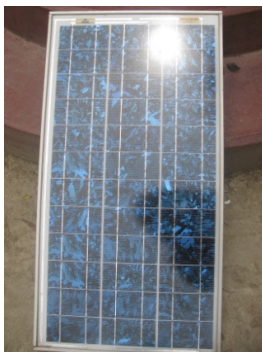
No Discoloration or delamination

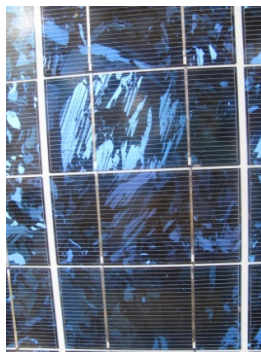
Minor corrosion in the busbars

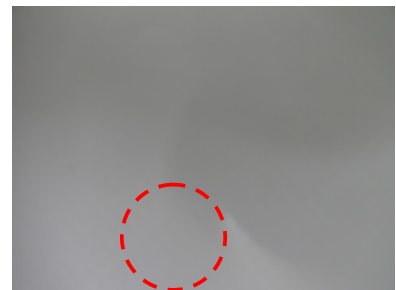
Slight dent in backsheet

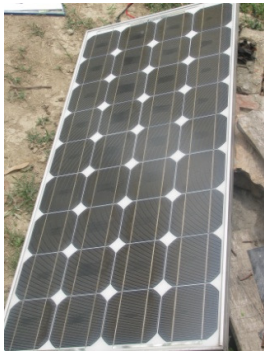
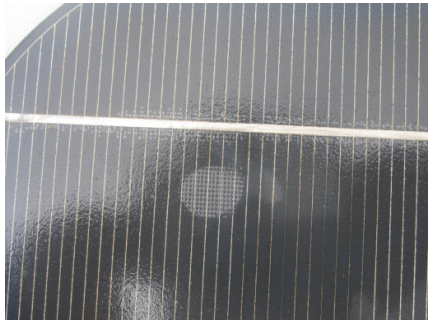
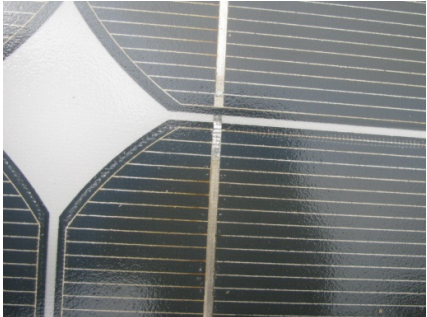
* Based on I-V Curve correction using assumed values for various coefficients (alpha = 0.12% per C, beta = -0.2% per C, Rs=0 & k=0) and assuming linear rate of degradation with time.					
<b>Key Observations:</b>					
<ul style="list-style-type: none"> <li>• Yellow discoloration and delamination between glass and encapsulant</li> <li>• Corrosion of the Metallization (fingers)</li> <li>• Extensive burn marks on the backsheet</li> </ul>					
<b>Recommendations:</b>					
Installation should be rectified by leaving sufficient space at the back side to enable faster cooling rate. Modules should be cleaned at least once a week since dust on the modules can reduce the power generation.					
<b>Yellow Discoloration</b>		<b>Delamination between glass and Encapsulant</b>		<b>Corrosion of the fingers</b>

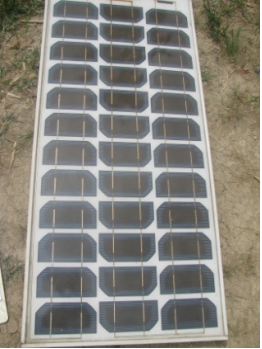
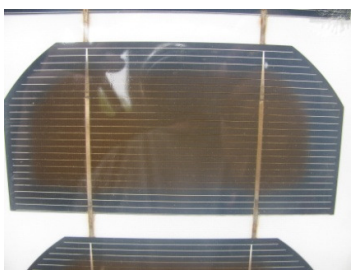
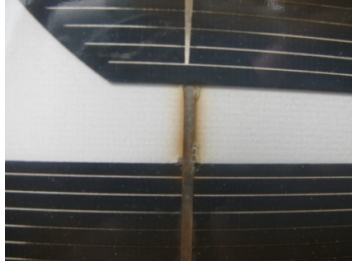
Degradation in Isc (% per year *)	1.04					
Degradation in Voc (% per year *)	-1.15					
<p>* Based on I-V Curve correction using assumed values for various coefficients (alpha = 0.12% per C, beta = -0.2% per C, Rs=0 &amp; k=0) and assuming linear rate of degradation with time.</p> <p><b>Key Observations:</b></p> <ul style="list-style-type: none"> <li>• Dark discoloration and delamination in cell</li> <li>• Heavy discoloration in the Metallization and interconnects</li> <li>• Extensive burn marks on the backsheet</li> </ul>

<b>Recommendations:</b>						
<p>Installation should be rectified by leaving sufficient space at the back side to enable faster cooling rate. Modules should be cleaned at least once a week since dust on the modules can reduce the power generation.</p>						
<b>Degradation visible in all solar cells</b>		<b>Discoloration at the middle of the Solar cell</b>		<b>Corrosion of the cell Interconnects</b>

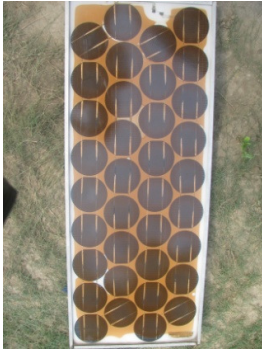
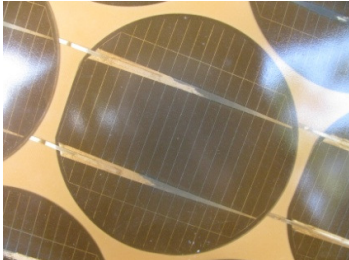
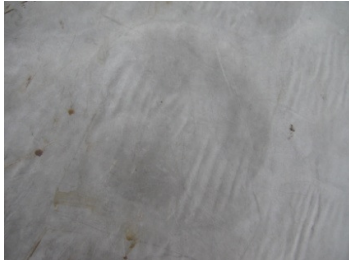
* Based on I-V Curve correction using assumed values for various coefficients (alpha = 0.12% per C, beta = -0.2% per C, Rs=0 & k=0) and assuming linear rate of degradation with time.					
<b>Key Observations:</b>					
<ul style="list-style-type: none"> <li>Dark discoloration and delamination in module</li> <li>Heavy corrosion of the Metallization</li> <li>Extensive burn marks and delamination on the backsheet.</li> <li>Heavy shading from nearby trees, which will degrade the module performance</li> </ul>					
<b>Recommendations:</b>					
Installation should be rectified by leaving sufficient space at the back side to enable faster cooling rate. Modules should be cleaned at least once a week since dust on the modules can reduce the power generation. Nearby trees to be pruned to get higher energy generation and longer module life.					
<b>Dark Discoloration</b>		<b>Corrosion of Metallization</b>		<b>Delamination below the solar cell</b>

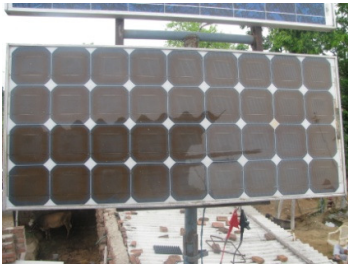
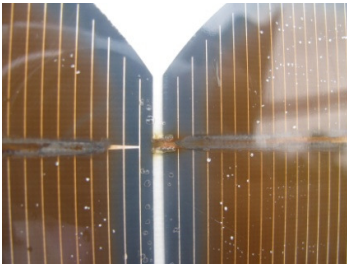
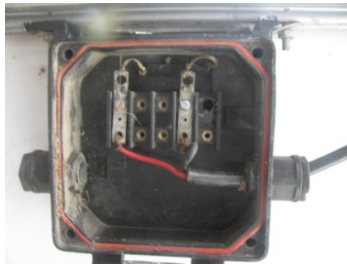
* Based on I-V Curve correction using assumed values for various coefficients (alpha = 0.12% per C, beta =-0.2% per C, Rs=0 & k=0) and assuming linear rate of degradation with time.					
<b>Key Observations:</b>					
<ul style="list-style-type: none"> <li>• Dark discoloration and delamination in cells</li> <li>• Heavy corrosion of the Metallization (fingers and interconnects)</li> <li>• Heavy shading from nearby trees, which will degrade the module performance</li> <li>• Bypass diode removed from the junction box</li> </ul>					
<b>Recommendations:</b>					
Nearby trees to be pruned to get higher energy generation and longer module life. If the module has to be used in series bypass diode must present for higher energy generation. Modules should be cleaned at least once a week since dust on the modules can reduce the power generation.					
<b>Discoloration in all solar cells</b>		<b>Corrosion in cell interconnects</b>		<b>Improper connection in junction box</b>

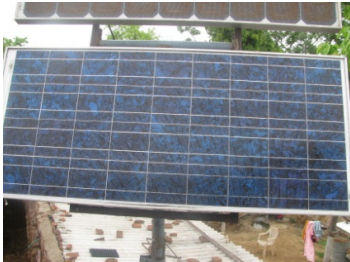
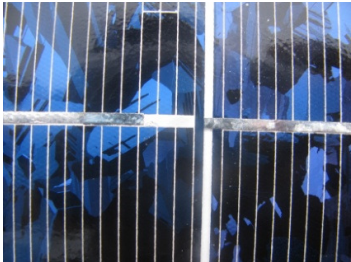
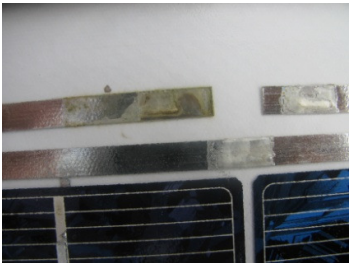
* Based on I-V Curve correction using assumed values for various coefficients (alpha = 0.12% per C, beta =-0.2% per C, Rs=0 & k=0) and assuming linear rate of degradation with time.					
<b>Key Observations:</b>					
<ul style="list-style-type: none"> <li>No discoloration and delamination in cell</li> <li>No discoloration in the metallization</li> <li>Heavy shading from nearby trees, which will degrade the module performance</li> </ul>					
<b>Recommendations:</b>					
Nearby trees to be pruned to get higher energy generation and longer module life. Modules should be cleaned at least once a week since dust on the modules can reduce the power generation.					
<b>Lightly soiled module</b>		<b>No discoloration in metallization</b>		<b>Mild corrosion in the string interconnects</b>

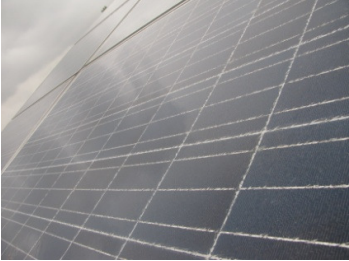
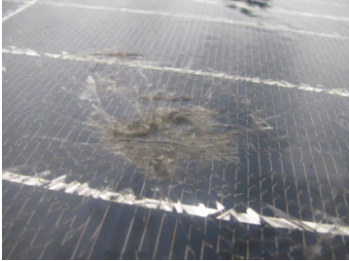
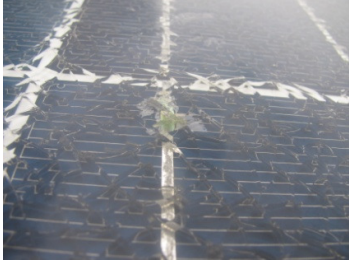
* Based on I-V Curve correction using assumed values for various coefficients (alpha = 0.12% per C, beta = -0.2% per C, Rs=0 & k=0) and assuming linear rate of degradation with time.						
<b>Key Observations:</b>						
<ul style="list-style-type: none"> <li>No discoloration and delamination in cell</li> <li>Light corrosion in the metallization (bus bars)</li> <li>Front glass broken and dented</li> </ul>						
<b>Recommendations:</b>						
It is safety hazard to use a module with broken glass. Modules should be cleaned at least once a week since dust on the modules can reduce the power generation.						
<b>Module with Shattered Glass</b>		<b>Dent in the front glass</b>		<b>Corrosion in the busbar</b>

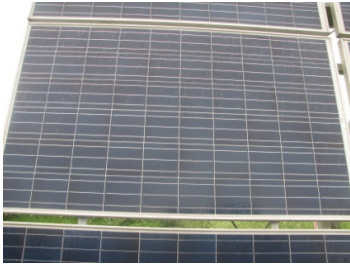
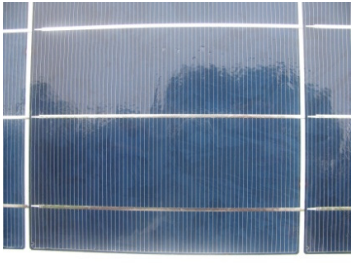
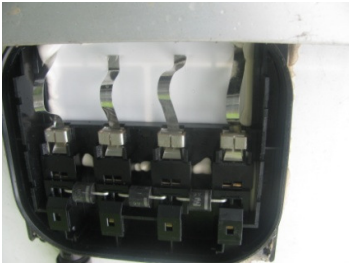
* Based on I-V Curve correction using assumed values for various coefficients (alpha = 0.12% per C, beta = -0.2% per C, Rs=0 & k=0) and assuming linear rate of degradation with time.						
<b>Key Observations:</b>						
<ul style="list-style-type: none"> <li>• No discoloration and delamination in cell</li> <li>• No discoloration in the metallization</li> <li>• Junction box intact</li> </ul>						
<b>Recommendations:</b>						
Modules should be cleaned at least once a week since dust on the modules can reduce the power generation.						
<b>Lightly soiled module</b>		<b>Solar Cell</b>		<b>Junction Box</b>

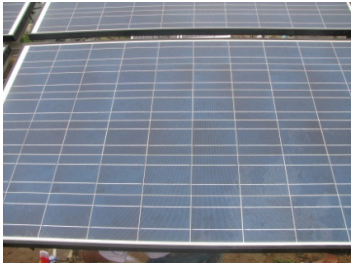
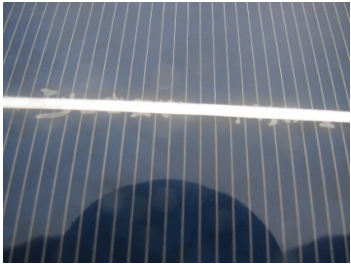
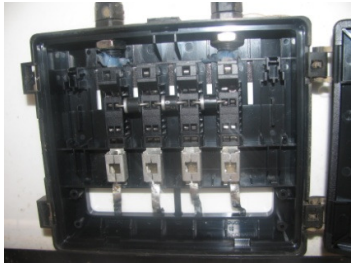
* Based on I-V Curve correction using assumed values for various coefficients (alpha = 0.12% per C, beta = -0.2% per C, Rs=0 & k=0) and assuming linear rate of degradation with time.					
<b>Key Observations:</b>					
<ul style="list-style-type: none"> <li>No discoloration and delamination in cell</li> <li>No discoloration in the metallization</li> <li>Junction box intact</li> </ul>					
<b>Recommendations:</b>					
Modules should be cleaned at least once a week since dust on the modules can reduce the power generation.					
<b>Lightly soiled module</b>		<b>Solar cell</b>		<b>Junction box</b>

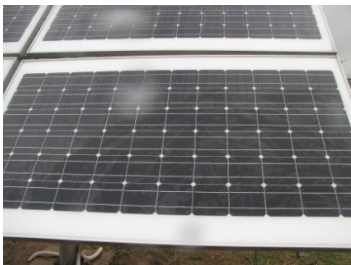
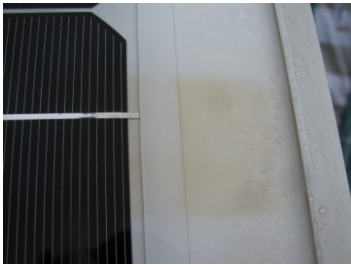
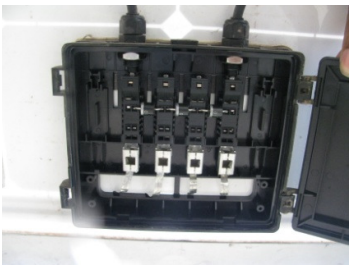
* Based on I-V Curve correction using assumed values for various coefficients (alpha = 0.12% per C, beta =-0.2% per C, Rs=0 & k=0) and assuming linear rate of degradation with time.					
<b>Key Observations:</b>					
<ul style="list-style-type: none"> <li>• No discoloration or delamination on the solar cells</li> <li>• Light discoloration in an area between cell and frame</li> </ul>

<b>Recommendations:</b>					
Modules should be cleaned at least once a week since dust on the modules can reduce the power generation.					
<b>No discoloration on solar cells</b>		<b>Light discoloration between cell and frame</b>		<b>Junction box intact</b>

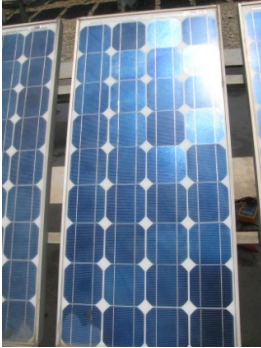
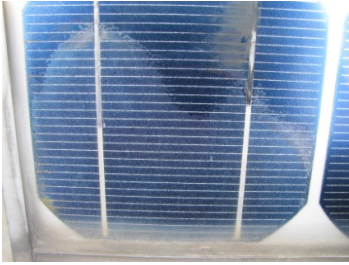
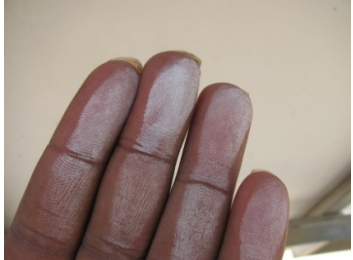
* Based on I-V Curve correction using assumed values for various coefficients (alpha = 0.12% per C, beta = -0.2% per C, Rs=0 & k=0) and assuming linear rate of degradation with time.						
<b>Key Observations:</b>						
<ul style="list-style-type: none"> <li>• Discoloration at the centre of a few solar cells</li> <li>• Major delamination and corrosion in 1 solar cell</li> <li>• Hard-to-remove dust deposits on the lower edge of the module</li> <li>• Chalking (white powder) from the backsheet</li> <li>• Tilt angle of Module is 35 deg. whereas Latitude is 28.5 deg.</li> <li>• (Non-optimum tilt)</li> </ul>						
<b>Recommendations:</b>						
Since the modules have been installed for research purpose and not for power generation, the research project's requirements need to be followed.						
<b>Module having significant variation in the colour of the solar cells</b>		<b>Major delamination and corrosion</b>		<b>Chalking (white powder) from backsheet</b>

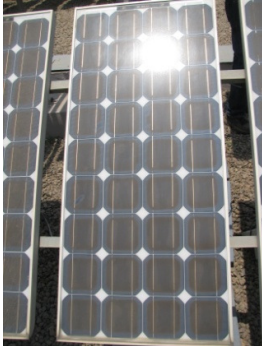
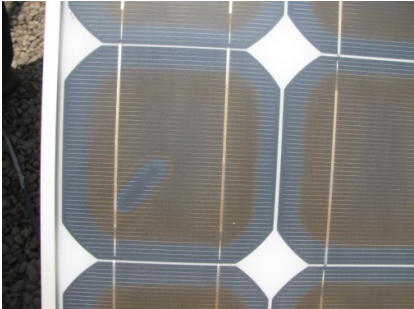
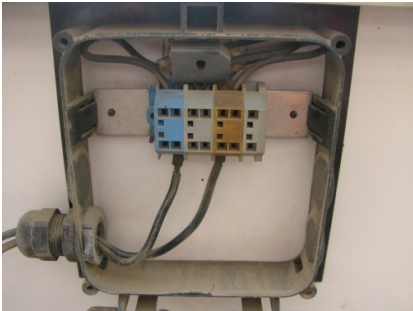
* Based on I-V Curve correction using assumed values for various coefficients (alpha = 0.12% per C, beta =-0.2% per C, Rs=0 & k=0) and assuming linear rate of degradation with time.					
<b>Key Observations:</b>					
<ul style="list-style-type: none"> <li>All cells have dark discolorations, but no delamination</li> <li>Corrosion in small portions of some busbars</li> <li>Small cracks in some solar cells have caused photo-oxidative bleaching of the discoloured encapsulant</li> <li>The connection cables have degraded significantly</li> <li>Tilt angle of Module is 37 deg. whereas Latitude is 28.5 deg.</li> <li>(Non-optimum tilt)</li> </ul>					
<b>Recommendations:</b>					
Since the modules have been installed for research purpose and not for power generation, the research project's requirements need to be followed.					
<b>Yellow Discoloration</b>		<b>Uneven discoloration caused by crack in the cell</b>		<b>Connecting wires are degraded</b>

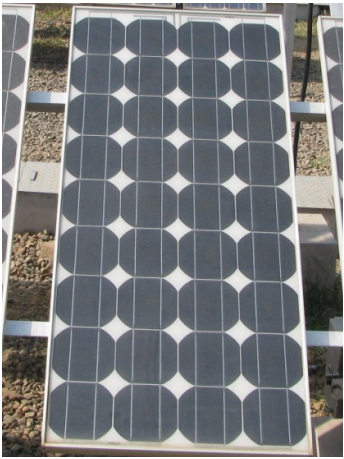
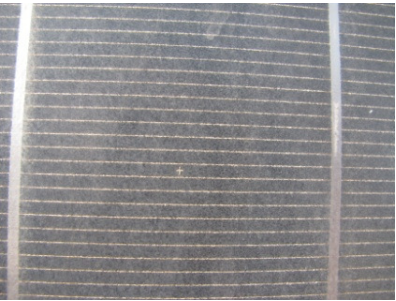
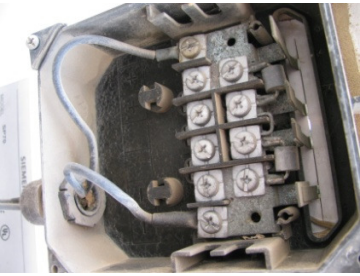
* Based on I-V Curve correction using assumed values for various coefficients (alpha = 0.12% per C, beta =-0.2% per C, Rs=0 & k=0) and assuming linear rate of degradation with time.					
<b>Key Observations:</b>					
<ul style="list-style-type: none"> <li>• Light discoloration but no delamination</li> <li>• Corrosion in the cell interconnect</li> <li>• Cover glass has become hazy</li> <li>• The cables have become weathered and degraded</li> <li>• Tilt angle of Module is 37 deg. whereas Latitude is 28.5 deg.</li> <li>• (Non-optimum tilt)</li> </ul>					
<b>Recommendations:</b>					
Since the modules have been installed for research purpose and not for power generation, the research project's requirements need to be followed.					
<b>Light Discoloration</b>		<b>Corrosion in busbar and Haziness in glass</b>		<b>Minor corrosion in output terminals, but wires degraded</b>

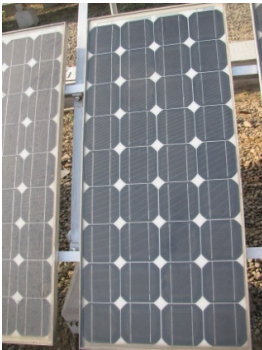
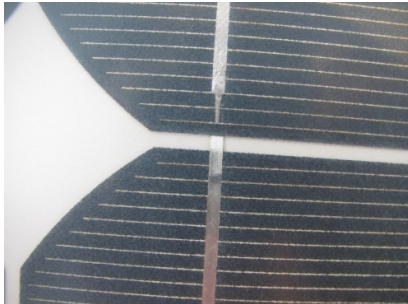
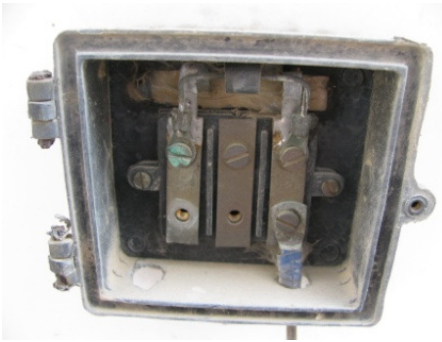
* Based on I-V Curve correction using assumed values for various coefficients (alpha = 0.12% per C, beta = -0.2% per C, Rs=0 & k=0) and assuming linear rate of degradation with time.					
<b>Key Observations:</b>					
<ul style="list-style-type: none"> <li>• Light discoloration but no delamination</li> <li>• Corrosion of the cell interconnects</li> <li>• Corrosion of the output terminals</li> <li>• Tilt angle of Module is 37 deg. whereas Latitude is 28.5deg.</li> <li>• (Non-optimum tilt)</li> </ul>					
<b>Recommendations:</b>					
Since the modules have been installed for research purpose and not for power generation, the research project's requirements need to be followed.					
<b>Light discoloration in the module</b>		<b>Corrosion of cell interconnects</b>		<b>Corrosion in Output terminals</b>

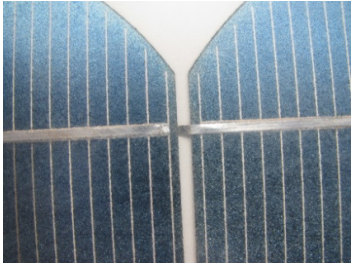
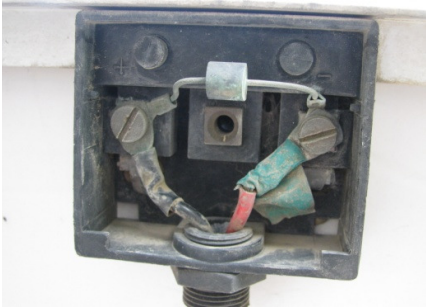
* Based on I-V Curve correction using assumed values for various coefficients (alpha = 0.12% per C, beta = -0.2% per C, Rs=0 & k=0) and assuming linear rate of degradation with time.					
<b>Key Observations:</b>					
<ul style="list-style-type: none"> <li>Light discoloration on some of the solar cells but no delamination</li> <li>Mild corrosion of the metallization in a few cells</li> <li>Output terminals are corroded and soiled</li> <li>Tilt angle of Module is 35 deg. whereas Latitude is 28.5 deg.</li> <li>(Non-optimum tilt)</li> </ul>					
<b>Recommendations:</b>					
Since the modules have been installed for research purpose and not for power generation, the research project's requirements need to be followed.					
<b>Light discoloration on some solar cells</b>		<b>Mild corrosion of the metallization</b>		<b>Corrosion of output terminals</b>

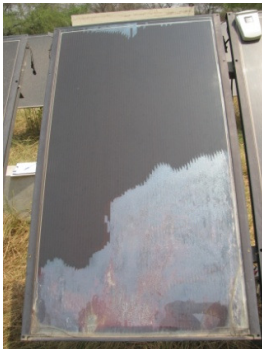
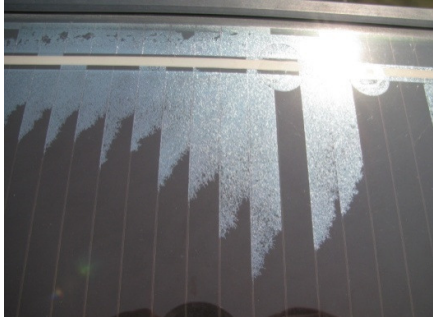
* Based on I-V Curve correction using assumed values for various coefficients (alpha = 0.12% per C, beta = -0.2% per C, Rs=0 & k=0) and assuming linear rate of degradation with time.					
<b>Key Observations:</b>					
<ul style="list-style-type: none"> <li>Major bar graph corrosion is found at the lower part of the module</li> <li>Bar graph corrosion is also found in the top edge of the module, near the electrodes.</li> <li>The module is broken at the two bottom corners.</li> </ul>					
<b>Recommendations:</b>					
Since the modules have been installed for research purpose and not for power generation, the research project's requirements need to be followed.					
<b>Module having major corrosion in the bottom part</b>		<b>Bar Graph Corrosion</b>		<b>Breakage in Module</b>

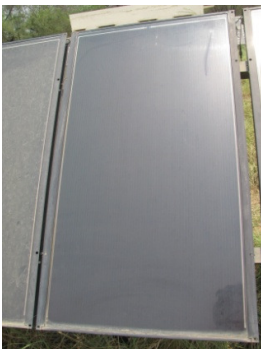
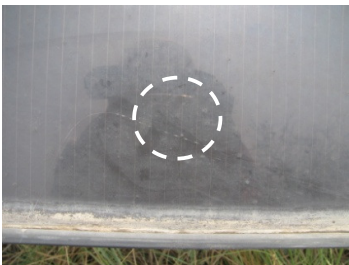
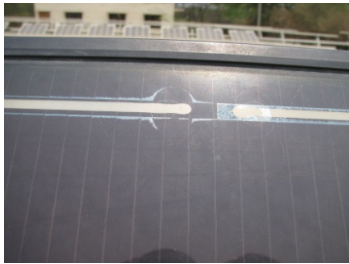
* Based on I-V Curve correction using assumed values for various coefficients (alpha = 0.12% per C, beta = -0.2% per C, Rs=0 & k=0) and assuming linear rate of degradation with time.					
<b>Key Observations:</b>					
<ul style="list-style-type: none"> <li>Small scratch has been found on the glass cover of the module</li> <li>Bar Graph corrosion has started at the top edge of the module, near the electrodes.</li> <li>Tilt angle of Module is 45 deg. whereas Latitude is 28.5 deg.</li> <li>(Non-optimum tilt)</li> </ul>					
<b>Recommendations:</b>					
Since the modules have been installed for research purpose and not for power generation, the research project's requirements need to be followed.					
<b>Amorphous Silicon module</b>		<b>Small scratch in the Glass</b>		<b>Bar graph corrosion near the electrodes</b>

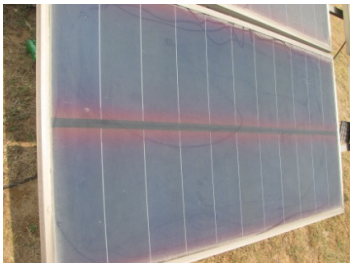
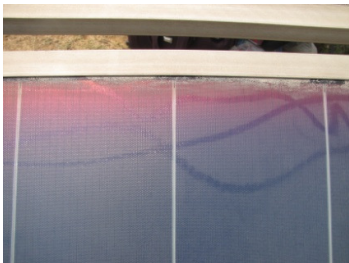
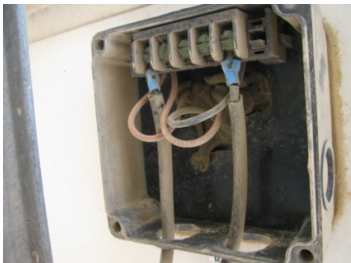
* Based on I-V Curve correction using assumed values for various coefficients (alpha = 0.12% per C, beta = -0.2% per C, Rs=0 & k=0) and assuming linear rate of degradation with time.						
<b>Key Observations:</b>						
<ul style="list-style-type: none"> <li>• “Snail tracks” are visible on the surface of the module, both through naked eye, and also in Infra-red images.</li> <li>• The output terminals are corroded, and soiled.</li> <li>• Tilt angle of Module is 45 deg. whereas Latitude is 28.5 deg.</li> <li>• (Non-optimum tilt)</li> </ul>						
<b>Recommendations:</b>						
Since the modules have been installed for research purpose and not for power generation, the research project’s requirements need to be followed.						
<b>Amorphous silicon module</b>		<b>“snail-trail”-like feature</b>		<b>Corrosion in output terminals</b>

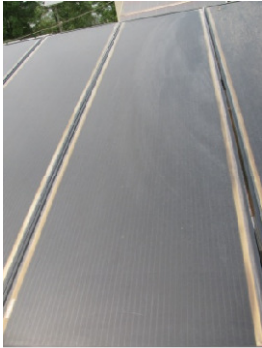
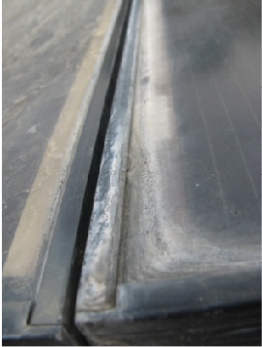
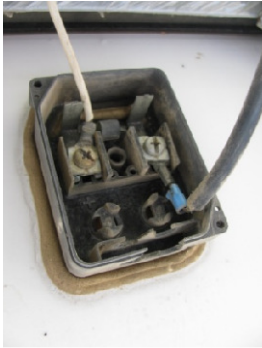
* Based on I-V Curve correction using assumed values for various coefficients (alpha = 0.12% per C, beta =-0.2% per C, Rs=0 & k=0) and assuming linear rate of degradation with time.					
<b>Key Observations:</b>					
<ul style="list-style-type: none"> <li>• Dark patches were observed near the electrodes.</li> <li>• White powdery deposits were present at the edges of the module.</li> <li>• Puncture in the backsheet of the module.</li> <li>• Tilt angle of Module is 45 deg. whereas Latitude is 28.5 deg.</li> <li>• (Non-optimum tilt)</li> </ul>					
<b>Recommendations:</b>					
Since the modules have been installed for research purpose and not for power generation, the research project's requirements need to be followed.					
<b>CIGS Module</b>		<b>Hard-to-remove deposits on module surface and blackening of electrodes</b>		<b>Corrosion in output terminals</b>

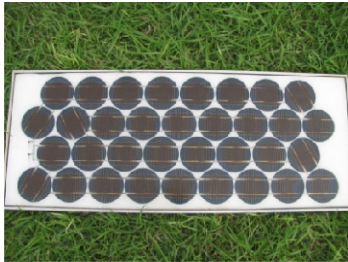
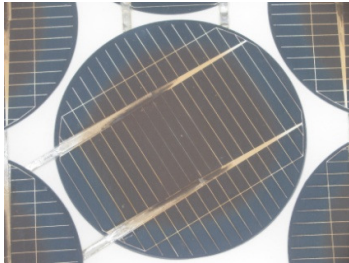
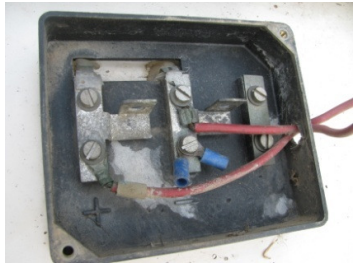
* Based on I-V Curve correction using assumed values for various coefficients (alpha = 0.12% per C, beta = -0.2% per C, Rs=0 & k=0) and assuming linear rate of degradation with time.					
<b>Key Observations:</b>					
<ul style="list-style-type: none"> <li>• Dark discoloration in all the solar cells but no delamination</li> <li>• Corrosion in some portion of the Metallization</li> <li>• Corrosion in output terminals</li> </ul>					
<div style="display: flex; align-items: center;"> <div style="flex: 1;"> <p><b>Recommendations:</b></p> <p>Modules should be cleaned at least once a week since dust on the modules can reduce the power generation. The module junction box should be properly covered so as to prevent entry of water into the junction box.</p> </div> <div style="flex: 1;">

</div> </div>					
<b>Dark Discoloration in middle of all solar cells</b>		<b>Corrosion in cell interconnects</b>		<b>Corrosion in output terminals</b>

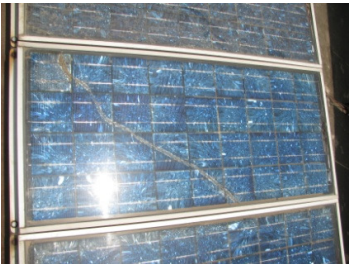
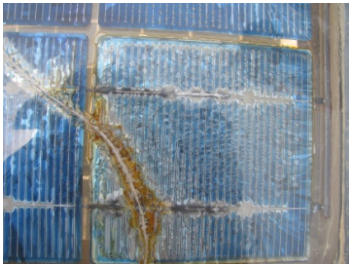
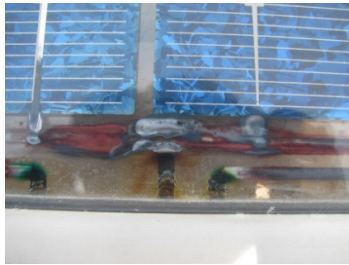
* Based on I-V Curve correction using assumed values for various coefficients (alpha = 0.12% per C, beta = -0.2% per C, Rs=0 & k=0) and assuming linear rate of degradation with time.					
<b>Key Observations:</b>					
<ul style="list-style-type: none"> <li>Light discoloration and delamination in cell</li> <li>Discoloration in the Metallization (fingers)</li> <li>Tilt angle of Module is 16 deg. whereas Latitude is 26 deg.</li> <li>(Non-optimum tilt)</li> <li>Heavily soiled</li> <li>Front glass broken</li> </ul>					
<b>Recommendations:</b>					
Tilt Angle should be rectified to get higher energy generation. Modules should be cleaned at least once a week since dust on the modules can reduce the power generation.					
<b>Module having a crack in the glass</b>		<b>Delamination in one of the solar cells through which the crack passes</b>		<b>Major corrosion in the string interconnects</b>

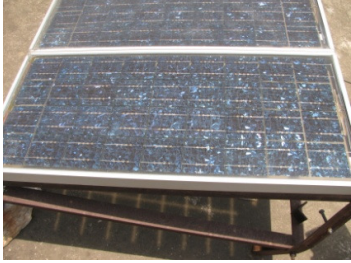
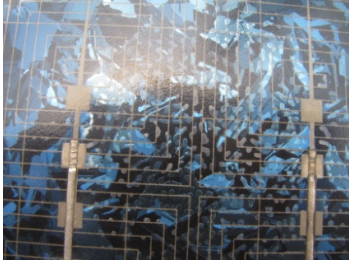
* Based on I-V Curve correction using assumed values for various coefficients (alpha = 0.12% per C, beta =-0.2% per C, Rs=0 & k=0) and assuming linear rate of degradation with time.					
<b>Key Observations:</b>					
<ul style="list-style-type: none"> <li>• Light discoloration and delamination in 1 cell</li> <li>• Corrosion in the string interconnects</li> <li>• Tilt angle of Module is 16 deg. whereas Latitude is 26 deg.</li> <li>• (Non-optimum tilt)</li> </ul>					
<b>Recommendations:</b>					
Modules should be cleaned at least once a week since dust on the modules can reduce the power generation. The tilt angle should be adjusted close to the latitude tilt to maximize the annual energy generation.					
<b>Multi crystalline silicon module with glass at both top and bottom</b>		<b>Corrosion in String Interconnects</b>		<b>Delamination (bubbles) in a solar cell</b>

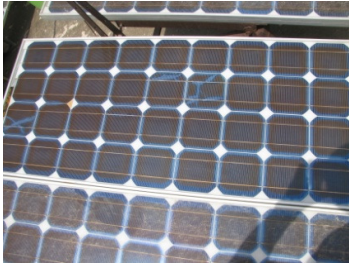
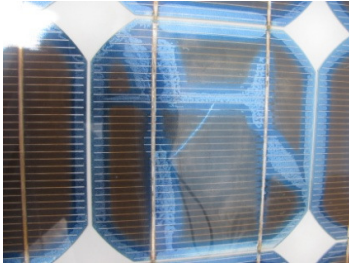
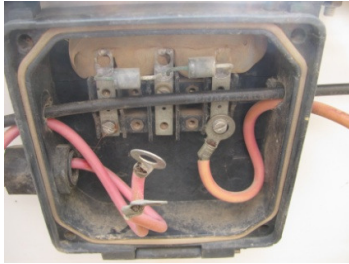
* Based on I-V Curve correction using assumed values for various coefficients (alpha = 0.12% per C, beta = -0.2% per C, Rs=0 & k=0) and assuming linear rate of degradation with time.					
<b>Key Observations:</b>					
<ul style="list-style-type: none"> <li>Dark discoloration in all of the solar cells</li> <li>Delamination in most of the cells along the cell periphery</li> <li>Minor corrosion in the output terminals</li> <li>Tilt angle of Module is 16 deg. whereas Latitude is 26 deg.</li> <li>(Non-optimum tilt)</li> </ul>					
<b>Recommendations:</b>					
Modules should be cleaned at least once a week since dust on the modules can reduce the power generation.					
<b>Dark discoloration in all solar cells</b>		<b>Delamination in a Solar cell</b>		<b>Corrosion in output terminals</b>

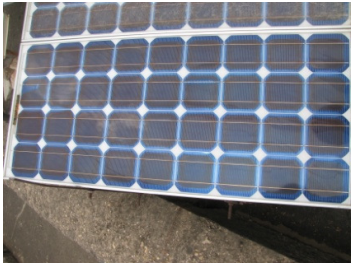
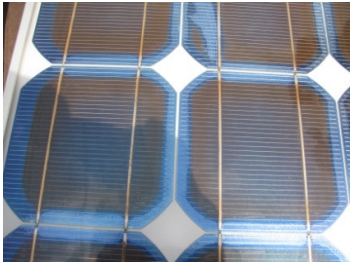
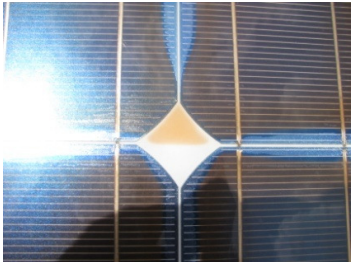
* Based on I-V Curve correction using assumed values for various coefficients (alpha = 0.12% per C, beta =-0.2% per C, Rs=0 & k=0) and assuming linear rate of degradation with time.					
<b>Key Observations:</b>					
<ul style="list-style-type: none"> <li>Dark discoloration in all solar cells</li> <li>Delamination along the periphery of most of the solar cells</li> <li>Major corrosion at some portions of the busbars and cell interconnects.</li> <li>Tilt angle of Module is close to the Latitude of the site.</li> </ul>					
<div style="display: flex; align-items: flex-start;"> <div style="flex: 1;"> <p style="text-align: center; margin-bottom: 5px;"><b>I-V Data</b></p> <p style="text-align: center; margin-bottom: 5px;">Irradiance 814 W/m<sup>2</sup> Module Temperature 50.7 °C</p>

<b>Dark discoloration in all solar cells</b>		<b>Delamination along the periphery of the solar cells</b>		<b>Discoloration just above the junction box area</b>

</div> </div>					
<b>Recommendations:</b>					
Modules should be cleaned at least once a week since dust on the modules can reduce the power generation.

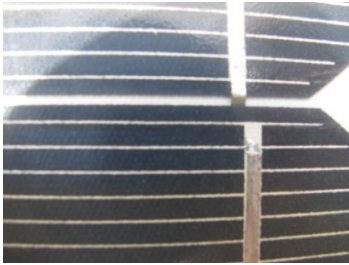
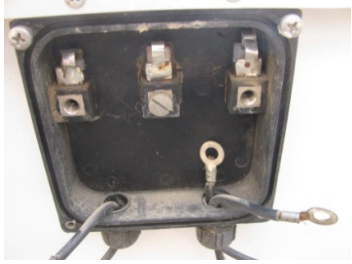
* Based on I-V Curve correction using assumed values for various coefficients (alpha = 0.12% per C, beta = -0.2% per C, Rs=0 & k=0) and assuming linear rate of degradation with time.					
<b>Key Observations:</b>					
<ul style="list-style-type: none"> <li>Light discoloration in all cells</li> <li>Discoloration in the cell interconnects</li> <li>Output terminals are free from corrosion but lightly soiled.</li> <li>Tilt angle of Module is close to the Latitude of the site.</li> </ul>

<b>Recommendations:</b>					
Modules should be cleaned at least once a week since dust on the modules can reduce the power generation.					
<b>Light Discoloration in all cells</b>		<b>corrosion in metallization</b>		<b>Output terminals are soiled but free from corrosion</b>

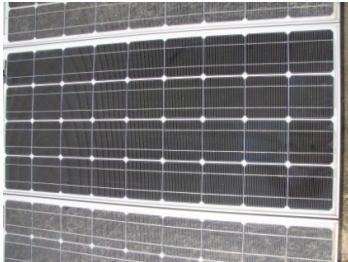
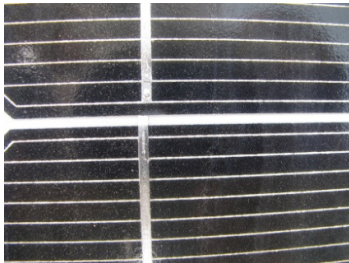
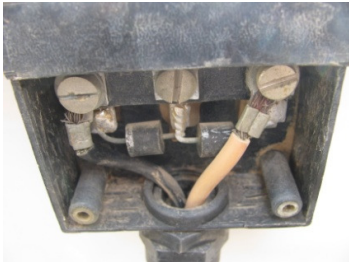
* Based on I-V Curve correction using assumed values for various coefficients (alpha = 0.12% per C, beta =-0.2% per C, Rs=0 & k=0) and assuming linear rate of degradation with time.					
<b>Key Observations:</b>					
<ul style="list-style-type: none"> <li>Light discoloration and delamination in 1 cell</li> <li>Discoloration in the Metallization (fingers)</li> <li>Corrosion in output terminals</li> <li>Tilt angle of Module is close to Latitude angle of site</li> </ul>					
<b>Recommendations:</b>					
Modules should be cleaned at least once a week since dust on the modules can reduce the power generation.					
<b>Light Discoloration</b>		<b>Front Glass has become grainy (coarse to touch)</b>		<b>Corrosion in output terminals</b>

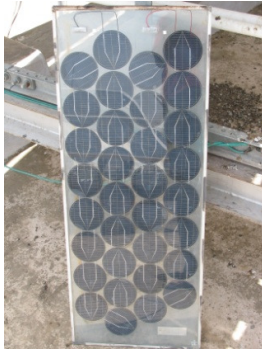
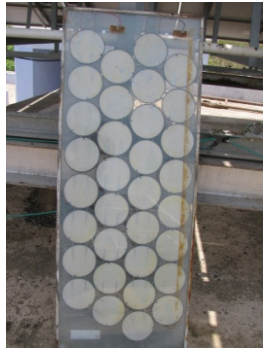
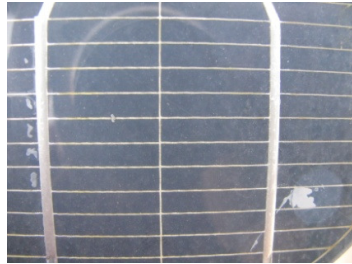
* Based on I-V Curve correction using assumed values for various coefficients (alpha = 0.12% per C, beta = -0.2% per C, Rs=0 & k=0) and assuming linear rate of degradation with time.					
<b>Key Observations:</b>					
<ul style="list-style-type: none"> <li>Very light discoloration in some cells</li> <li>Delamination in a few cells</li> <li>Delamination (air pockets or void) at some positions between solar cells.</li> <li>Minor corrosion in the fingers in some cells</li> <li>Tilt angle of Module is close to the Latitude angle.</li> </ul>					
<b>Recommendations:</b>					
Modules should be cleaned at least once a week since dust on the modules can reduce the power generation.					
<b>Mono Crystalline silicon module with Glass on top (and bottom)</b>		<b>Back side of the Module</b>		<b>Delamination</b>

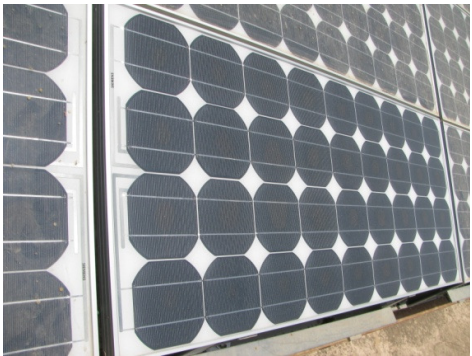
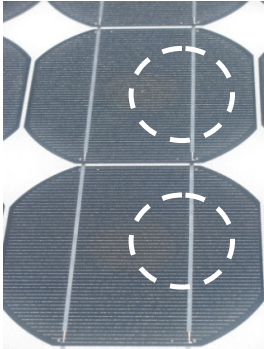
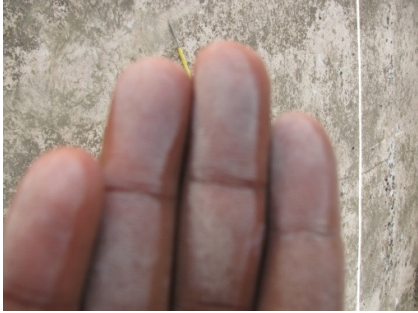
* Based on I-V Curve correction using assumed values for various coefficients (alpha = 0.12% per C, beta =-0.2% per C, Rs=0 & k=0) and assuming linear rate of degradation with time.					
<b>Key Observations:</b>					
<ul style="list-style-type: none"> <li>• Light discoloration in the middle of each cell</li> <li>• No delamination in any of the cells</li> <li>• No corrosion in the metallization and output terminals</li> <li>• Tilt angle of Module is 18 deg. whereas Latitude is 9 deg.</li> <li>• (Non-optimum tilt)</li> <li>• Chalking (white powder) from the backsheet</li> </ul>					
<b>Recommendations:</b>					
Modules should be cleaned at least once a week since dust on the modules can reduce the power generation.					
<b>Module is free from delamination</b>		<b>Light discoloration in centre of each solar cell</b>		<b>Chalking (white powder) from backsheet</b>

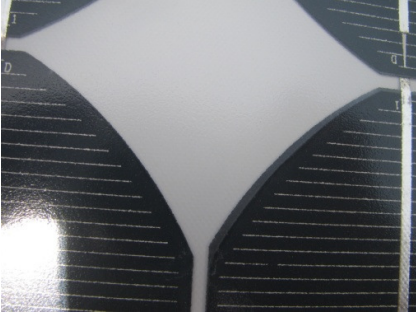
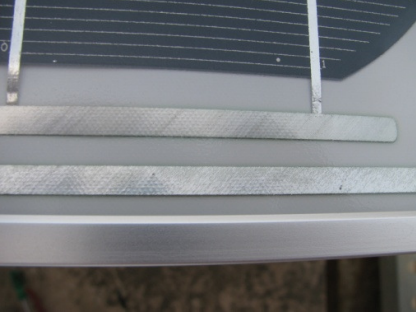
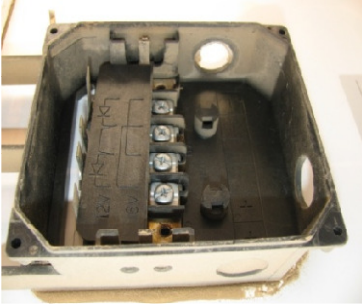
* Based on I-V Curve correction using assumed values for various coefficients (alpha = 0.12% per C, beta = -0.2% per C, Rs=0 & k=0) and assuming linear rate of degradation with time.					
<b>Key Observations:</b>					
<ul style="list-style-type: none"> <li>No discoloration in the middle of each cell</li> <li>No delamination in any of the cells</li> <li>No corrosion in the metallization and output terminals</li> <li>Tilt angle of Module is 18 deg. whereas Latitude is 9 deg.</li> <li>(Non-optimum tilt)</li> </ul>					
<b>Recommendations:</b>					
Modules should be cleaned at least once a week since dust on the modules can reduce the power generation.					
<b>No Discoloration</b>		<b>No Discoloration in Metallization</b>		<b>Junction box intact and good seal</b>

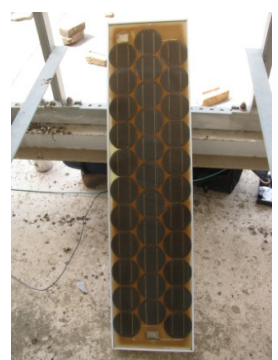
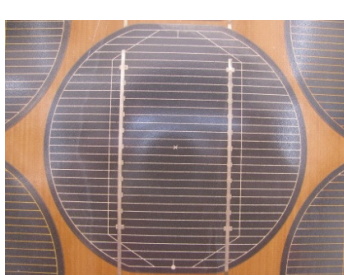
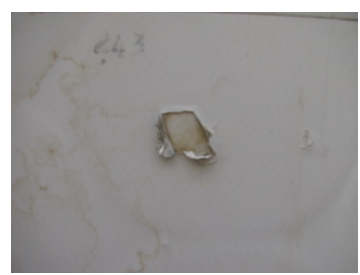
* Based on I-V Curve correction using assumed values for various coefficients (alpha = 0.12% per C, beta = -0.2% per C, Rs=0 & k=0) and assuming linear rate of degradation with time.					
<b>Key Observations:</b>					
<ul style="list-style-type: none"> <li>• Dark discoloration not only above the solar cells but also in between the solar cells</li> <li>• Discoloration in the Metallization (fingers)</li> <li>• Puncture in the backsheet just below a solar cell</li> </ul>

<b>Recommendations:</b>					
Modules should be cleaned at least once a week since dust on the modules can reduce the power generation. Module should be handled with care during installation so as to prevent any scratches or puncture in the modules.					
<b>Dark discoloration over almost the entire module</b>		<b>Corrosion in Metallization</b>		<b>Puncture/scratch in the backsheet, just below a solar cell</b>

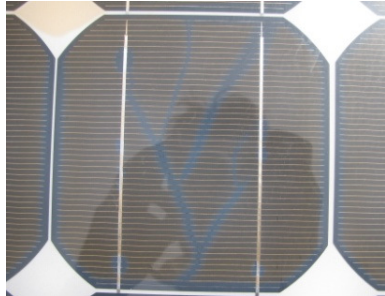
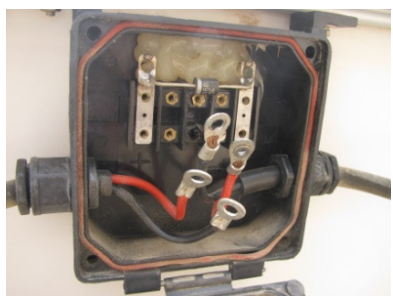
* Based on I-V Curve correction using assumed values for various coefficients (alpha = 0.12% per C, beta = -0.2% per C, Rs=0 & k=0) and assuming linear rate of degradation with time.					
<b>Key Observations:</b>					
<ul style="list-style-type: none"> <li>Dark discoloration in all solar cells in the module</li> <li>Cracks in some solar cells (made visible by photo-oxidative bleaching)</li> <li>No corrosion in the output terminals</li> <li>Tilt angle of Module is equal to the latitude of the place</li> </ul>					
<div style="display: flex; align-items: center;"> <div style="flex: 1;"> <p style="font-size: small; margin: 0;">I-V Data Irradiance 582 W/m<sup>2</sup>    Module Temperature 31.0 °C</p>

<b>Module having discoloration in all solar cells</b>		<b>Crack in the solar cell made visible by the photo-oxidation process</b>		<b>Output terminals are intact</b>

</div> </div>					
<b>Recommendations:</b>					
Modules should be cleaned at least once a week since dust on the modules can reduce the power generation. Module should be handled with care during installation so as to prevent any scratches or puncture in the modules. Module junction boxes should be properly covered to prevent moisture ingress (which can corrode the output terminals) and the cables should be regularly checked for any breakage, animal bites etc.
